**DIAMOND HILL
COMMUNITY DEVELOPMENT DISTRICT**

**FEBRUARY 12, 2024
AGENDA PACKAGE**

- 1.0 ERP PERMIT INFORMATION
- 2.0 PERMIT INSPECTION HISTORY
- 3.0 RECONCILIATION OF CURRENT DEFECT OBSERVATIONS
- 4.0 POND ELEVATION SUMMARY
- 5.0 INSPECTION REPORTS & PICTURES

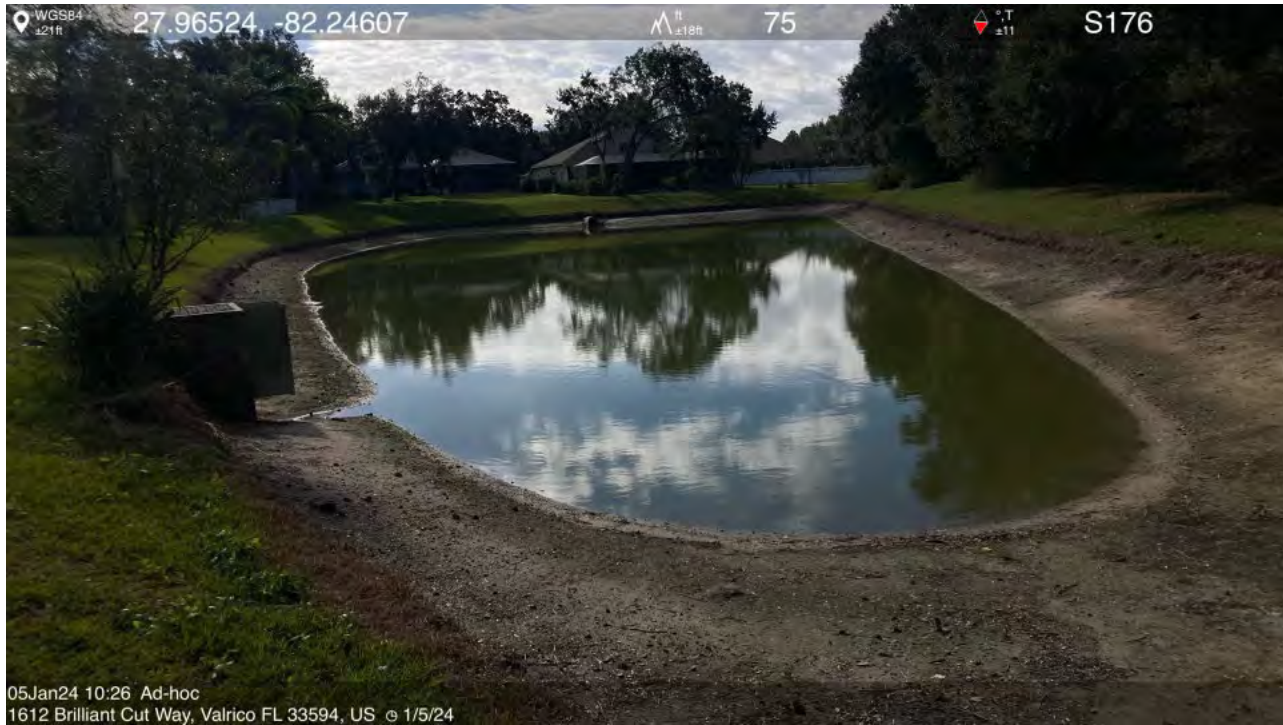
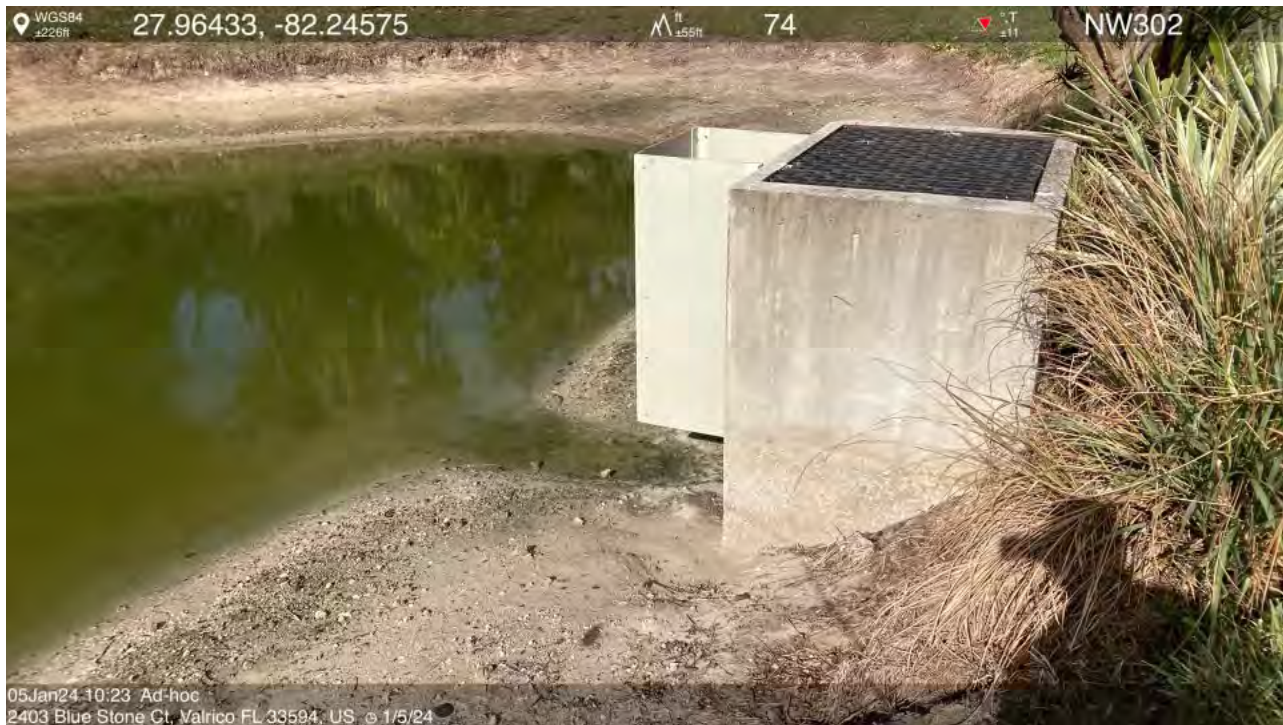
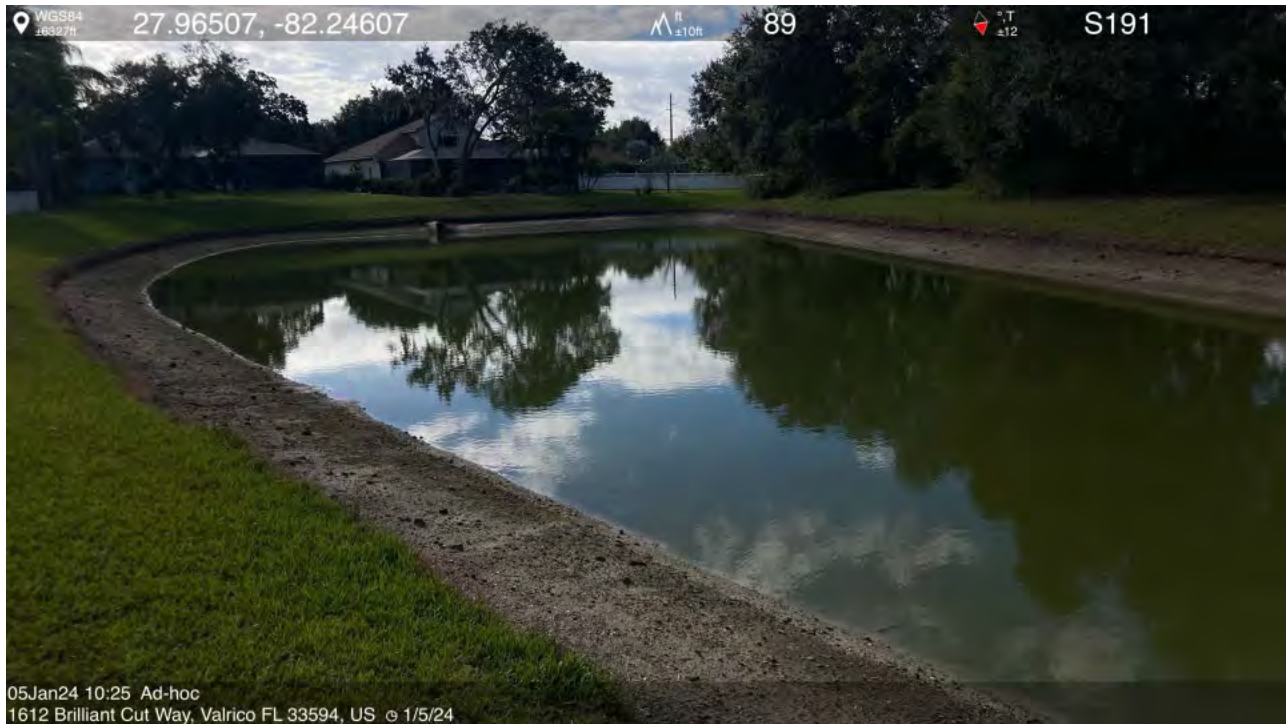
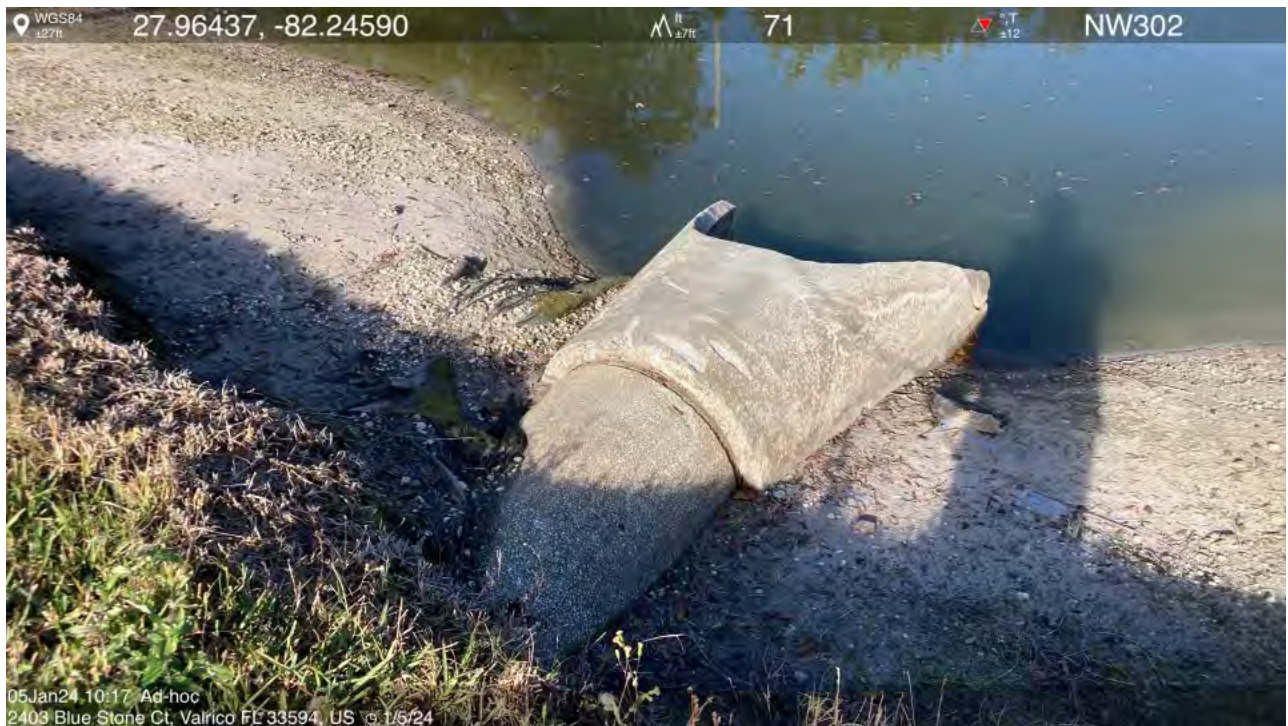
Bank Erosion Notes: No erosion or shoreline erosion observed. Seasonal high water table at lowest point during inspection and exposed banks are expected this time of year.			
CONDITION OF POND STRUCTURES (CONTROL STRUCTURES, MITERED END SECTIONS, INLETS)			
Severity Ranking:	Minor		
Type of Damage:	FES Eroded		
Structures Notes: One control structure with skimmer and one FES observed to be in operational condition. FES is extended into pond and has eroded behind with exposed pipe. Recommended to monitor this site.

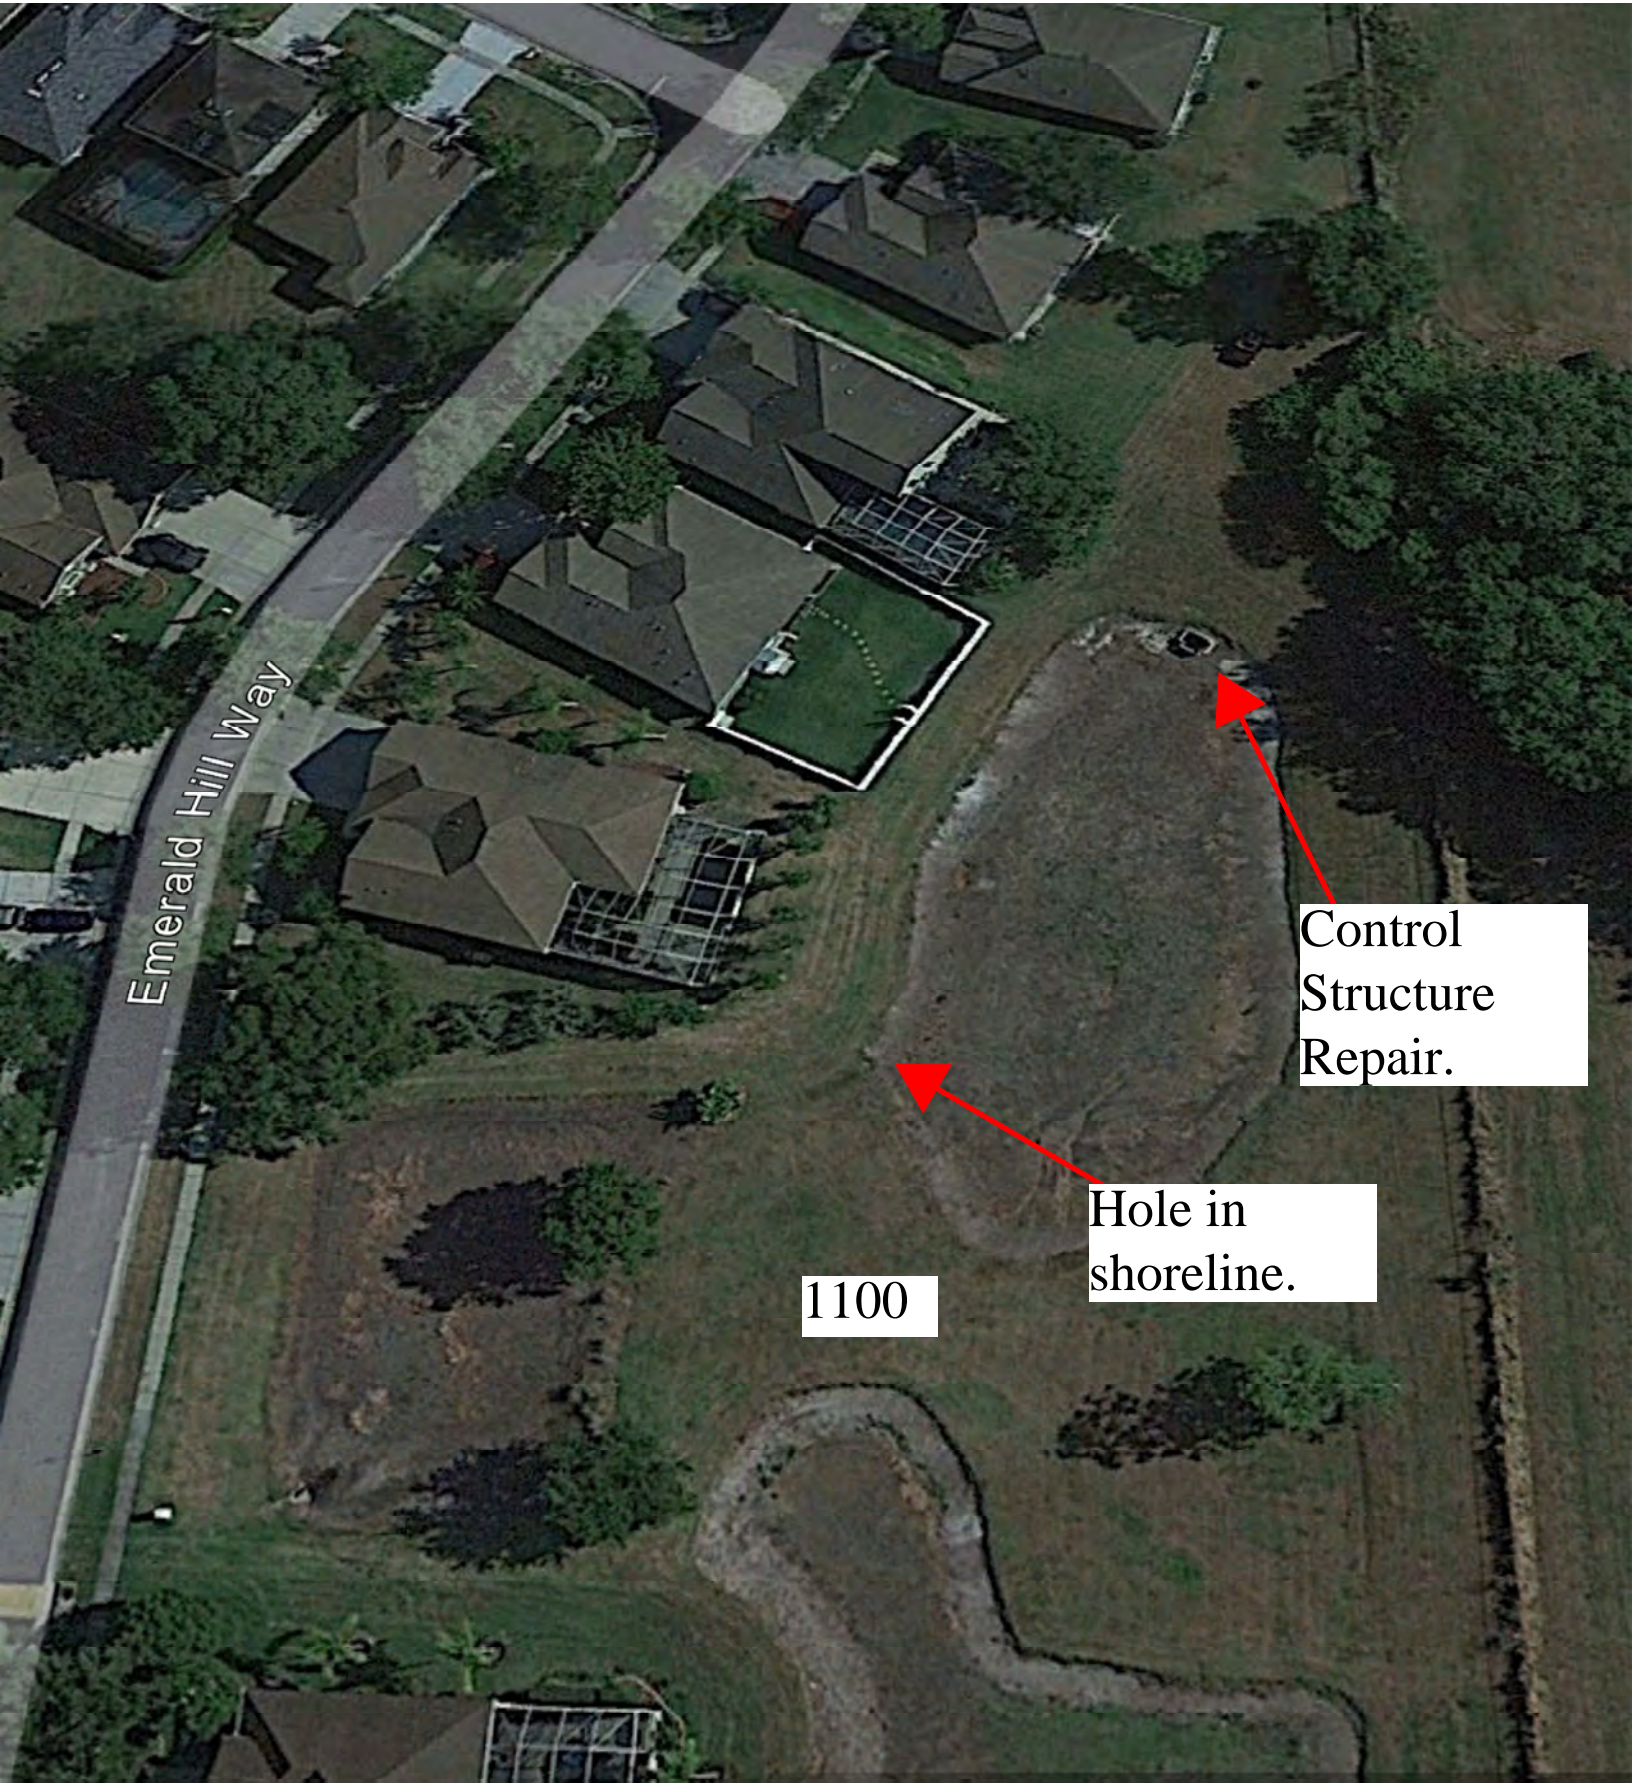
1100

Bank Erosion Notes: There was a section of pond bank observed to have a large hole of undermined turf on the West side of the Northern most pond that should be investigated further.			
CONDITION OF POND STRUCTURES (CONTROL STRUCTURES, MITERED END SECTIONS, INLETS)			
Severity Ranking:	Moderate		
Type of Damage:	Control Strutre Repair		
Structures Notes: The control structure in the northern most pond was observed to have a broken grate boarder. The piece is mangled and jutting off the structure. There is also broken off concrete from the structure with exposed skimmer mounting hardware behind. Two FES were observed in operational condition with no defects.

Hole in shoreline.

Control Structure Repair.

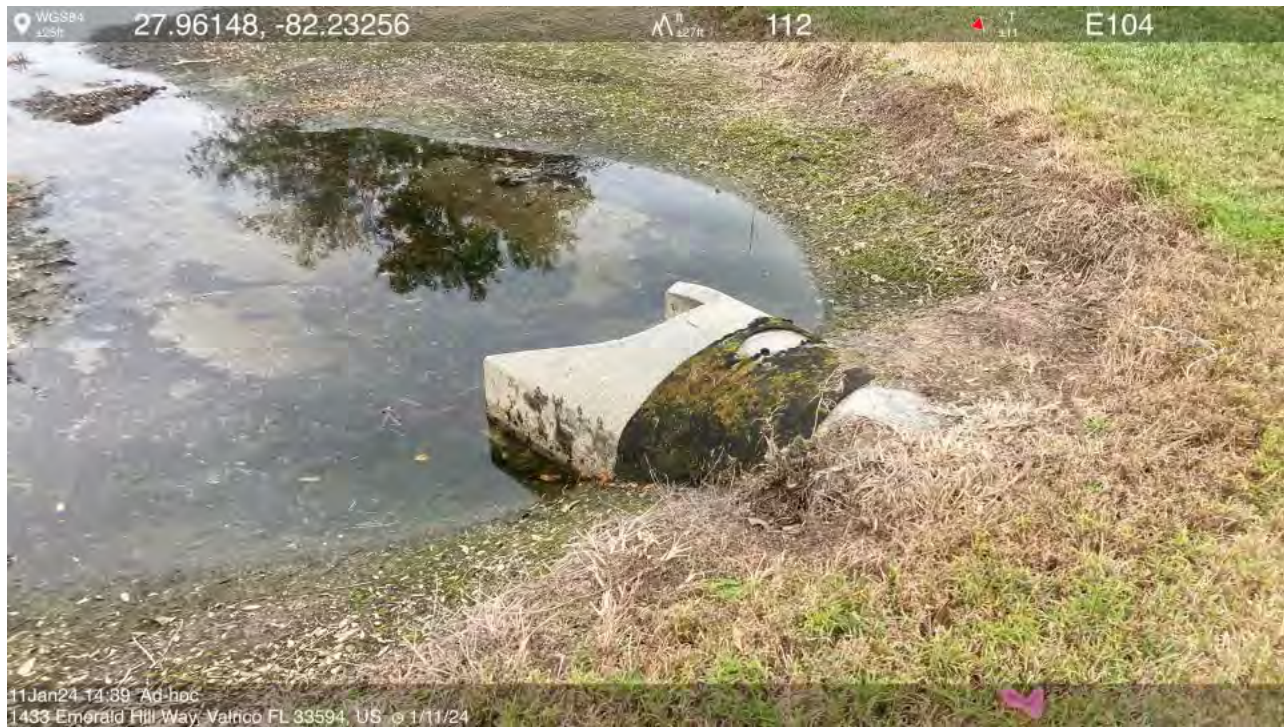
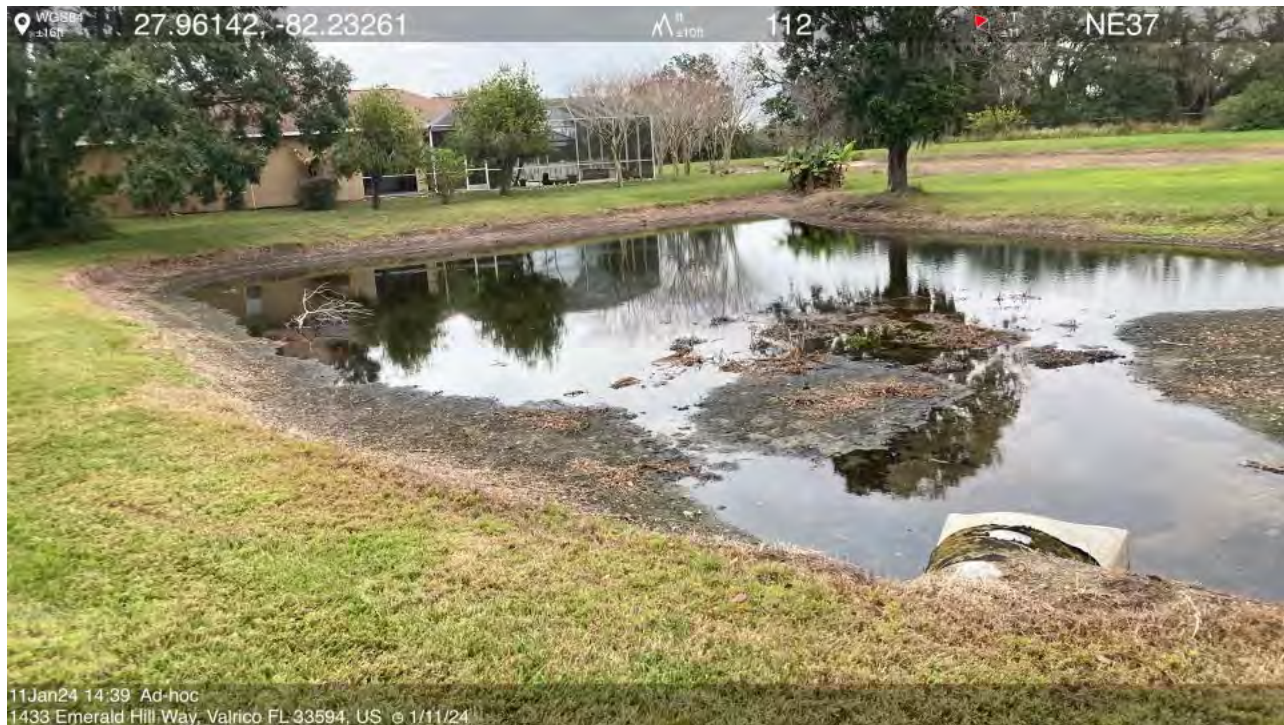
CDD POND EVALUATION			
INSPECTION DATE:	1/11/2024	PERMIT NUMBER:	24679.003
INSPECTED BY:	Jerry Whited	POND PERIMETER:	1,049 ft
POND NUMBER:	1100	POND AREA:	42,923 sq ft
Full Pond Access:	Yes	Trash Observed:	Yes
Benifitial Vegetaion Present:	No	Water Quality:	Average
Tailwater Issue Observed:	No	Water Quality Notes:	NA
Observed Depth:	Less than 1'	Observed Temperature:	65
POND ELEVATION ANALYSIS			
Treatment Type:	Wet (Wetland)	Design Bottom Elevation:	104
Weir/Orifice Elevation:	106.5	Observed Bottom Elevation:	104
Skimmer Bottom Elevation:	106	Elevation Difference:	0
Pond Elevation Notes: Pond 1100 is a wet pond with wetland. There are 3 separate pond areas surrounding the wetland. Two of the pond areas we're dry and the third pond area had less than 1' of water. Normal season high water level is 1' which was within what was observed.			
BANK EROSION AND SCOUR			
Severity Ranking:	Minor		
Type of Erosion:	Hole in bank

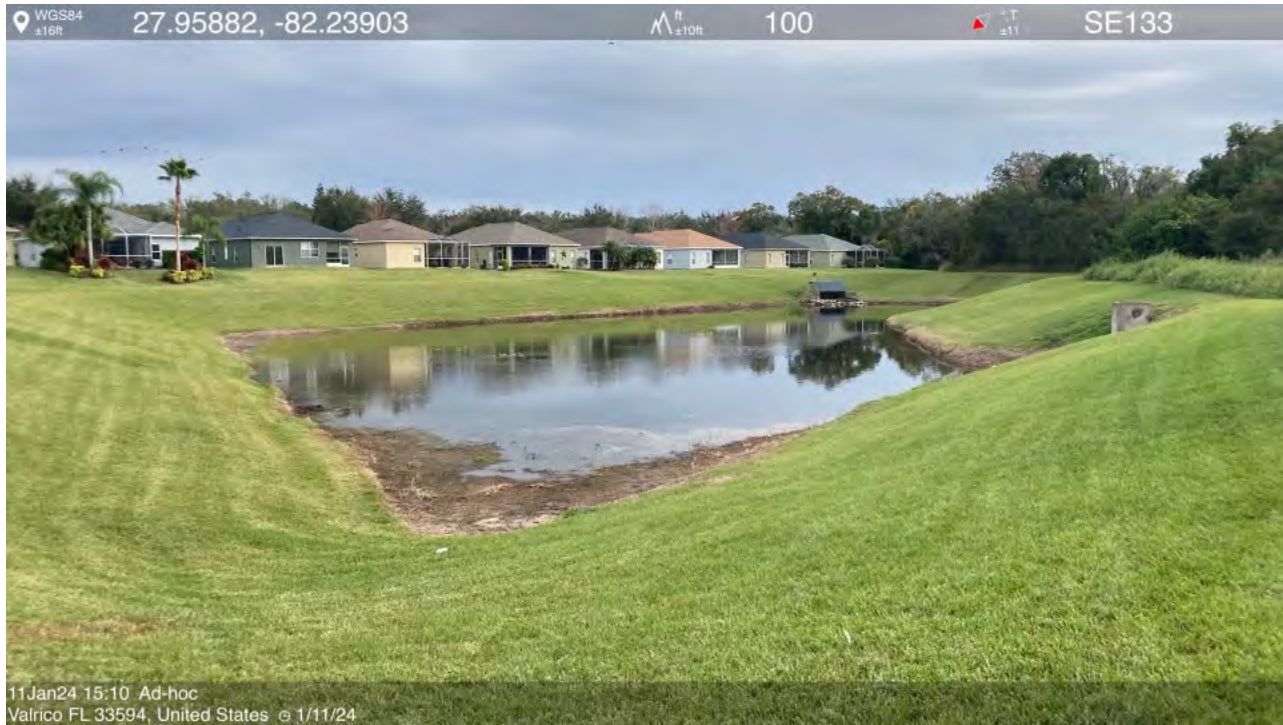
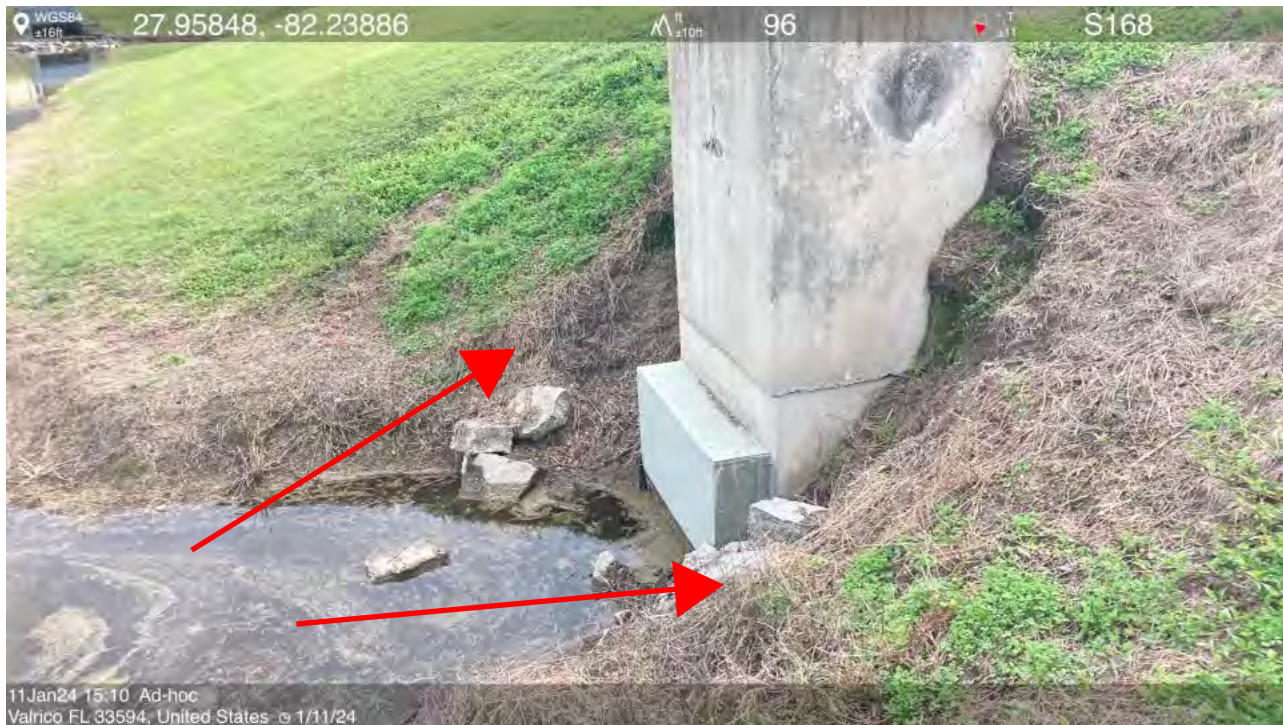
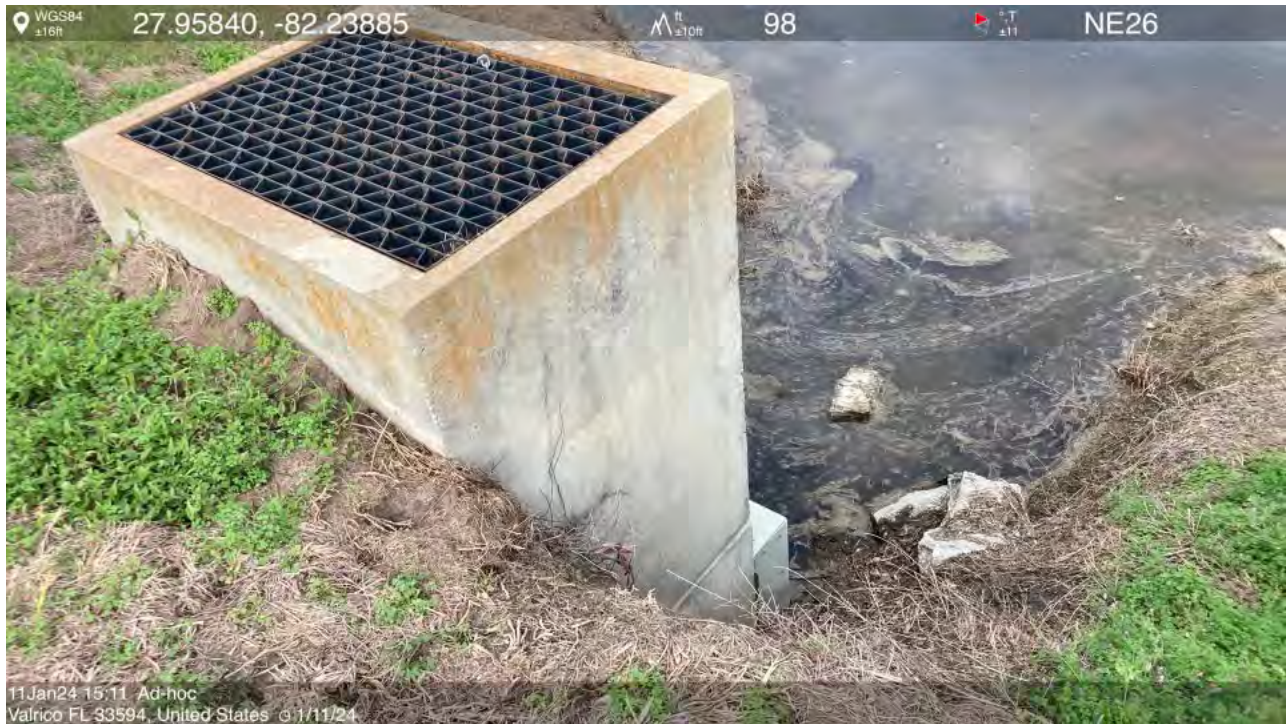
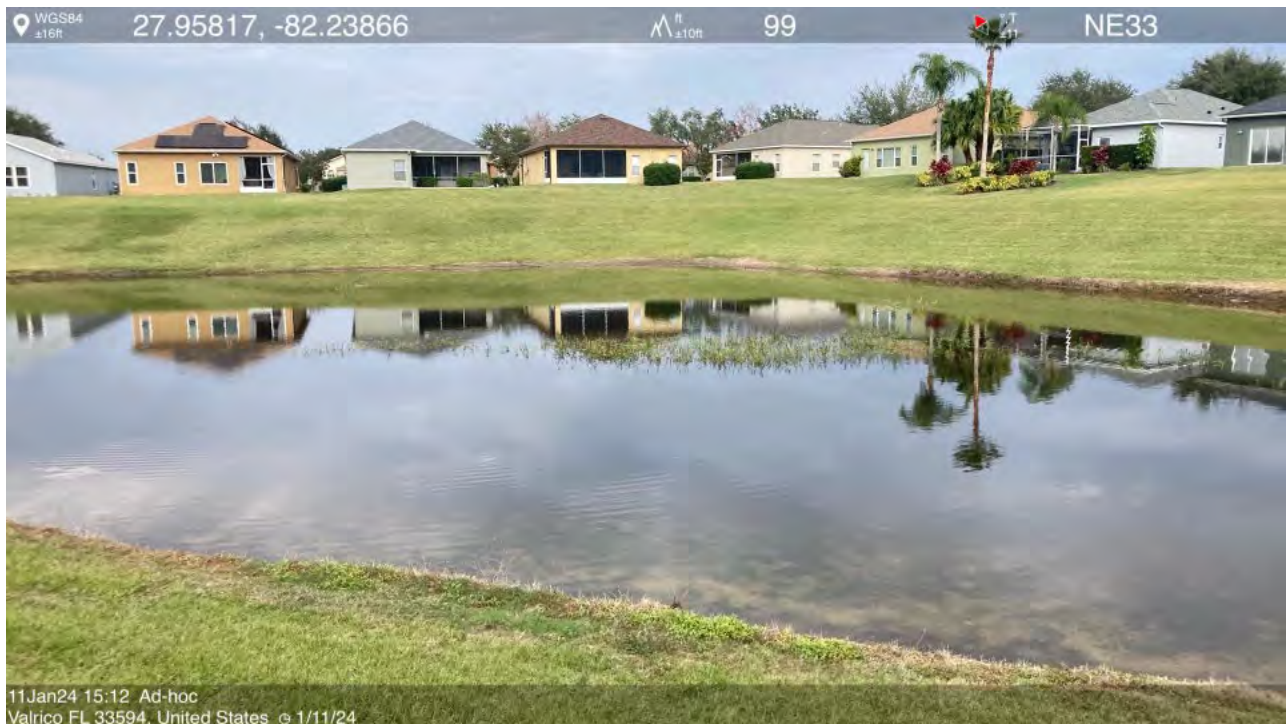
CDD POND EVALUATION			
INSPECTION DATE:	1/11/2024	PERMIT NUMBER:	24679.003
INSPECTED BY:	Jerry Whited	POND PERIMETER:	815.27 ft
POND NUMBER:	1400	POND AREA:	32,622.11 sq ft
Full Pond Access:	Yes	Trash Observed:	No
Benifitial Vegetaion Present:	No	Water Quality:	Average
Tailwater Issue Observed:	No	Water Quality Notes:	NA
Observed Depth:	2' 6"	Observed Temperature:	65.12 Degrees
POND ELEVATION ANALYSIS			
Treatment Type:	Dry Filter	Design Bottom Elevation:	97
Weir/Orifice Elevation:	98.4	Observed Bottom Elevation:	95.90
Skimmer Bottom Elevation:	97.9	Elevation Difference:	-1.10
Pond Elevation Notes: Pond elevation was observed to be approximately 1.10' more than design elevation. The elevation difference does not appear to affect the functionality of the pond.			
BANK EROSION AND SCOUR			
Severity Ranking:	Minor		
Type of Erosion:	Water Level Fluctuation		
Bank Erosion Notes: Minor erosion around control structure. Seasonal high water table at lowest point during inspection and exposed banks are expected this time of year.

CONDITION OF POND STRUCTURES (CONTROL STRUCTURES, MITERED END SECTIONS, INLETS)			
Severity Ranking:	Minor		
Type of Damage:	Concrete damage on structure.		
Structures Notes: One FES with grate observed to be in operational condition however there is a section of concrete that is broken off exposing some of the grate hardware. One control structure with skimmer observed to be in operational condition.

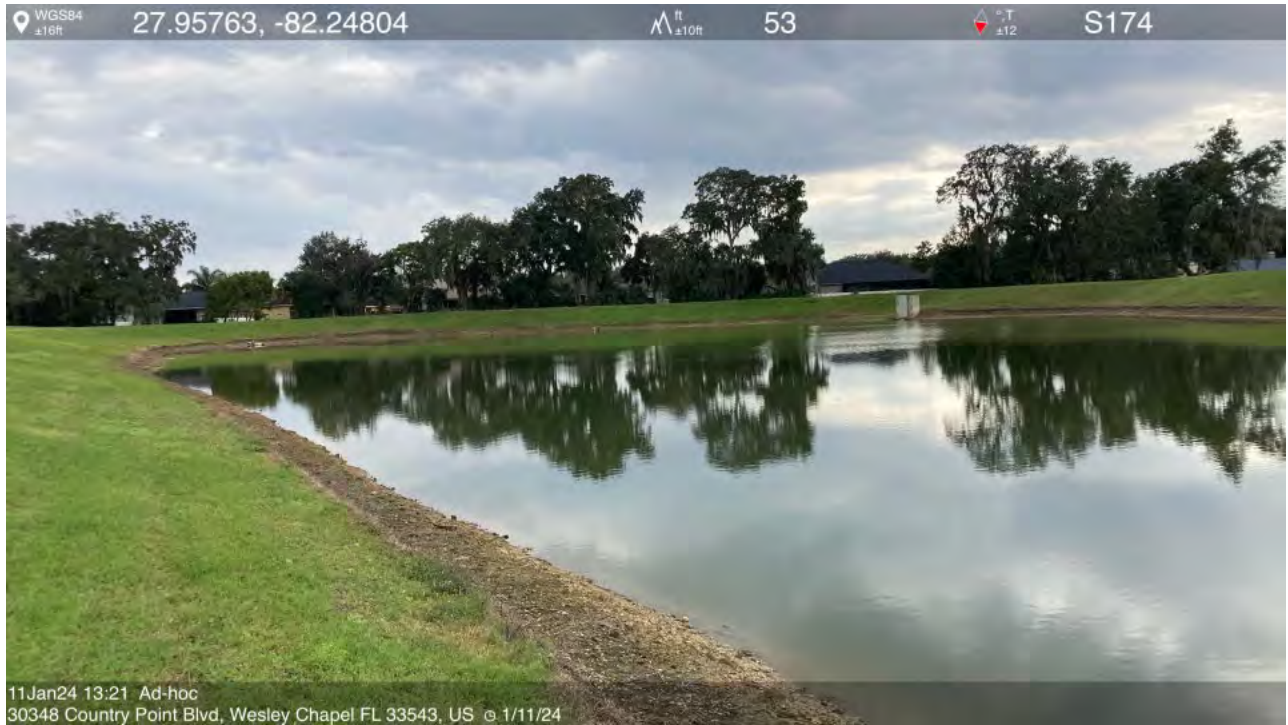
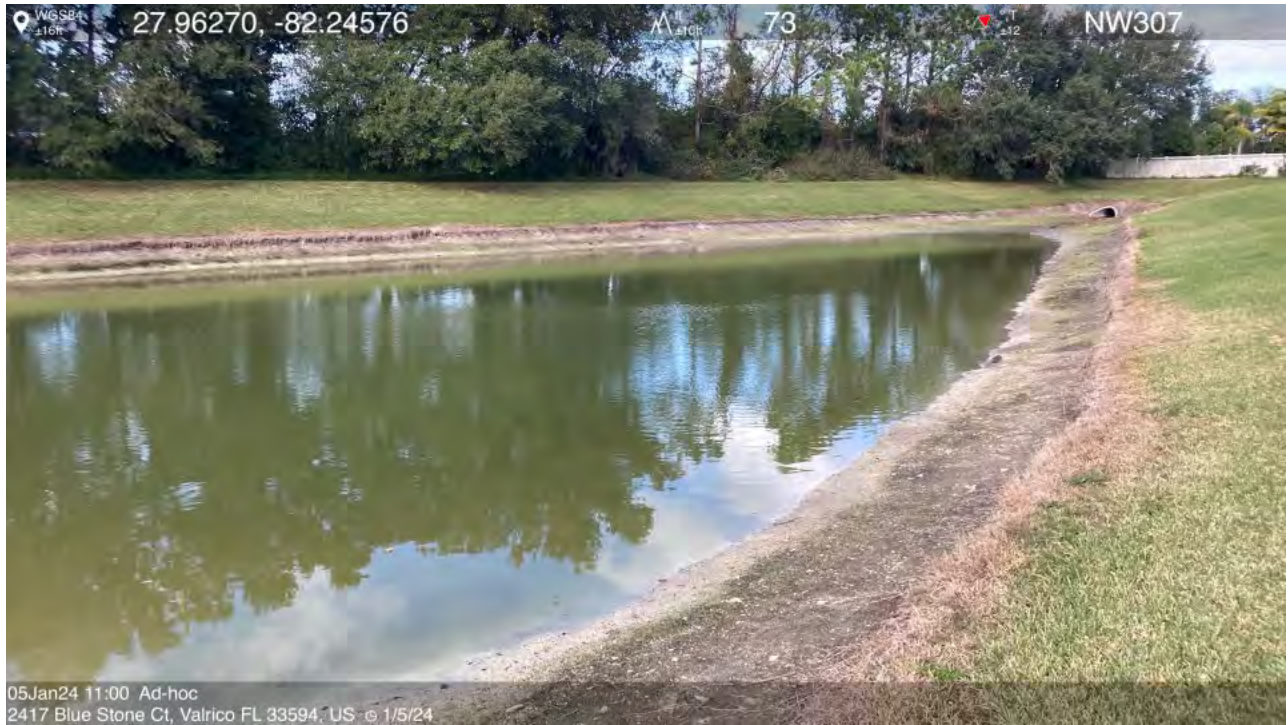
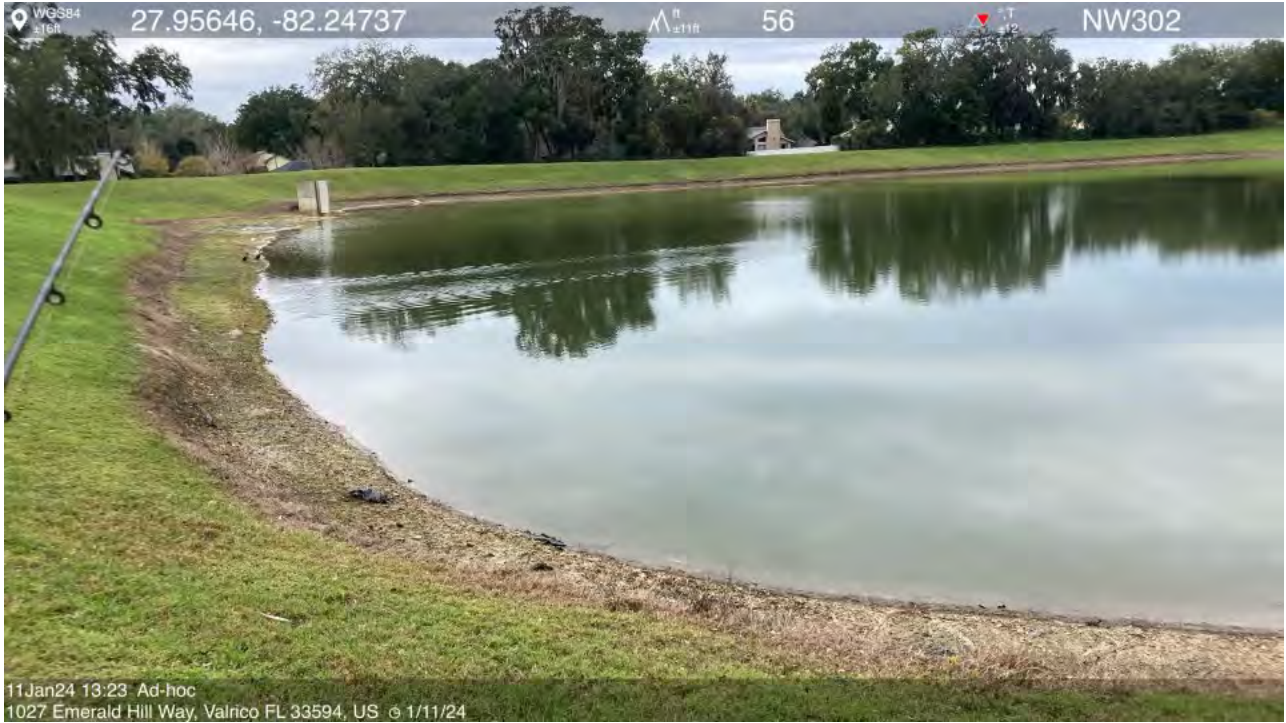
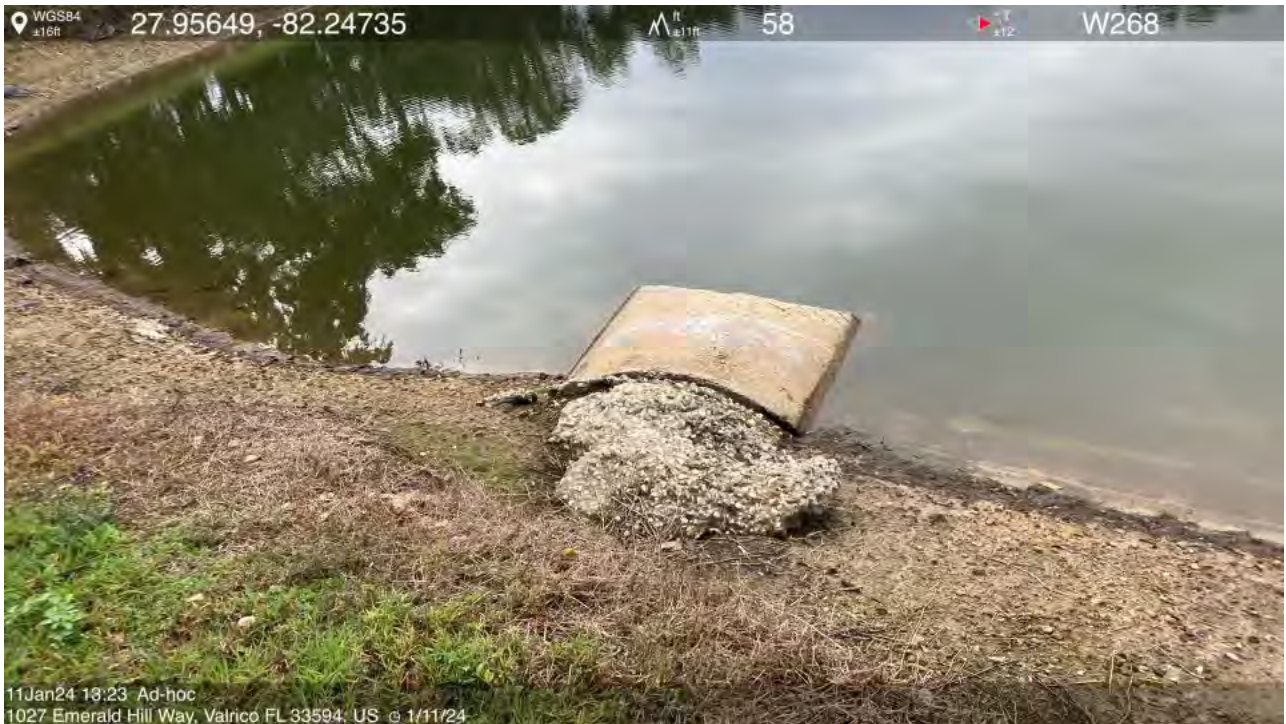
CONDITION OF POND STRUCTURES (CONTROL STRUCTURES, MITERED END SECTIONS, INLETS)			
Severity Ranking:	Minor		
Type of Damage:	Control Structure		
Structures Notes: One control structure with skimmer observed. One of the grates is rusted and warped topping the control structure. Some cracks in concrete structure. Behind structure is eroding away and will soon expose pipe. Two FES's observed in operational condition with no defects. There is a control structure (525 in plans) that is adjacent to pond 40 and has a broken skimmer in need of repair.
