**DIAMOND HILL
COMMUNITY DEVELOPMENT DISTRICT**

**FEBRUARY 12, 2024
AGENDA PACKAGE**

- 1.0 ERP PERMIT INFORMATION
- 2.0 PERMIT INSPECTION HISTORY
- 3.0 RECONCILIATION OF CURRENT DEFECT OBSERVATIONS
- 4.0 POND ELEVATION SUMMARY
- 5.0 INSPECTION REPORTS & PICTURES

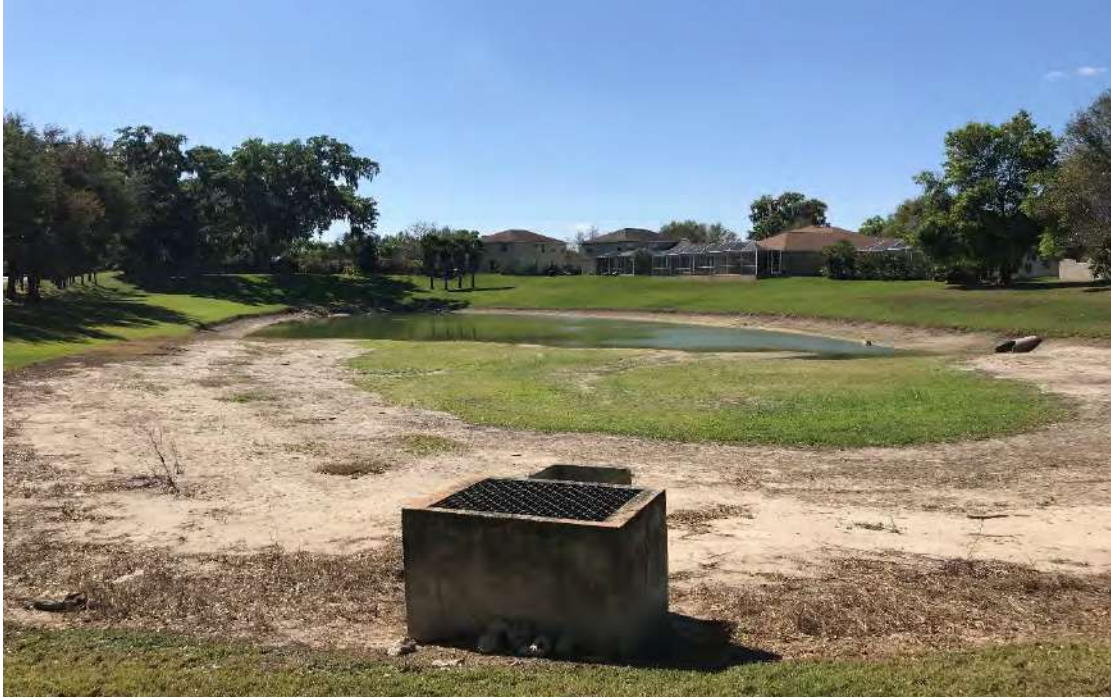
Photo 5
Southernly View of Pond 10

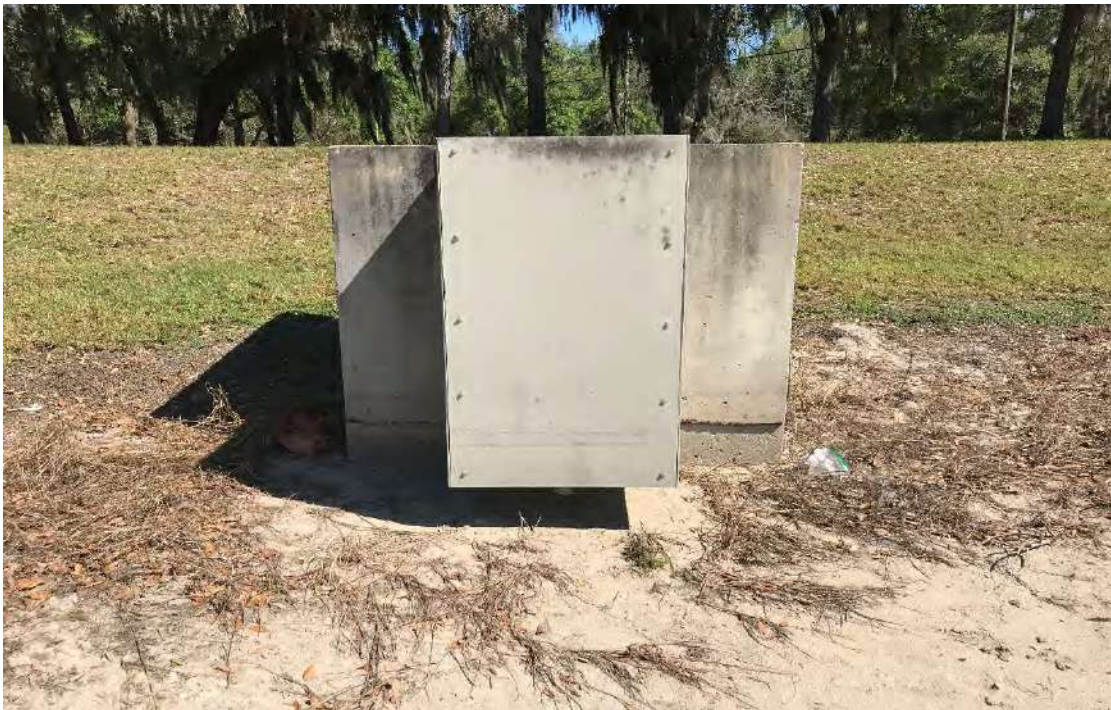
Structural Condition Notes: Skimmer detached from OCS NW Entrance Pond. Sediment build-up around OCS 100 and 300 orifice.
Rating List
Select 3

Photo 6
View of OCS 100 (Blocked Orifice)

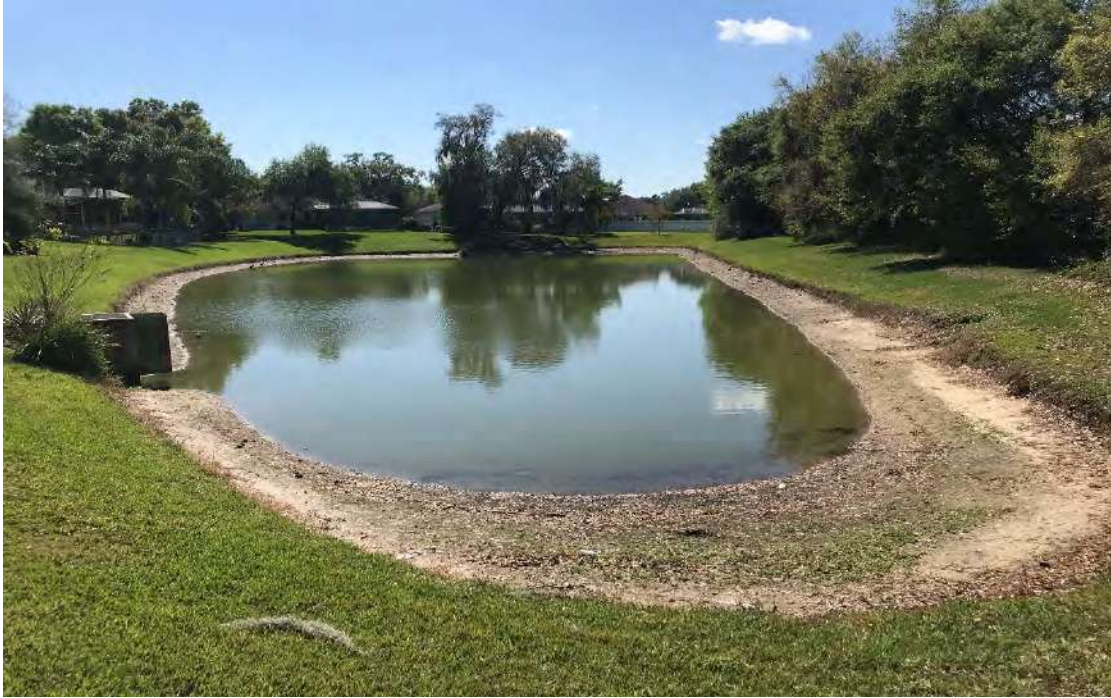
Photo 7
Southerly View of Pond 20

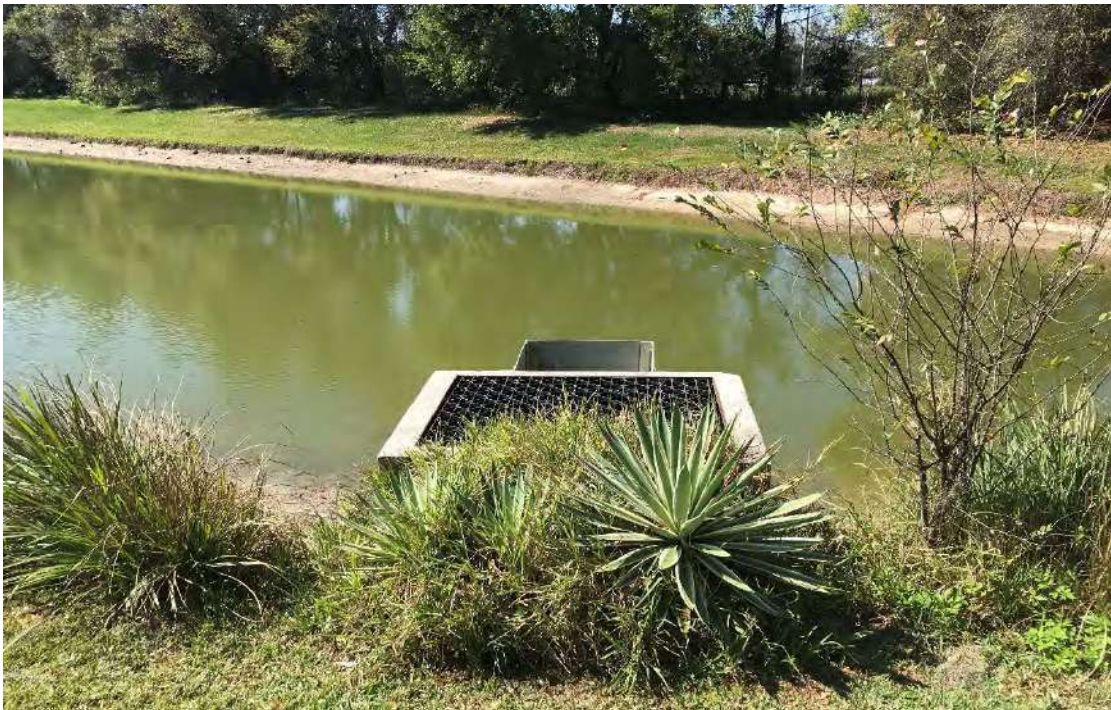
Photo 8
View of OCS 200

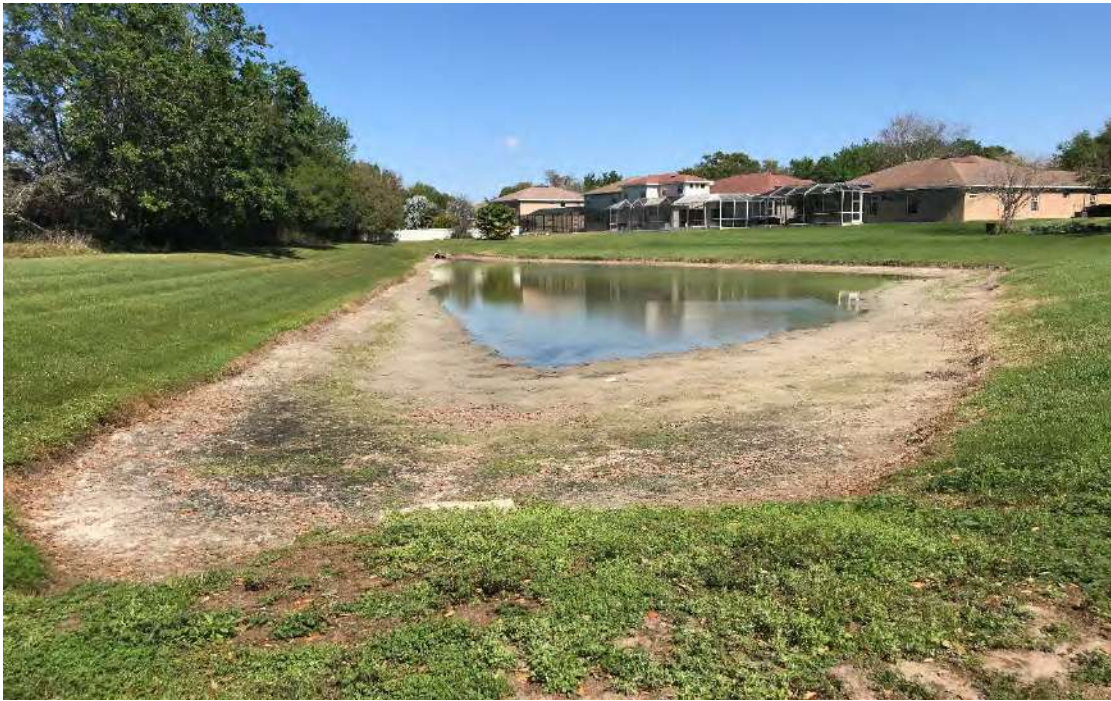
Photo 9
Northerly View of North Half of Pond 30

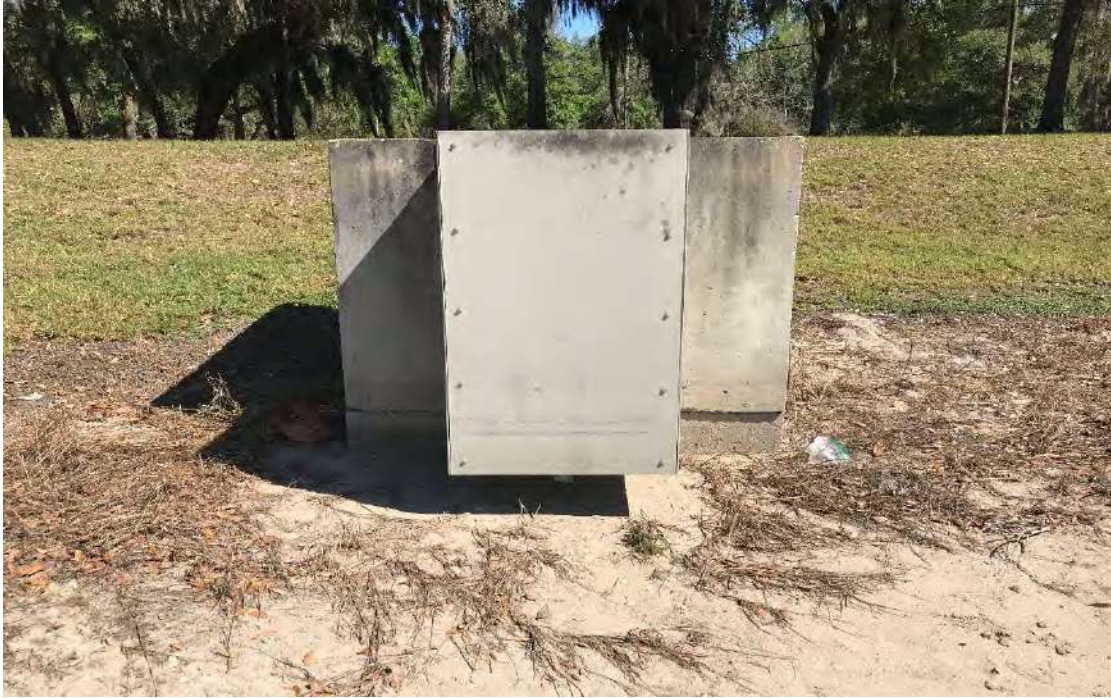
Photo 11
View of OCS 300
