**DIAMOND HILL
COMMUNITY DEVELOPMENT DISTRICT**

**FEBRUARY 12, 2024
AGENDA PACKAGE**

- 1.0 ERP PERMIT INFORMATION
- 2.0 PERMIT INSPECTION HISTORY
- 3.0 RECONCILIATION OF CURRENT DEFECT OBSERVATIONS
- 4.0 POND ELEVATION SUMMARY
- 5.0 INSPECTION REPORTS & PICTURES

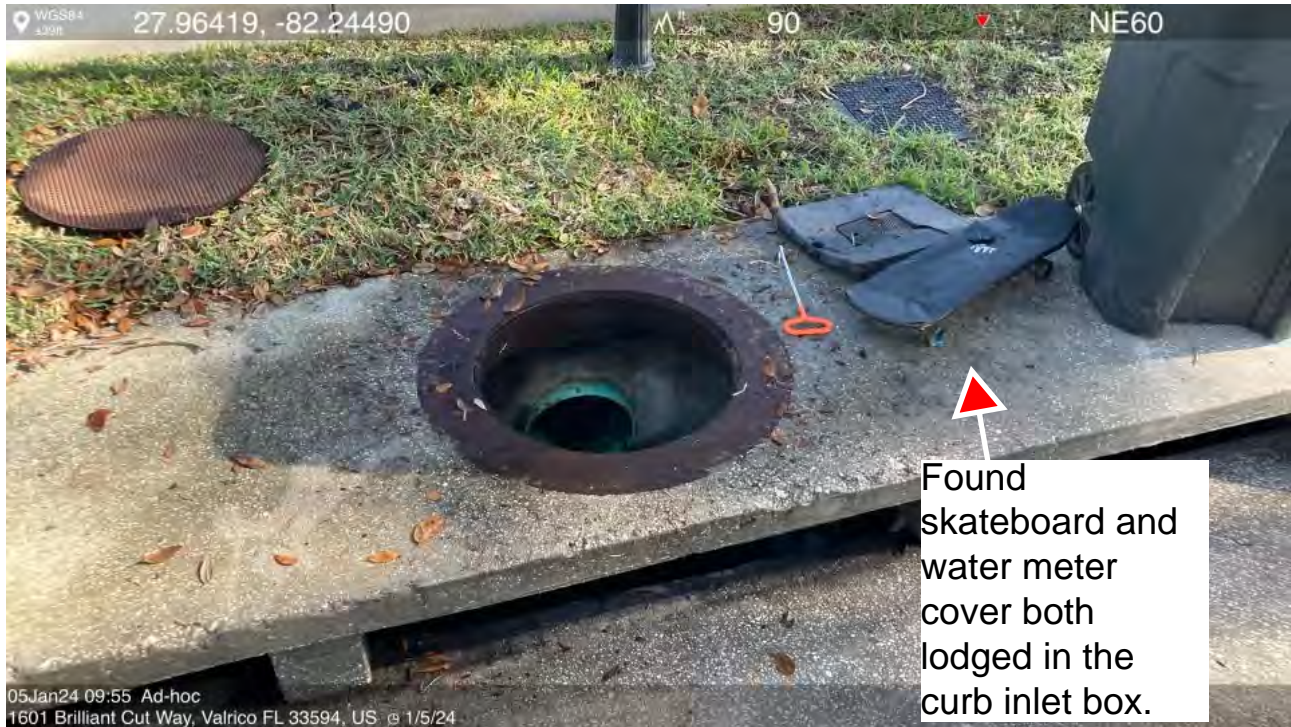
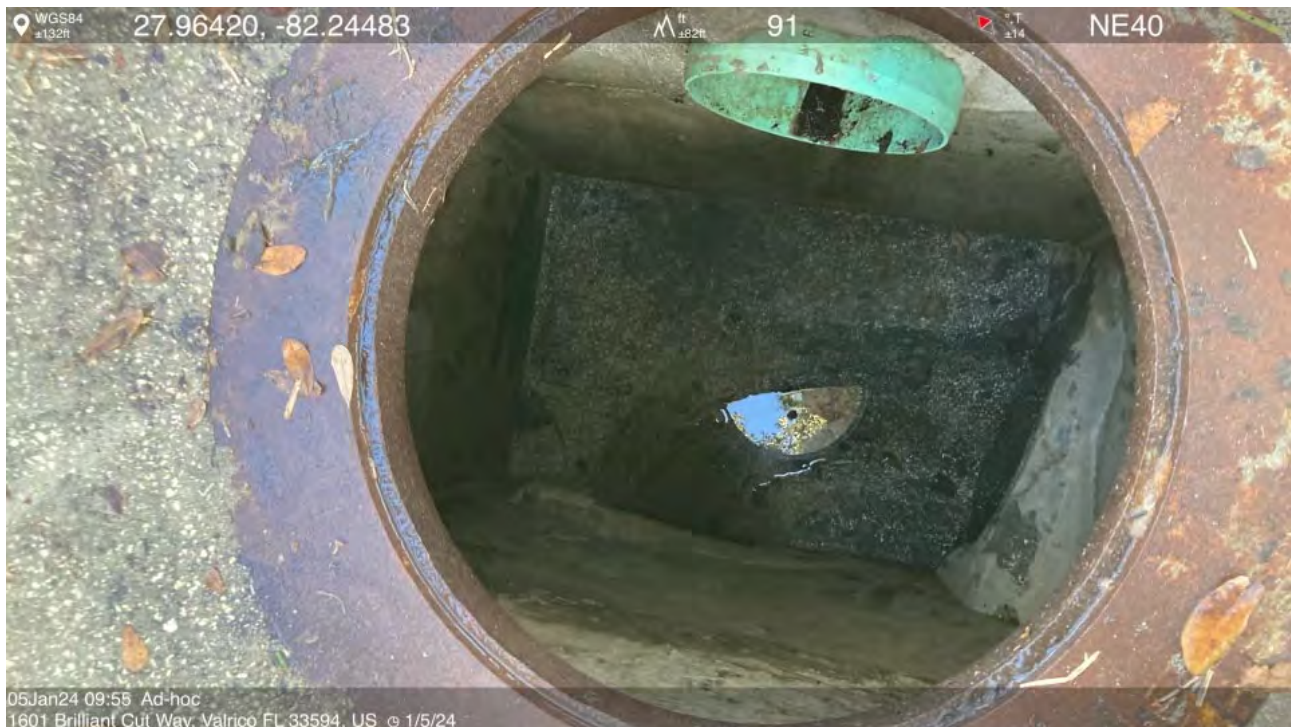
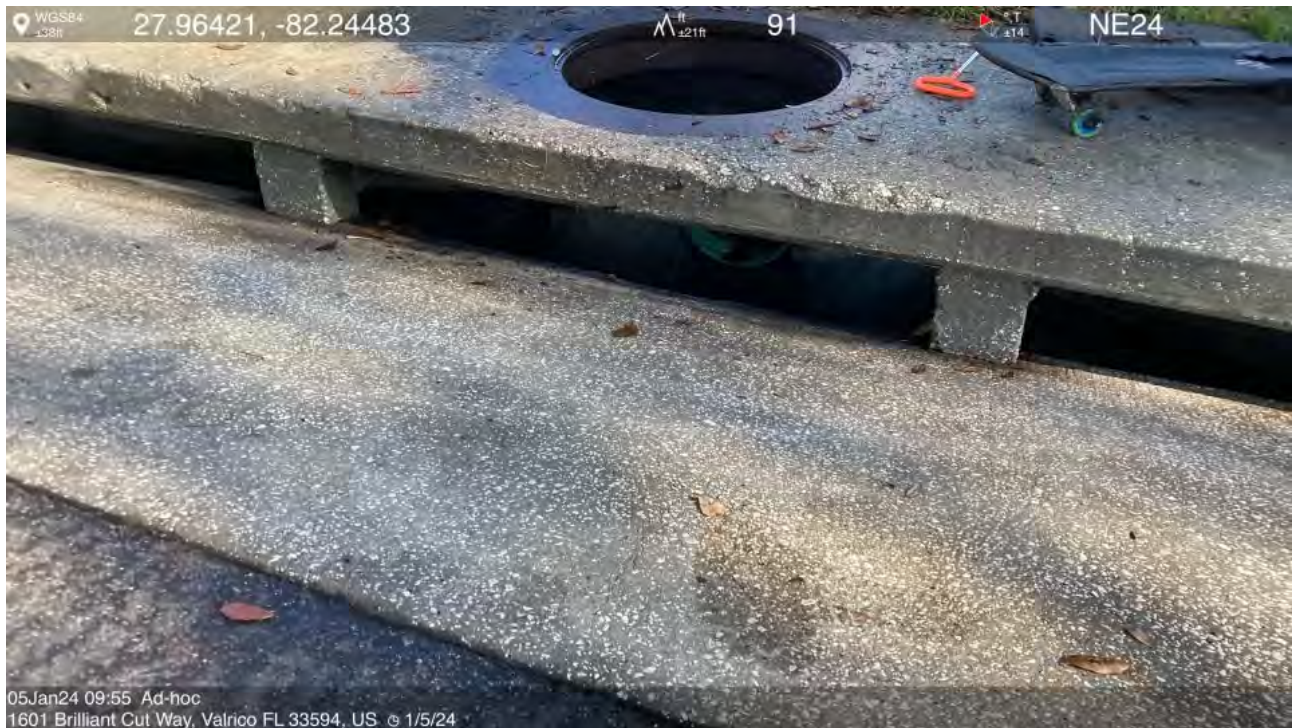
Brilliant Cut Way Cleanout

The curb inlet on Brilliant Cut Way was serviced on 01-05-2024. A skateboard and the top to a water meter box we're both found and may have created or contributed to the clog. The section of pipe and curb inlet on Emerald Hill Way that was clogged was also serviced on 01-05-2024 to clear the pipe obstruction.

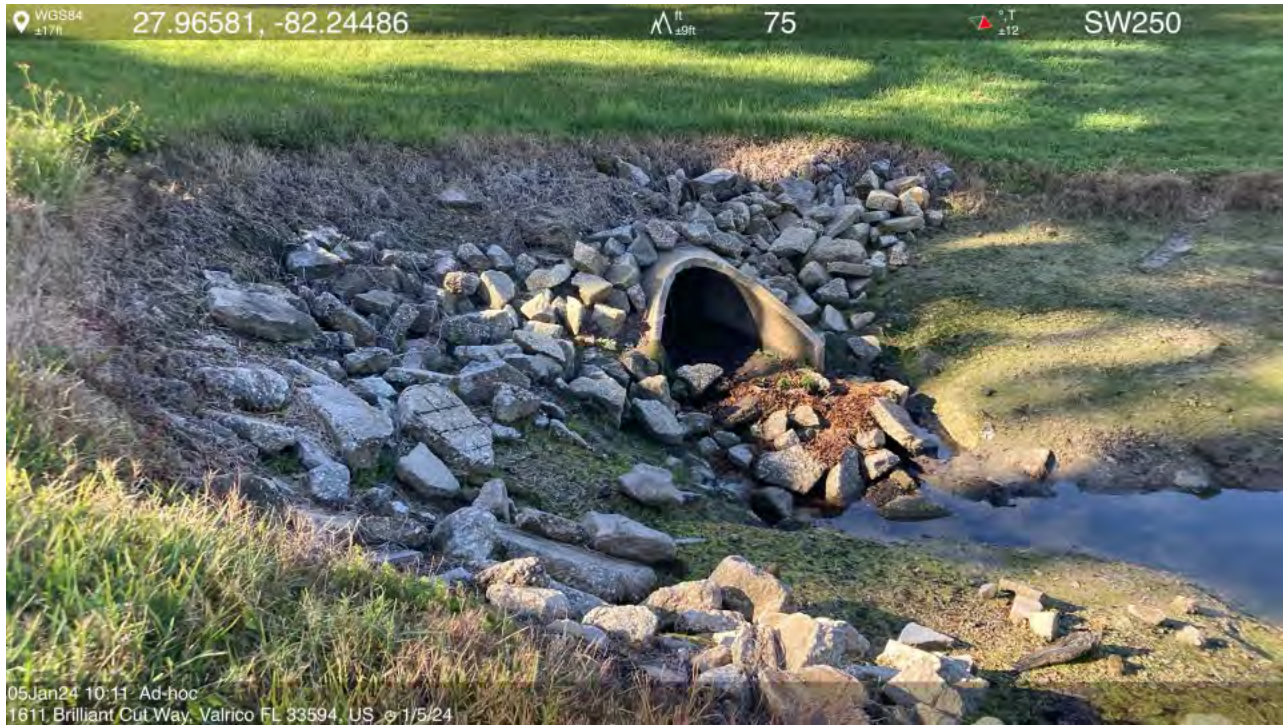
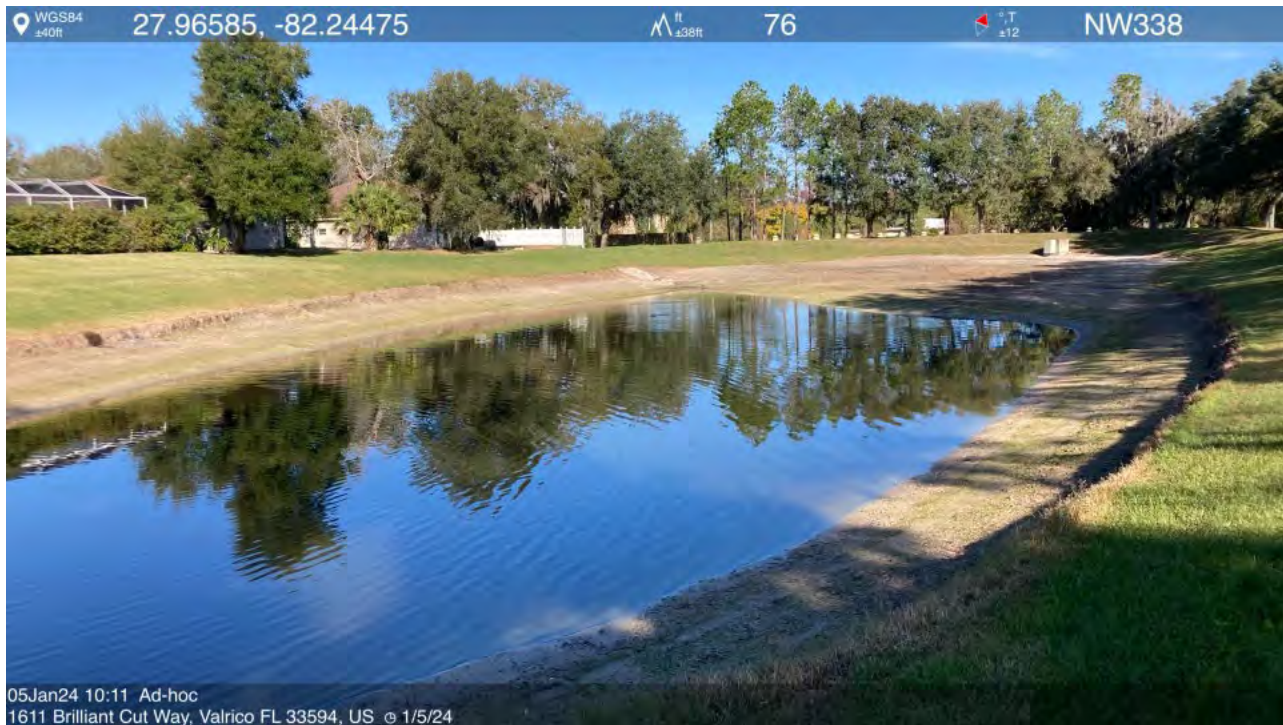
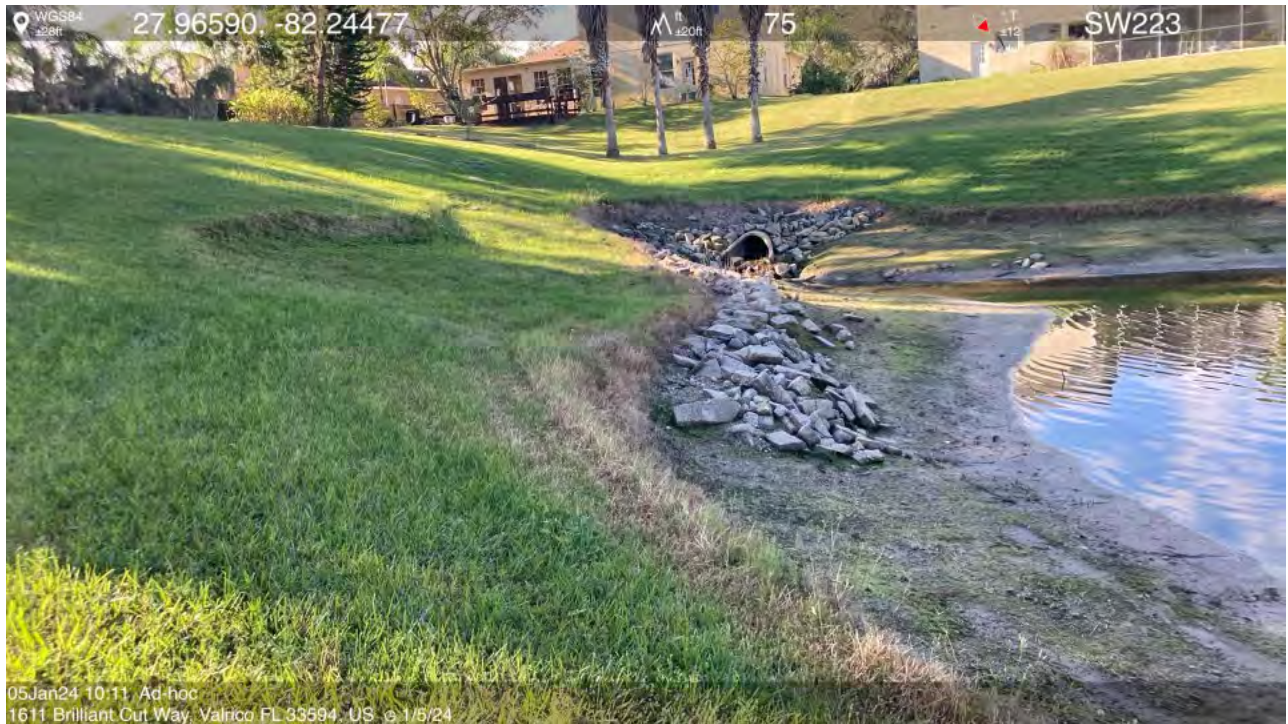
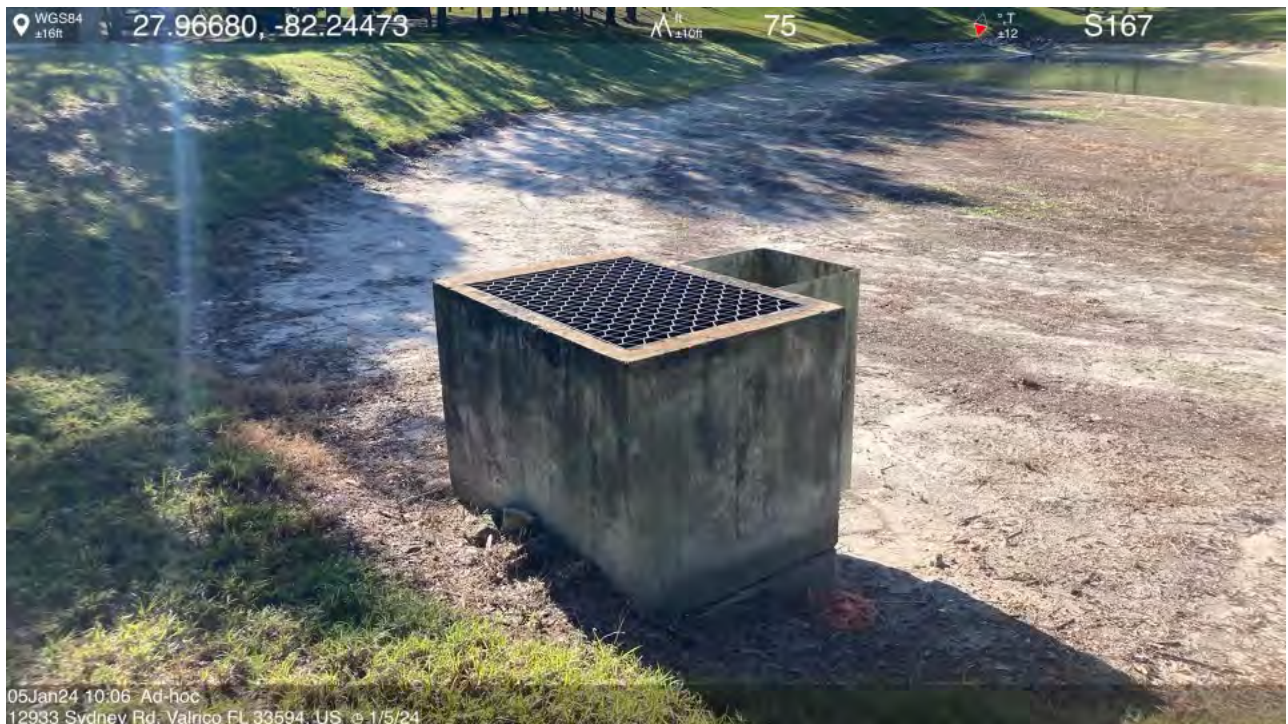
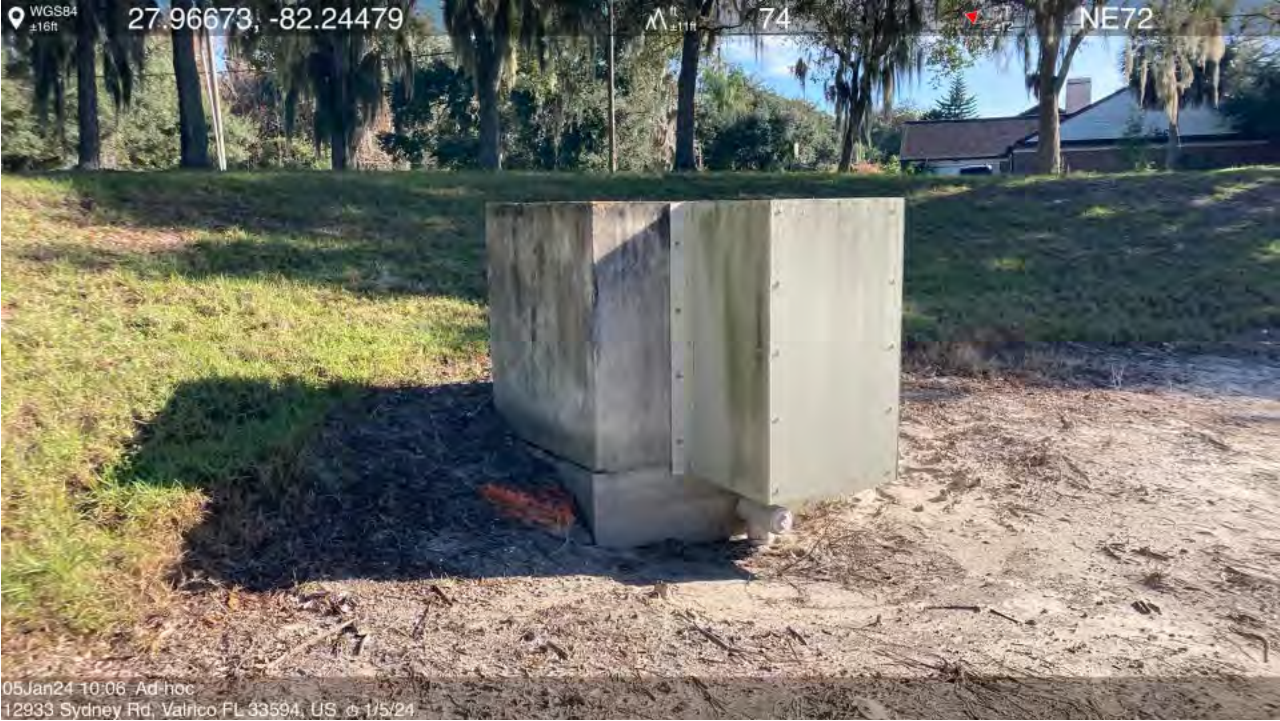
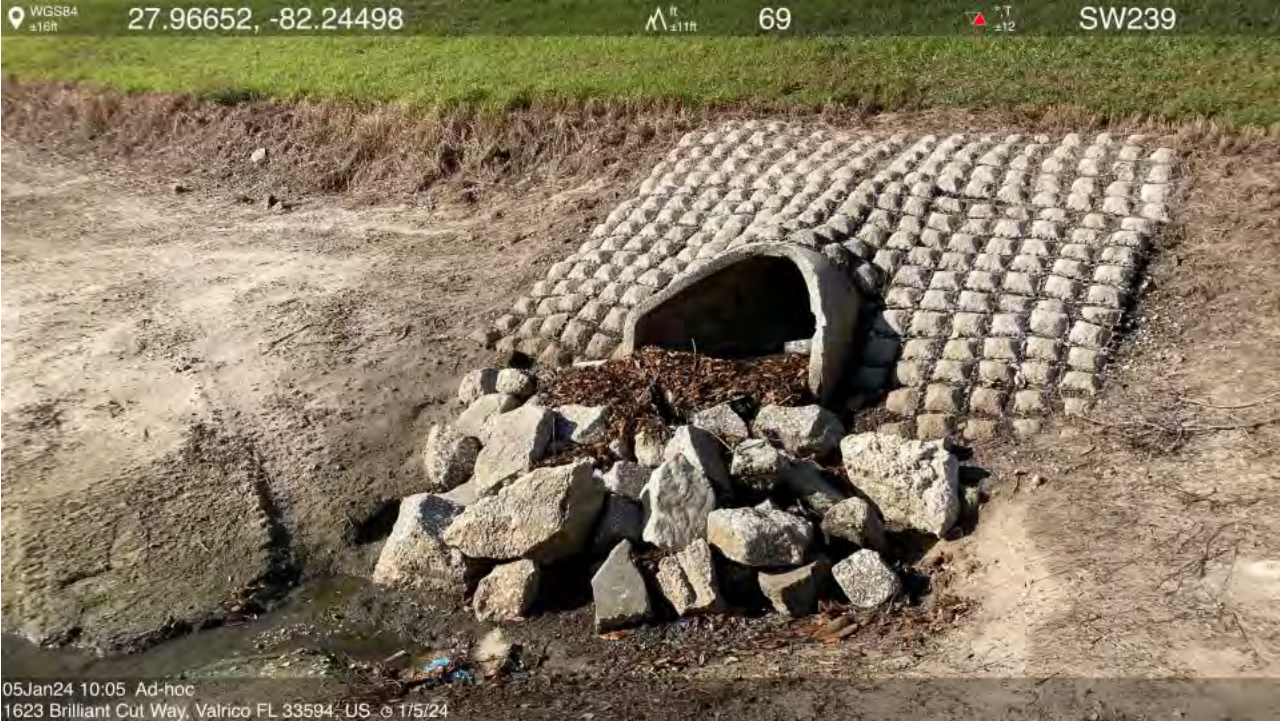
CDD POND EVALUATION			
INSPECTION DATE:	1/5/2024	PERMIT NUMBER:	24679.000
INSPECTED BY:	Jerry Whited	POND PERIMETER:	843 ft
POND NUMBER:	10	POND AREA:	36,541 sq ft
Full Pond Access:	Yes	Trash Observed:	No
Beneficial Vegetaion Present:	No	Water Quality:	Average
Tailwater Issue Observed:	No	Water Quality Notes:	NA
Observed Depth:	4' 4"	Observed Temperature:	66.2
POND ELEVATION ANALYSIS			
Treatment Type:	Wet Detention	Design Bottom Elevation:	62.5
Weir Elevation:	69.4	Observed Bottom Elevation:	61.50
Skimmer Bottom Elevation:	68.9	Elevation Difference:	-1.00
Pond Elevation Notes: Pond was observed to have approximately 1' more elevation than the design elevation. The elevation difference does not appear to effect the functionality of the pond. *Note - SOI pictures taken 1/5/2024 and pond depth measurement taken 01/11/2024 after rainfall.			
BANK EROSION AND SCOUR			
Severity Ranking:	NA		
Type of Erosion:	None

Bank Erosion Notes: No erosion or shoreline defects observed. Seasonal high water table at lowest point during inspection and exposed banks are expected this time of year.			
CONDITION OF POND STRUCTURES (CONTROL STRUCTURES, MITERED END SECTIONS, INLETS)			
Severity Ranking:	N/A		
Type of Damage:	None		
Structures Notes: One control structure with skimmer and two FES's observed to be in operational condition with no defects.

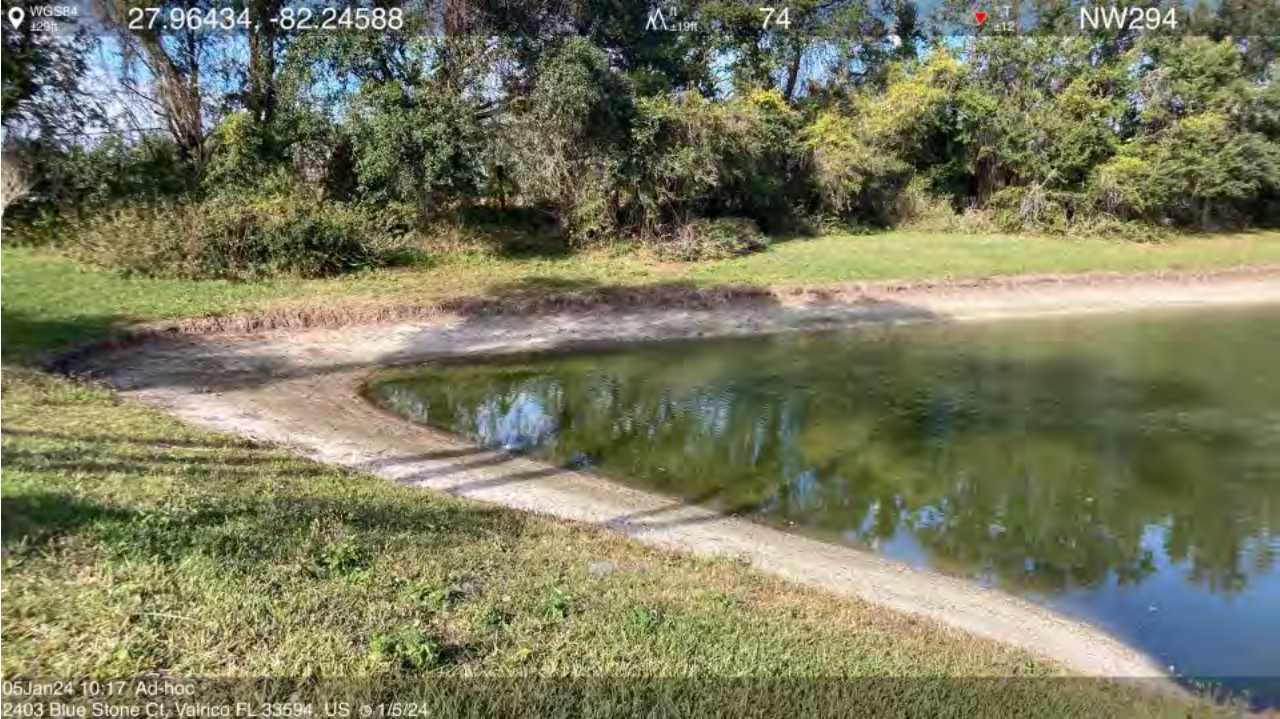
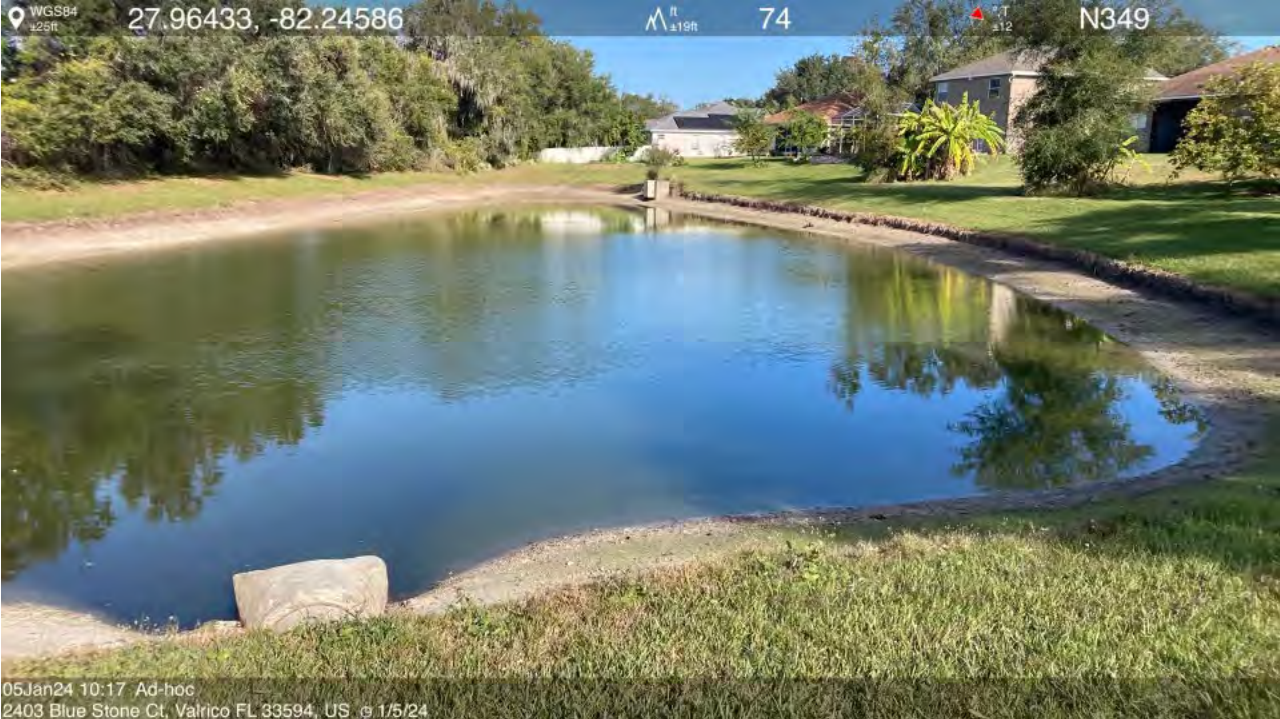
CDD POND EVALUATION			
INSPECTION DATE:	1/5/2024	PERMIT NUMBER:	24679.000
INSPECTED BY:	Jerry Whited	POND PERIMETER:	759 ft
POND NUMBER:	20	POND AREA:	27,468 sq ft
Full Pond Access:	Yes	Trash Observed:	No
Beneficial Vegetaion Present:	No	Water Quality:	Average
Tailwater Issue Observed:	No	Water Quality Notes:	NA
Observed Depth:	4' 2"	Observed Temperature:	66.92
POND ELEVATION ANALYSIS			
Treatment Type:	Wet Detention	Design Bottom Elevation	66
Weir/Orifice Elevation:	72	Observed Bottom Elevation:	66.75
Skimmer Bottom Elevation:	71.5	Elevation Difference:	0.75
Pond Elevation Notes: Pond elevation observed to be approximately within 1' of design elevation. The elevation difference does not appear to affect the functionality of the pond. *Note - SOI pictures taken on 01/05/2024 and pond depth measurement taken on 01/11/2024 after rainfall.			
BANK EROSION AND SCOUR			
Severity Ranking:	NA		
Type of Erosion:	None

Bank Erosion Notes: No erosion or shoreline erosion observed. Seasonal high water table at lowest point during inspection and exposed banks are expected this time of year.			
CONDITION OF POND STRUCTURES (CONTROL STRUCTURES, MITERED END SECTIONS, INLETS)			
Severity Ranking:	Minor		
Type of Damage:	FES Eroded		
Structures Notes: One control structure with skimmer and one FES observed to be in operational condition. FES is extended into pond and has eroded behind with exposed pipe. Recommended to monitor this site.

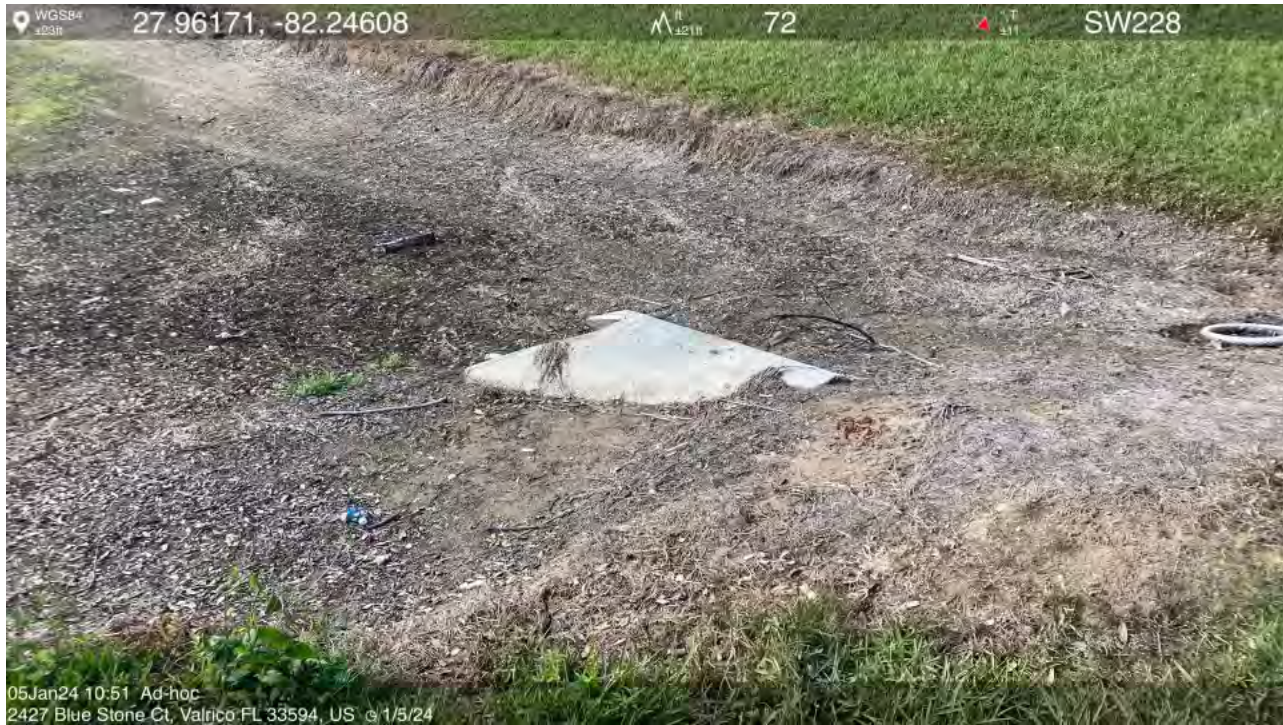
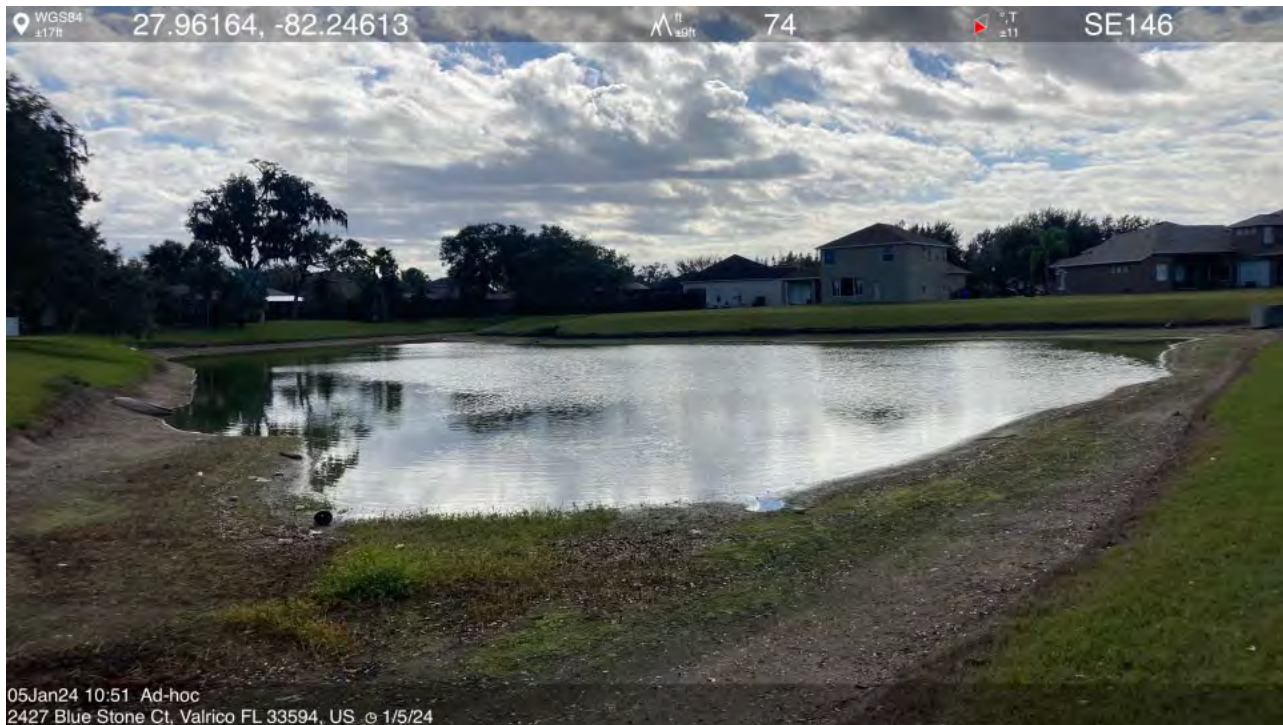
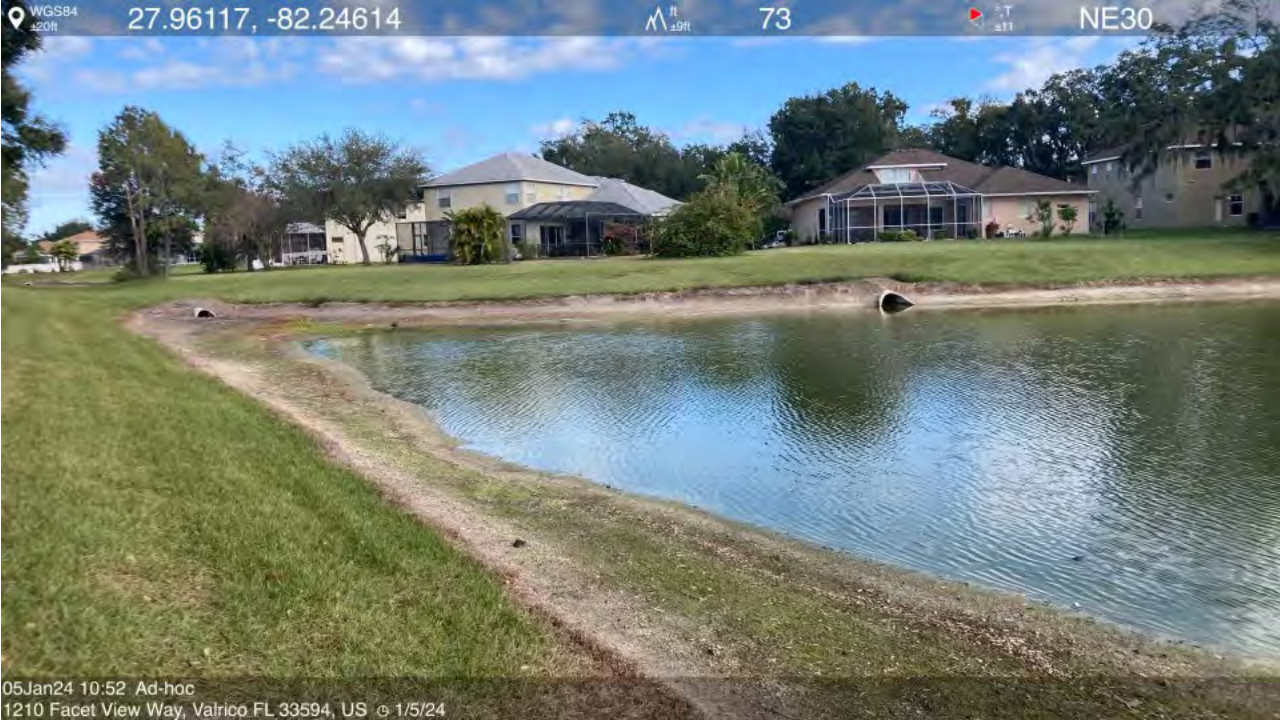
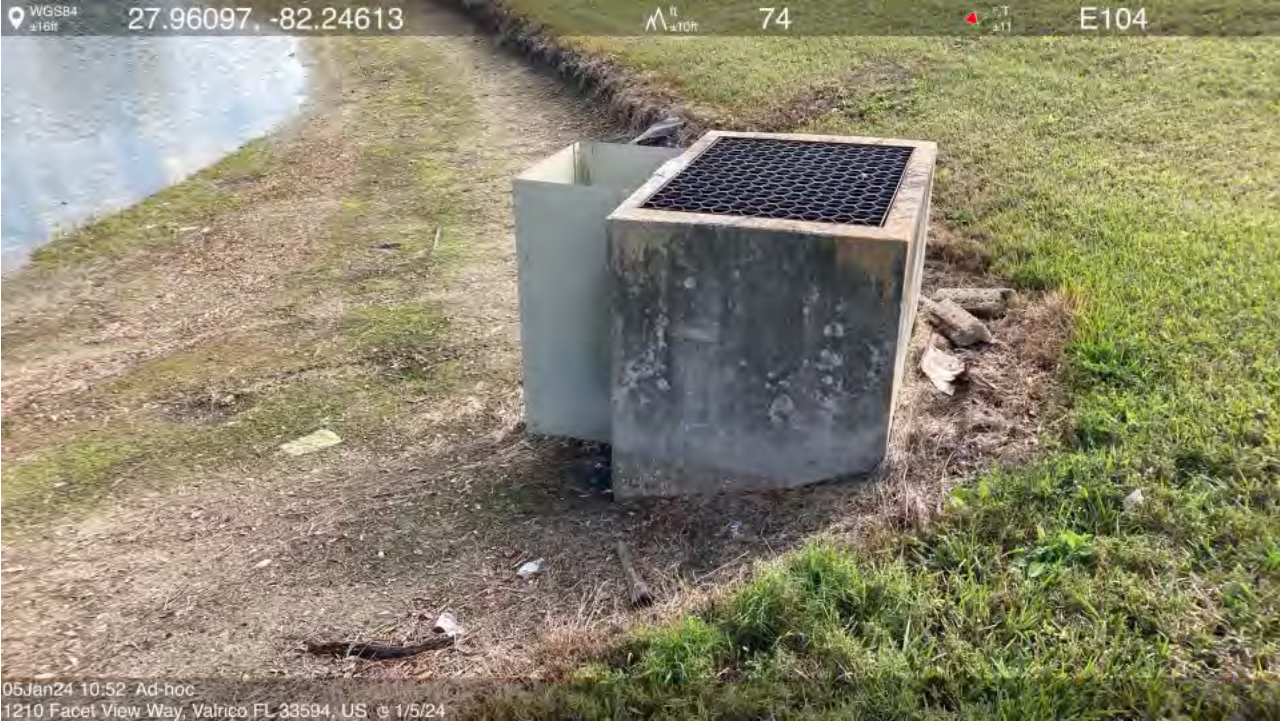
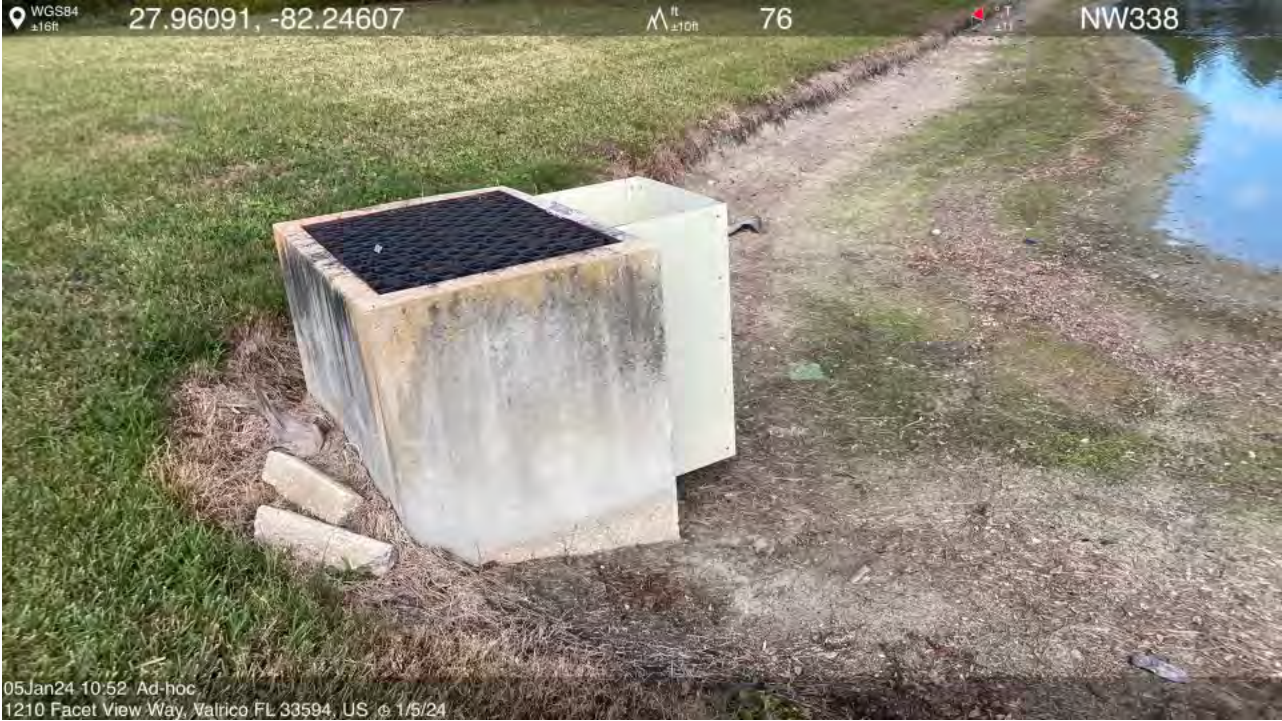
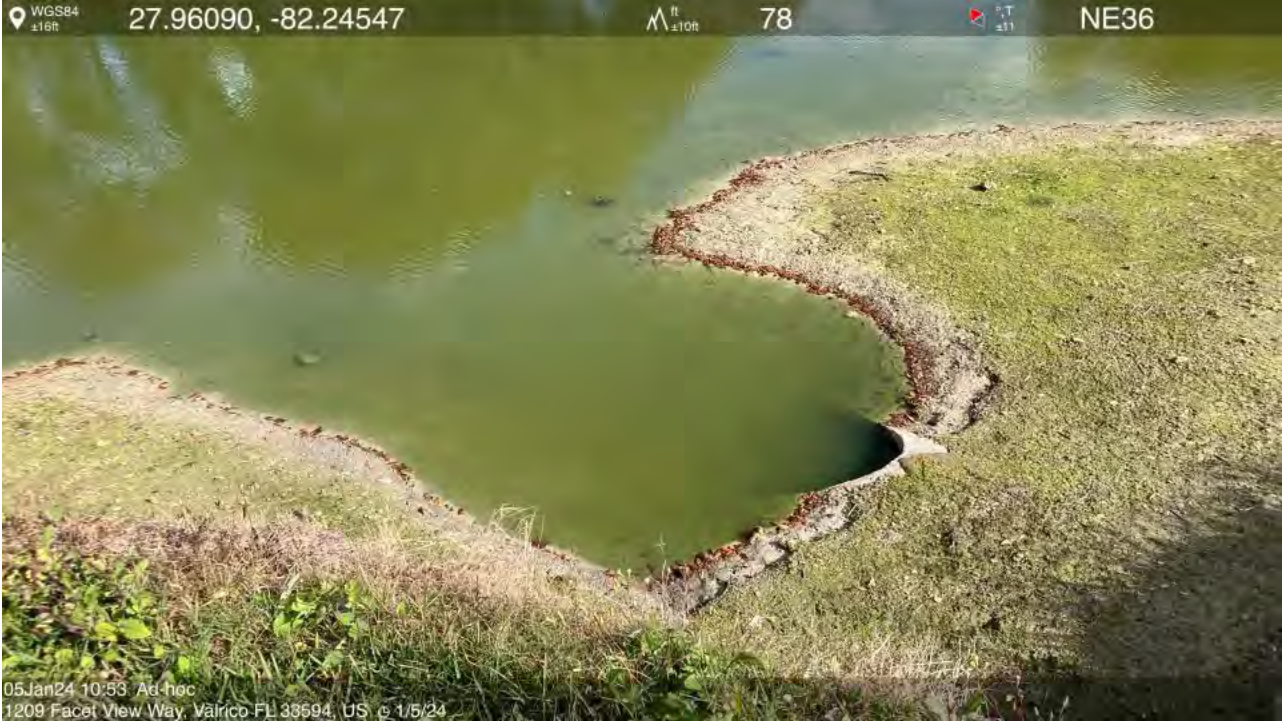
CDD POND EVALUATION			
INSPECTION DATE:	1/5/2024	PERMIT NUMBER:	24679.000
INSPECTED BY:	Jerry Whited	POND PERIMETER:	2,393 ft
POND NUMBER:	30	POND AREA:	87,526 sq ft
Full Pond Access:	Yes	Trash Observed:	No
Beneficial Vegetaion Present:	No	Water Quality:	Average
Tailwater Issue Observed:	No	Water Quality Notes:	NA
Observed Depth:	3' 8"	Observed Temperature:	66.92
POND ELEVATION ANALYSIS			
Treatment Type:	Wet Detention	Design Bottom Elevation:	65.6
Weir/Orifice Elevation:	69.1	Observed Bottom Elevation:	62.35
Skimmer Bottom Elevation:	68.06	Elevation Difference:	-3.25
Pond Elevation Notes: Pond elevation was observed to be approximately 3.25' more than the designed elevation. The elevation difference does not appear to affect the functionality of the pond. *Note: SOI pictures taken 01/05/2024 and pond depth measurement taken 01/11/2024 to allow for rainfall.			
BANK EROSION AND SCOUR			
Severity Ranking:	NA

Type of Erosion:	None		
Bank Erosion Notes: No erosion or pond bank defects observed. Seasonal high water table at lowest point during inspection and exposed banks are expected this time of year.			
CONDITION OF POND STRUCTURES (CONTROL STRUCTURES, MITERED END SECTIONS, INLETS)			
Severity Ranking:	N/A		
Type of Damage:	None		
Structures Notes: One control structure with skimer and 5 FES's observed to be in operational condition with no defects.

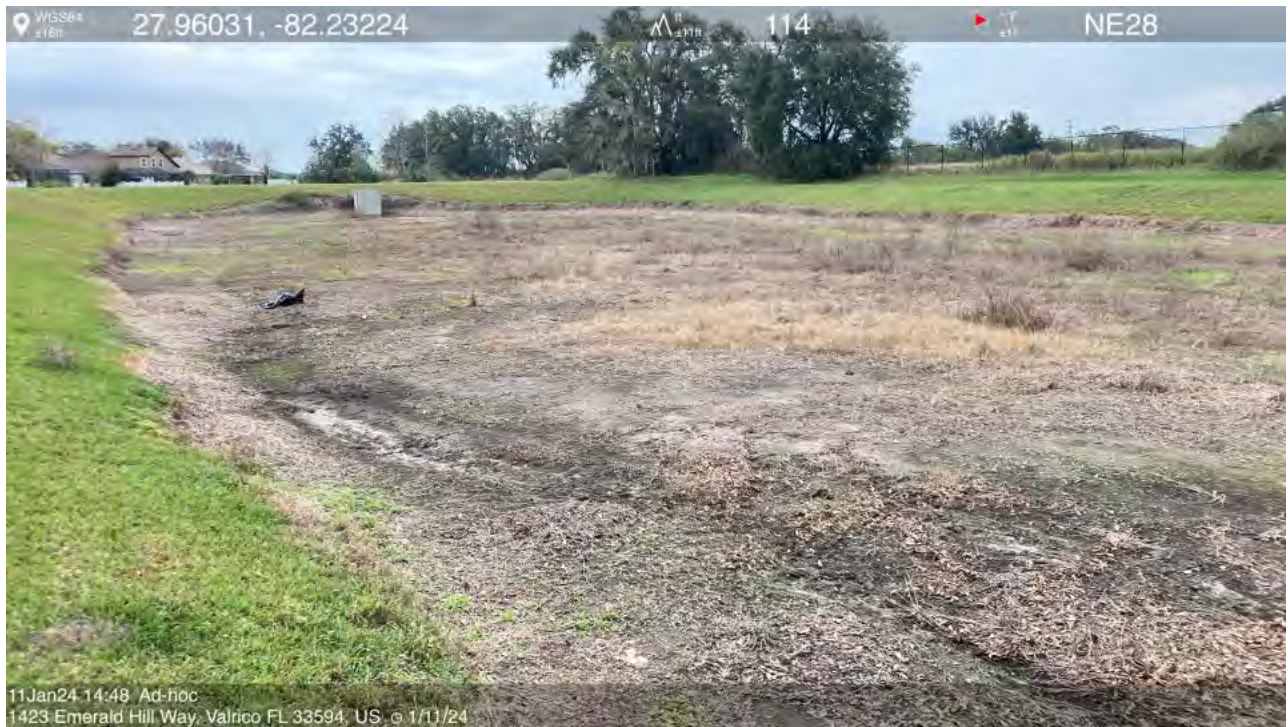
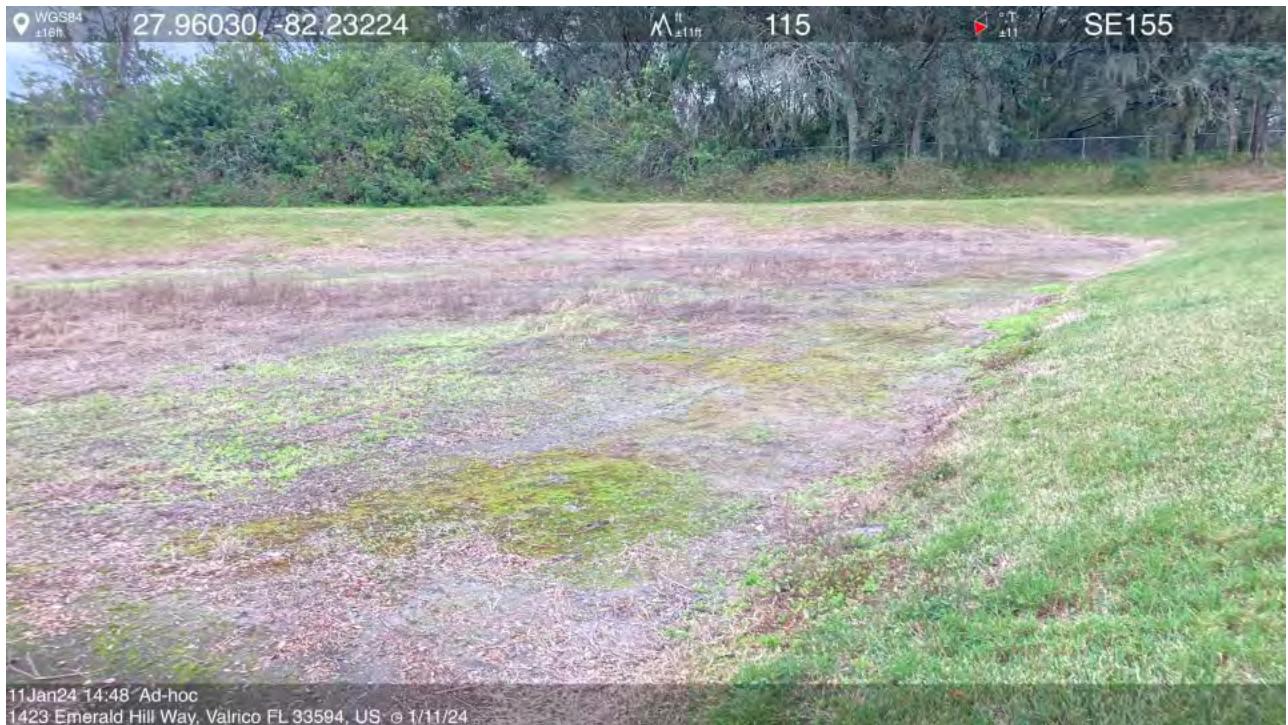
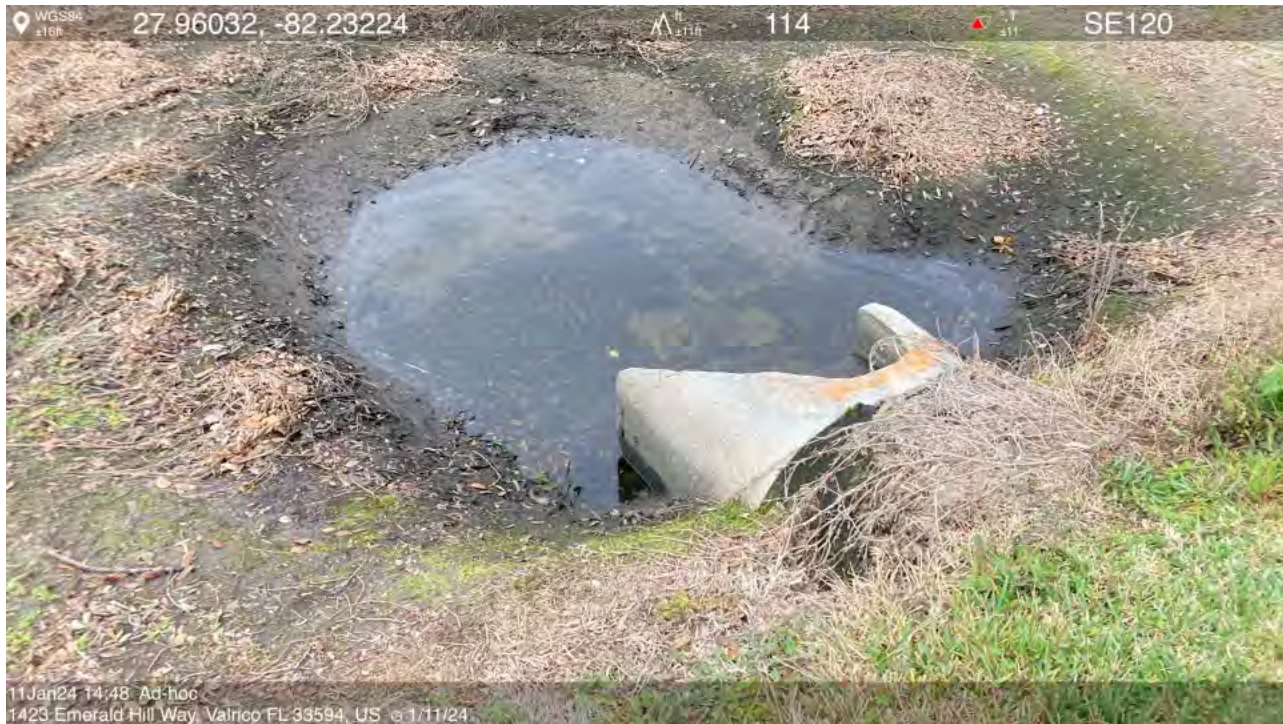
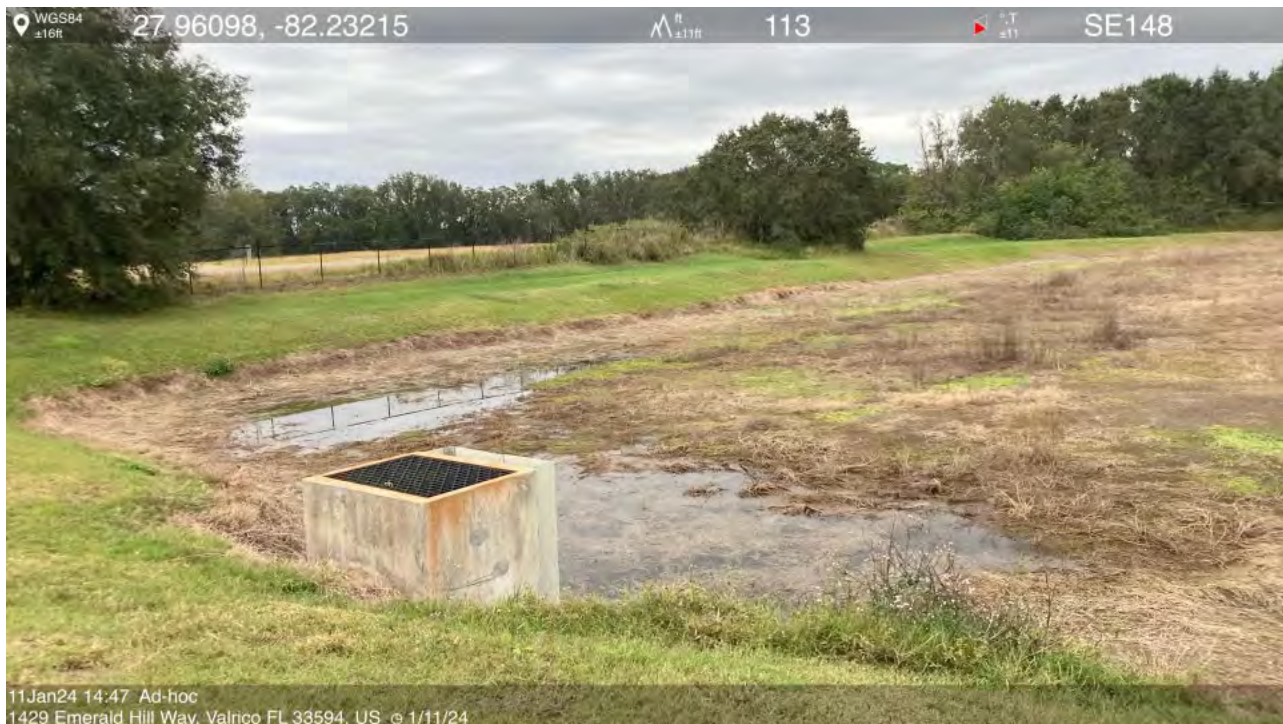
CDD POND EVALUATION			
INSPECTION DATE:	1/11/2024	PERMIT NUMBER:	24679.003
INSPECTED BY:	Jerry Whited	POND PERIMETER:	851 ft
POND NUMBER:	1000	POND AREA:	30,047 sq ft
Full Pond Access:	Yes	Trash Observed:	No
Beneficial Vegetaion Present:	No	Water Quality:	NA
Tailwater Issue Observed:	No	Water Quality Notes:	NA
Observed Depth:	0	Observed Temperature:	NA
POND ELEVATION ANALYSIS			
Treatment Type:	Dry (NA)	Design Bottom Elevation:	105
Weir/Orifice Elevation:	105	Observed Bottom Elevation:	105
Skimmer Bottom Elevation:	104.5	Elevation Difference:	0
Pond Depth Notes: This is a dry pond.			
BANK EROSION AND SCOUR			
Severity Ranking:	NA		
Type of Erosion:	None		
Bank Erosion Notes: No erosion or shoreline defects observed.			
CONDITION OF POND STRUCTURES (CONTROL STRUCTURES, MITERED END SECTIONS, INLETS)			
Severity Ranking:	N/A		
Type of Damage:	None		
Structures Notes: One control structure with skimmer and one FES observed in operational condition with no defects.
