**DIAMOND HILL
COMMUNITY DEVELOPMENT DISTRICT**

**FEBRUARY 12, 2024
AGENDA PACKAGE**

- 1.0 ERP PERMIT INFORMATION
- 2.0 PERMIT INSPECTION HISTORY
- 3.0 RECONCILIATION OF CURRENT DEFECT OBSERVATIONS
- 4.0 POND ELEVATION SUMMARY
- 5.0 INSPECTION REPORTS & PICTURES

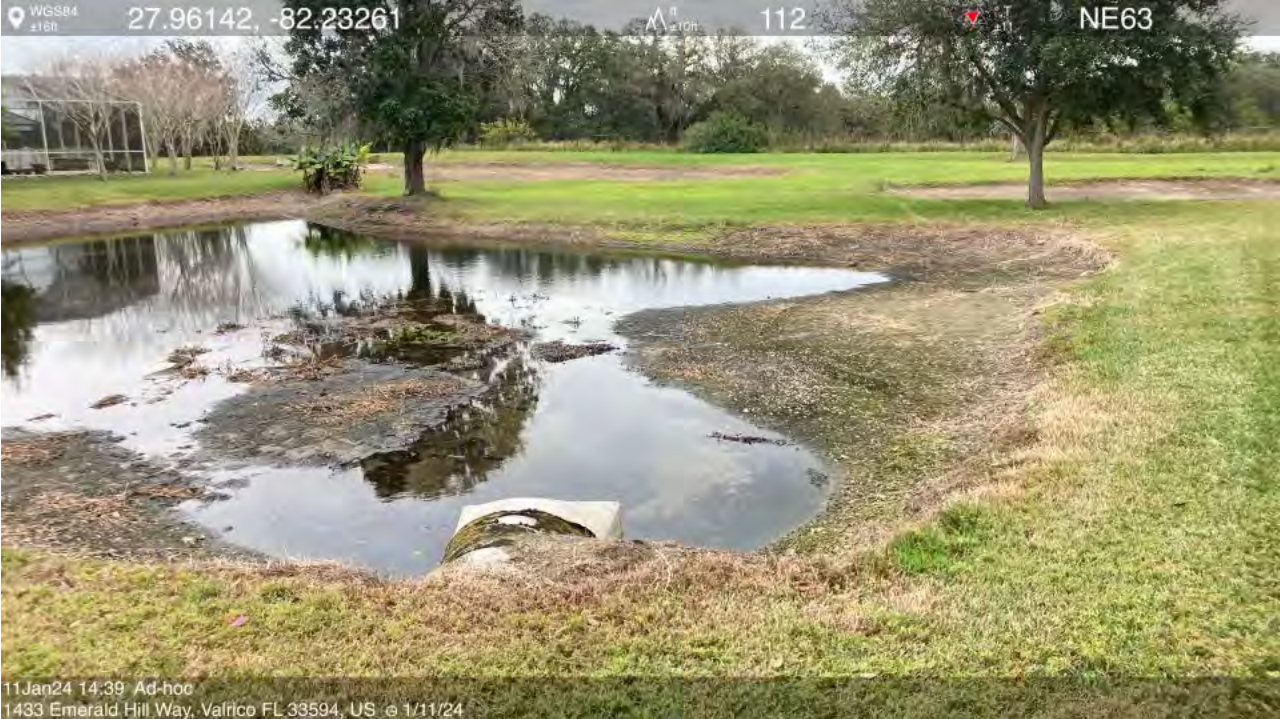
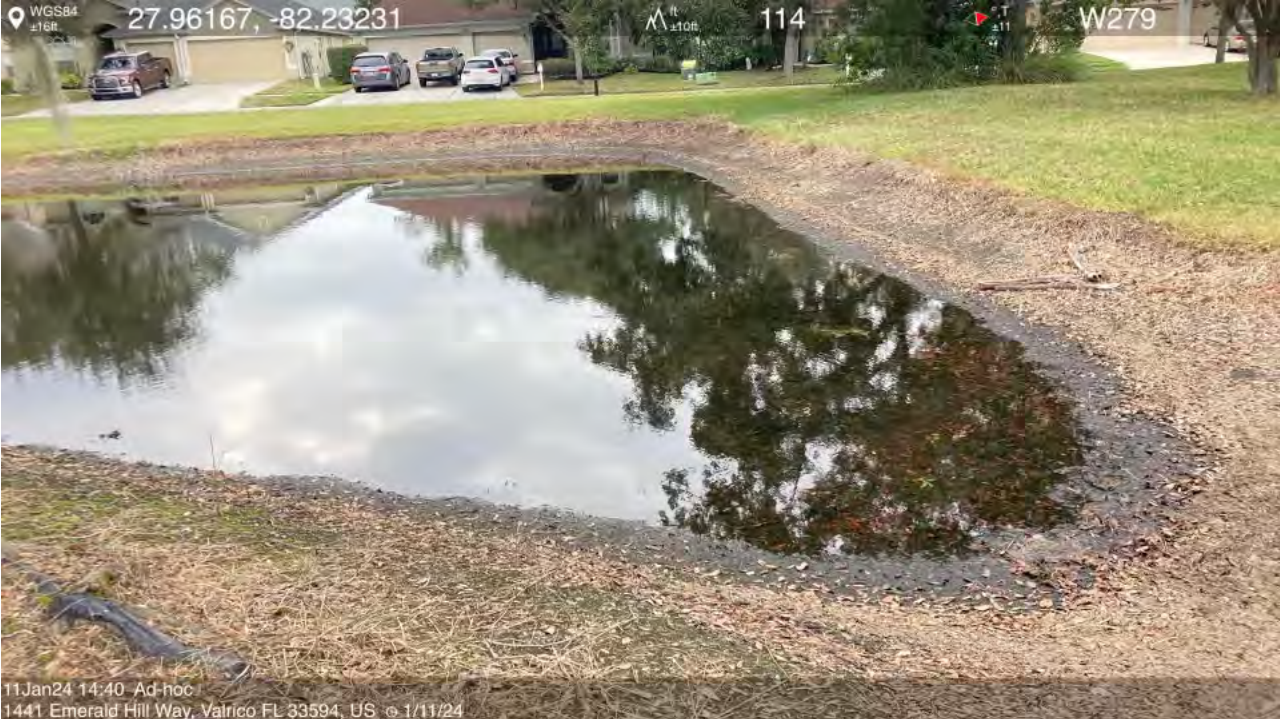
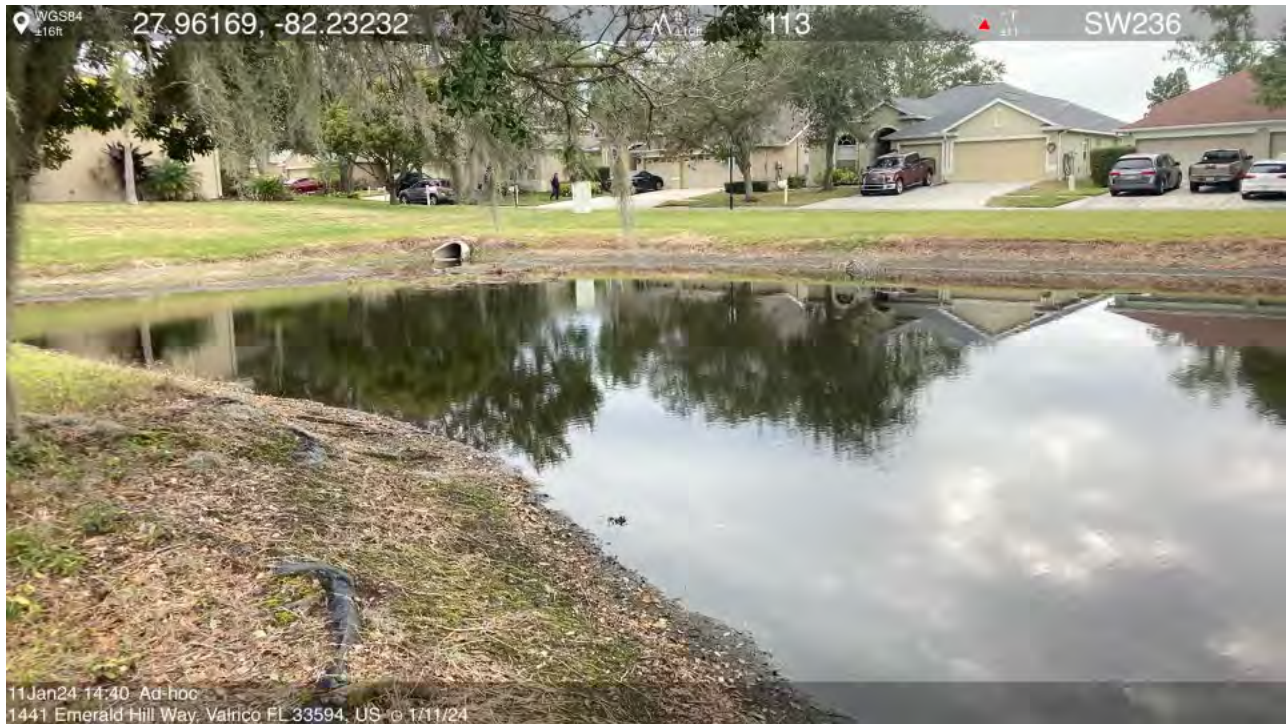
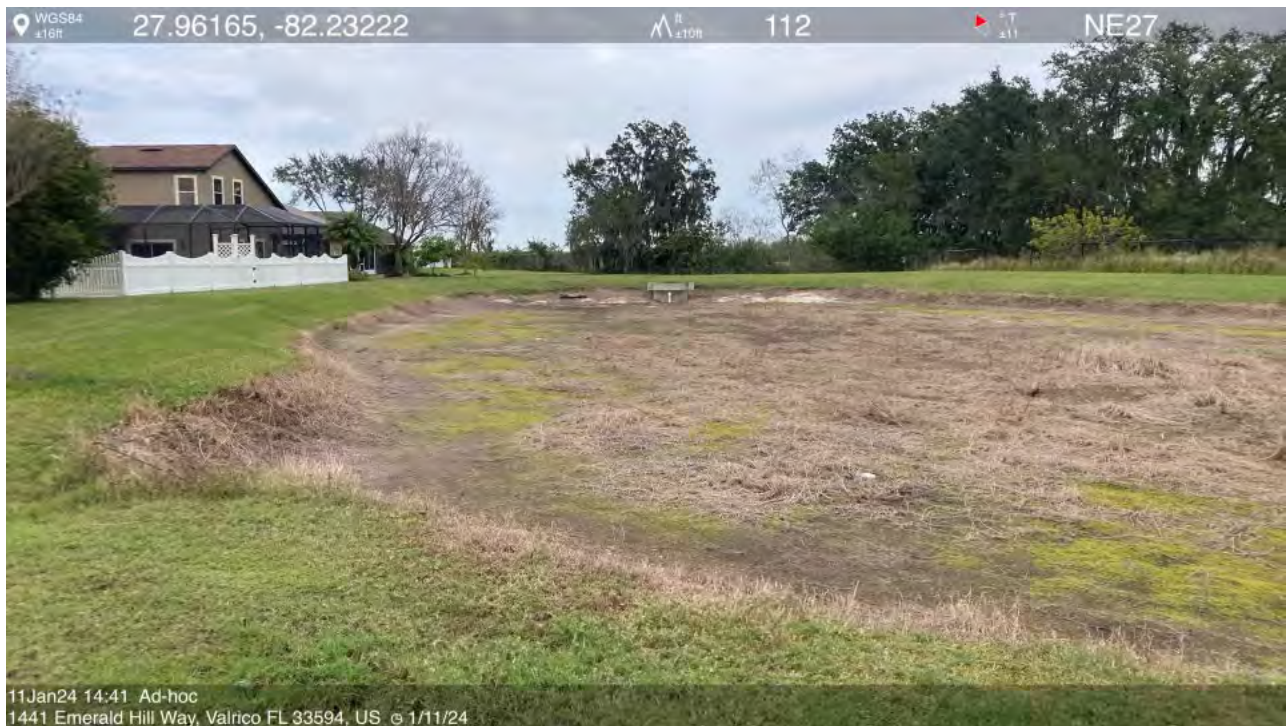
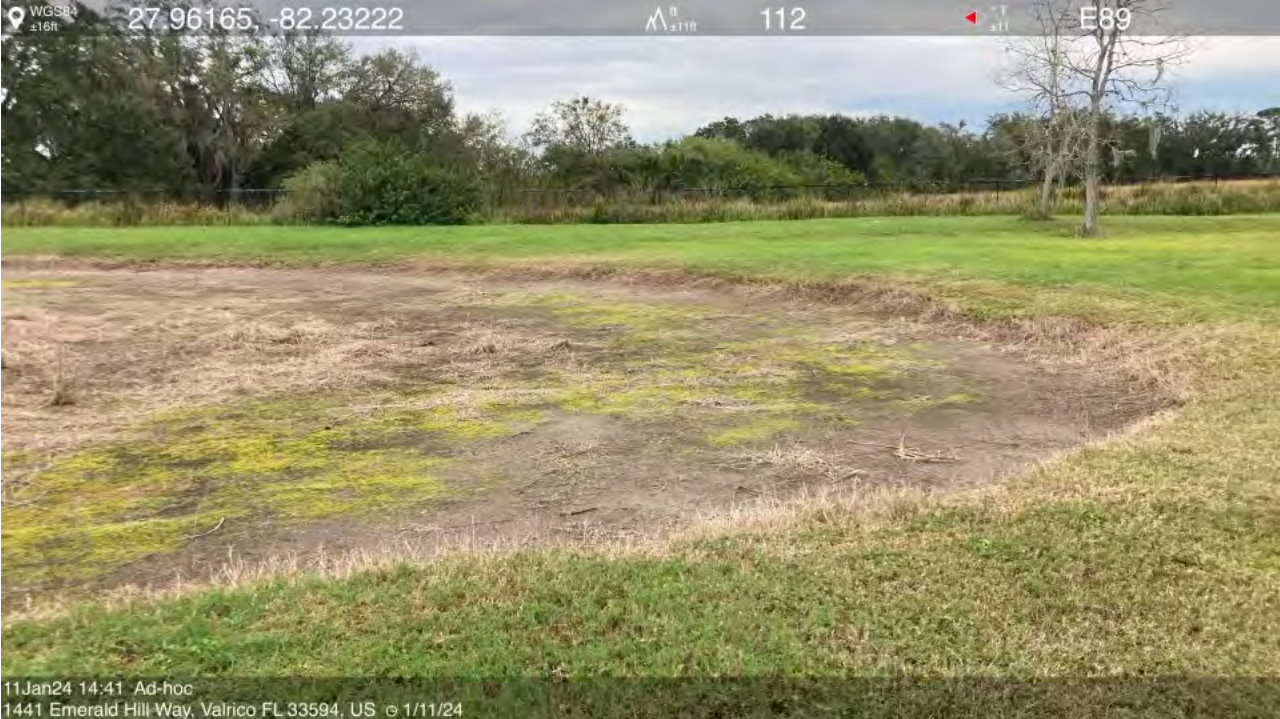
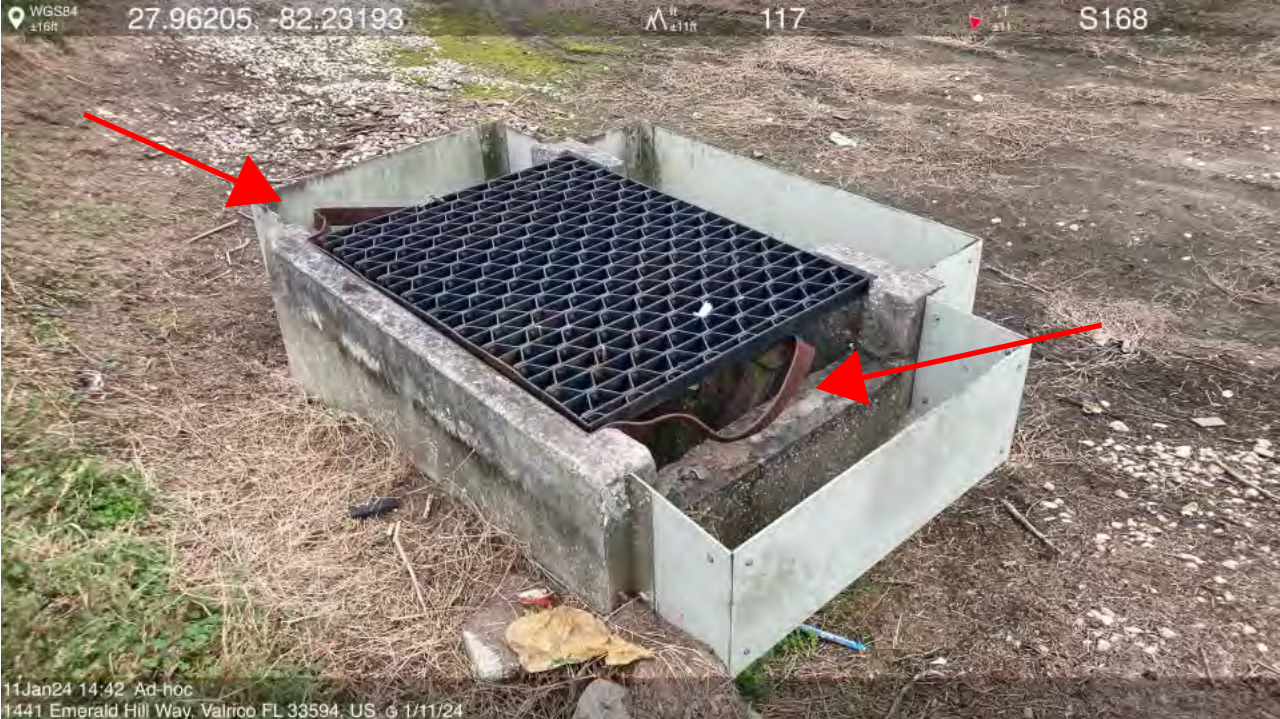
CDD POND EVALUATION			
INSPECTION DATE:	1/11/2024	PERMIT NUMBER:	24679.003
INSPECTED BY:	Jerry Whited	POND PERIMETER:	1,049 ft
POND NUMBER:	1100	POND AREA:	42,923 sq ft
Full Pond Access:	Yes	Trash Observed:	Yes
Benifitial Vegetaion Present:	No	Water Quality:	Average
Tailwater Issue Observed:	No	Water Quality Notes:	NA
Observed Depth:	Less than 1'	Observed Temperature:	65
POND ELEVATION ANALYSIS			
Treatment Type:	Wet (Wetland)	Design Bottom Elevation:	104
Weir/Orifice Elevation:	106.5	Observed Bottom Elevation:	104
Skimmer Bottom Elevation:	106	Elevation Difference:	0
Pond Elevation Notes: Pond 1100 is a wet pond with wetland. There are 3 separate pond areas surrounding the wetland. Two of the pond areas we're dry and the third pond area had less than 1' of water. Normal season high water level is 1' which was within what was observed.			
BANK EROSION AND SCOUR			
Severity Ranking:	Minor		
Type of Erosion:	Hole in bank

Bank Erosion Notes: There was a section of pond bank observed to have a large hole of undermined turf on the West side of the Northern most pond that should be investigated further.			
CONDITION OF POND STRUCTURES (CONTROL STRUCTURES, MITERED END SECTIONS, INLETS)			
Severity Ranking:	Moderate		
Type of Damage:	Control Strutre Repair		
Structures Notes: The control structure in the northern most pond was observed to have a broken grate boarder. The piece is mangled and jutting off the structure. There is also broken off concrete from the structure with exposed skimmer mounting hardware behind. Two FES were observed in operational condition with no defects.

Control Structure Repair.

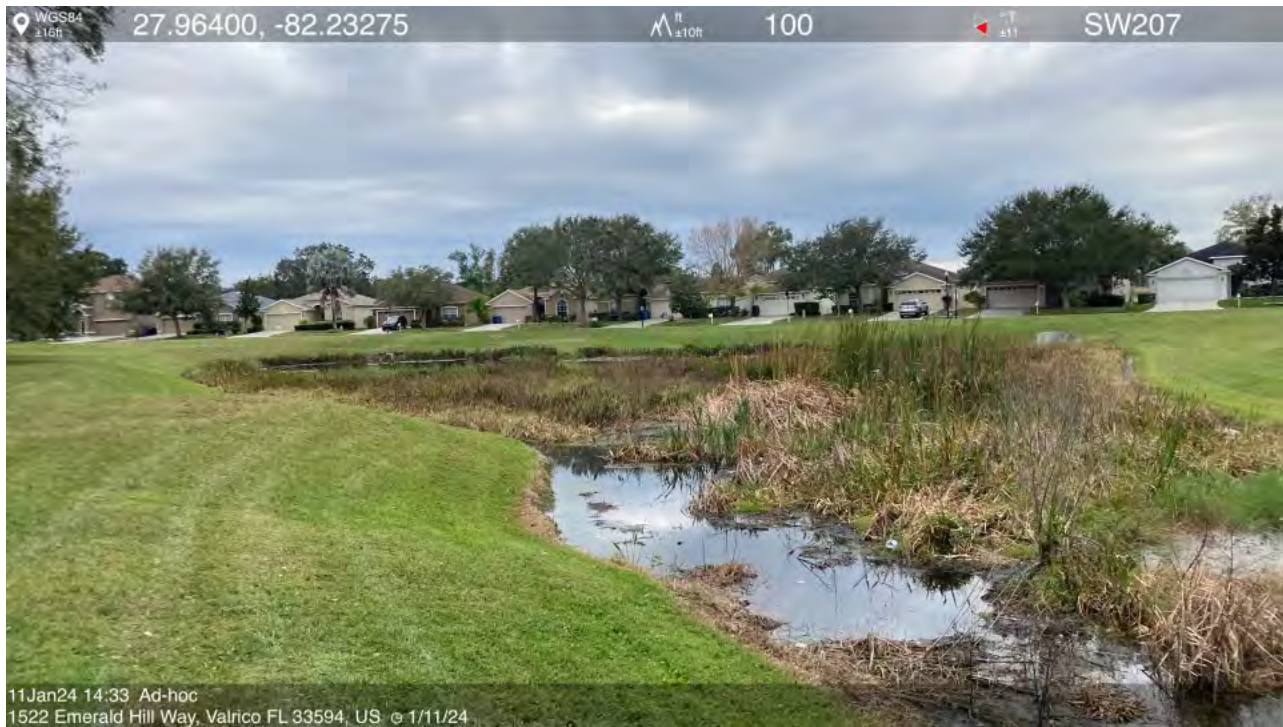
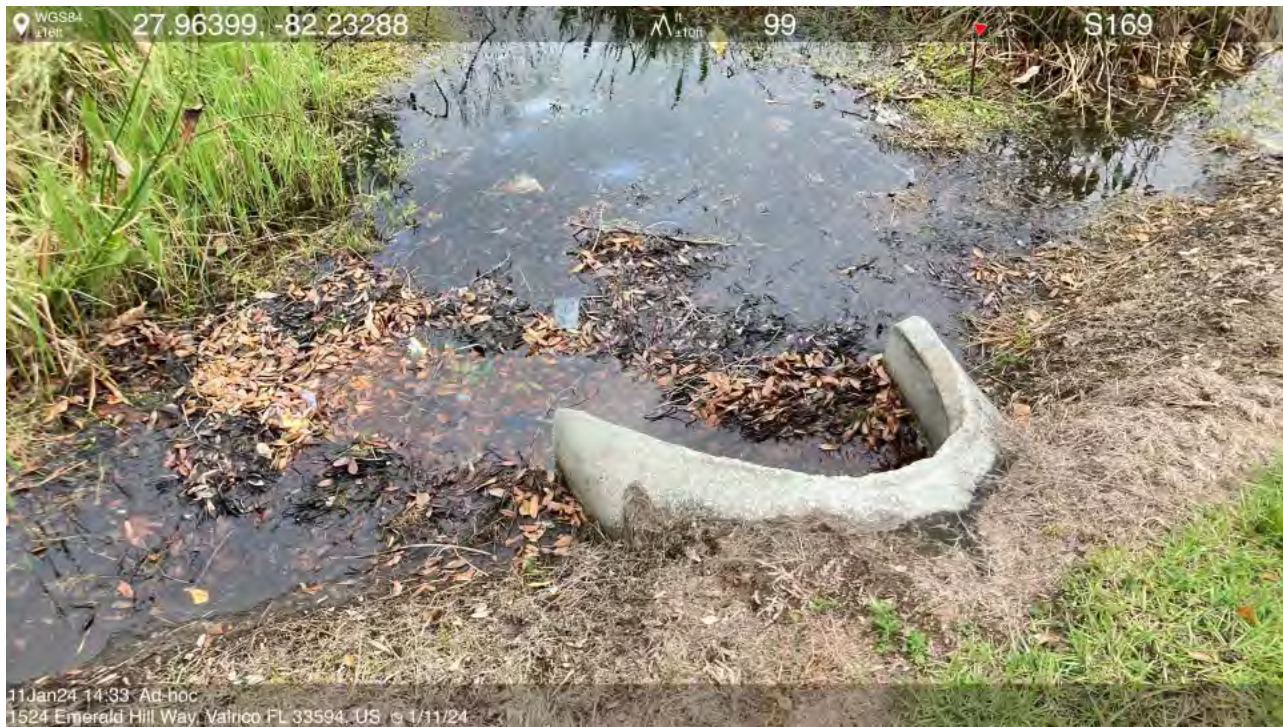
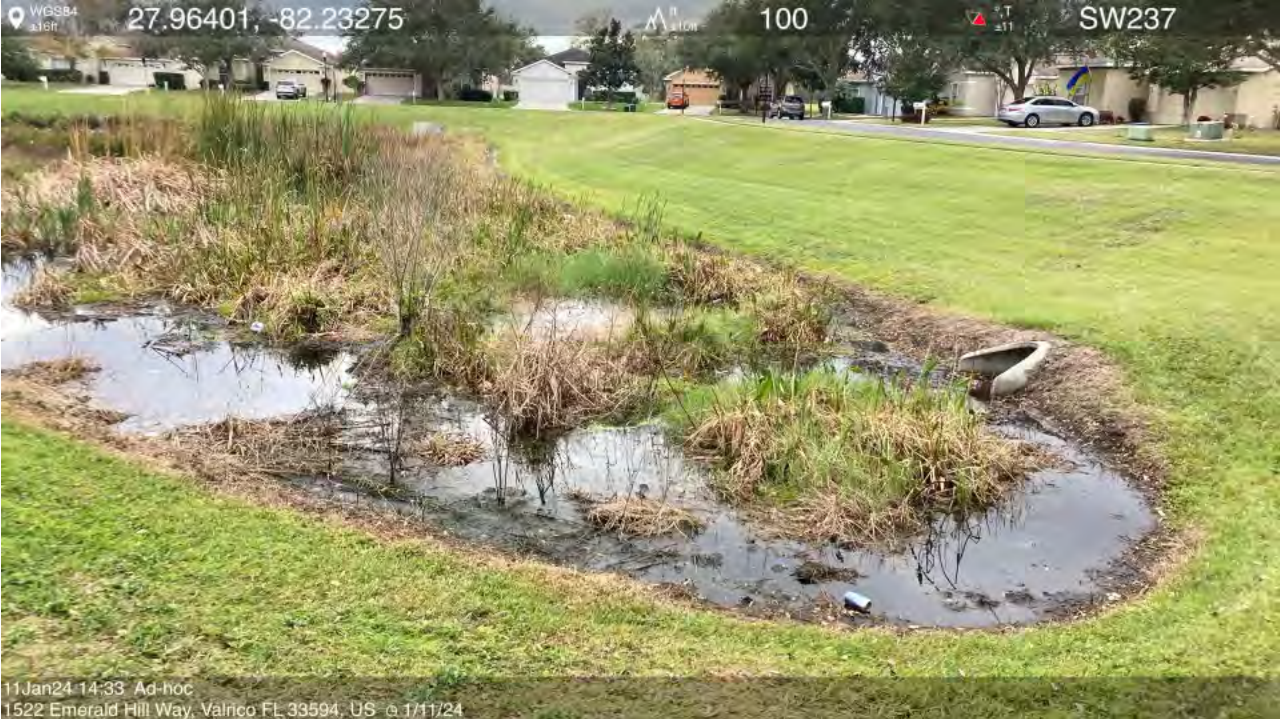
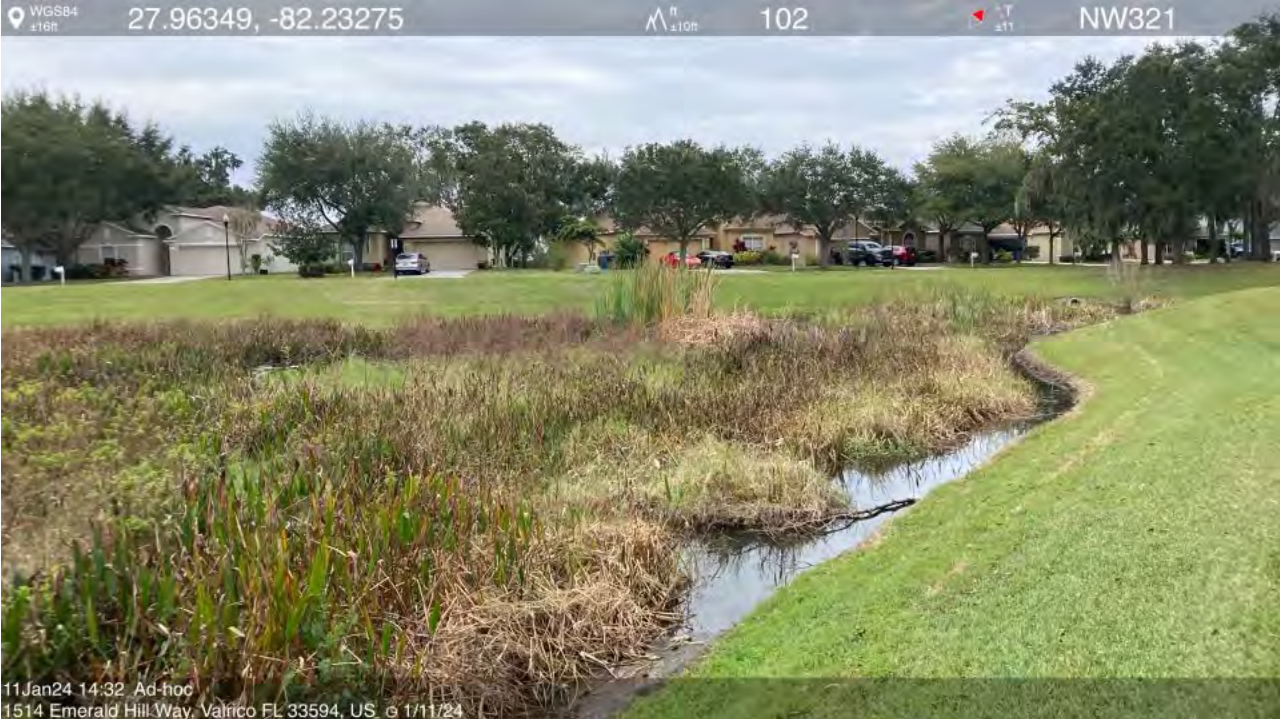
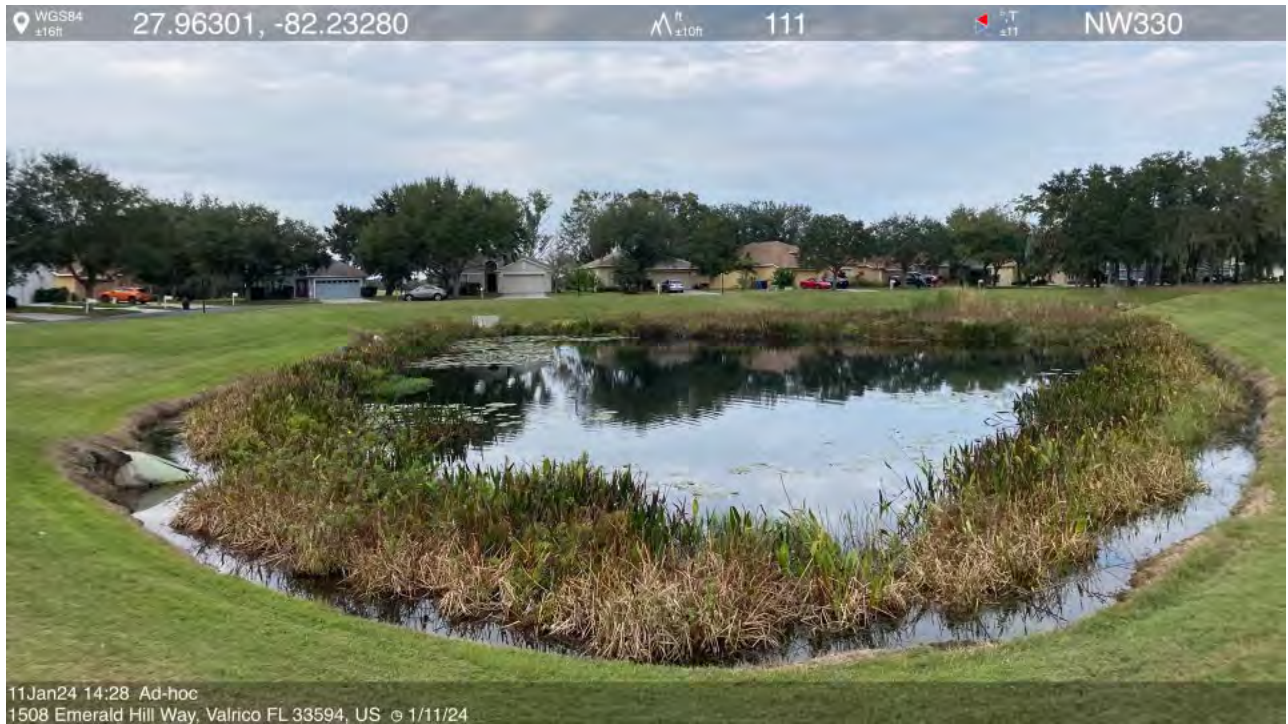
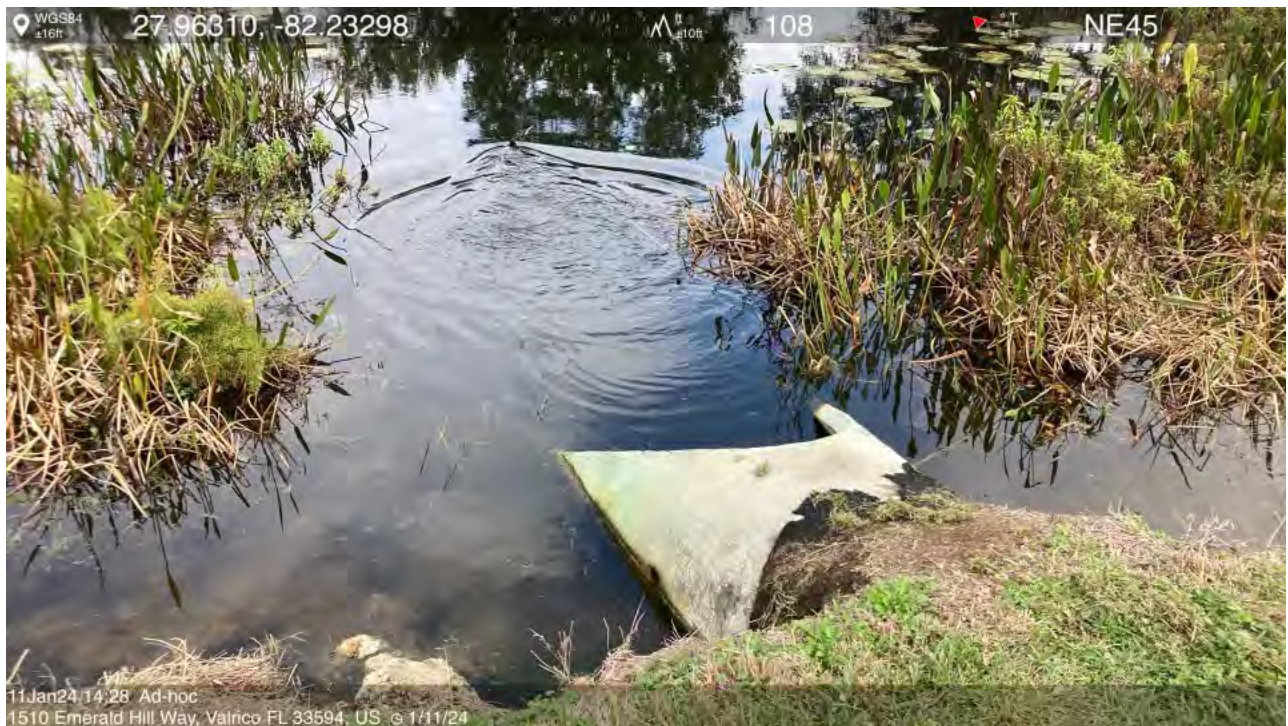
CDD POND EVALUATION			
INSPECTION DATE:	1/11/2024	PERMIT NUMBER:	24679.003
INSPECTED BY:	Jerry Whited	POND PERIMETER:	803 ft
POND NUMBER:	1200	POND AREA:	33,997 sq ft
Full Pond Access:	Yes	Trash Observed:	No
Beneficial Vegetaion Present:	Yes	Water Quality:	Above Average
Tailwater Issue Observed:	No	Water Quality Notes:	Lots of fish, plants
Observed Depth:	3' 1"	Observed Temperature:	66.92
POND ELEVATION ANALYSIS			
Treatment Type:	Wet Detention	Design Bottom Elevation:	90
Weir/Orifice Elevation:	96	Observed Bottom Elevation:	92.75
Skimmer Bottom Elevation:	95.5	Elevation Difference:	2.75
Pond Elevation Notes: Pond elevation was observed to be 2.75' less than design elevation. The majority of the pond is a littoral shelf that is in good condition. Based on the design elevations the main part of the pond may possibly call for a need to dredge in the future, however the pond is functioning properly. Recommended to monitor levels over time.

BANK EROSION AND SCOUR			
Severity Ranking:	NA		
Type of Erosion:	None		
Bank Erosion Notes: No erosion or shoreline defects observed.			
CONDITION OF POND STRUCTURES (CONTROL STRUCTURES, MITERED END SECTIONS, INLETS)			
Severity Ranking:	N/A		
Type of Damage:	None		
Structures Notes: One control structure with skimmer and three FES's observed all in operational condition with no defects.

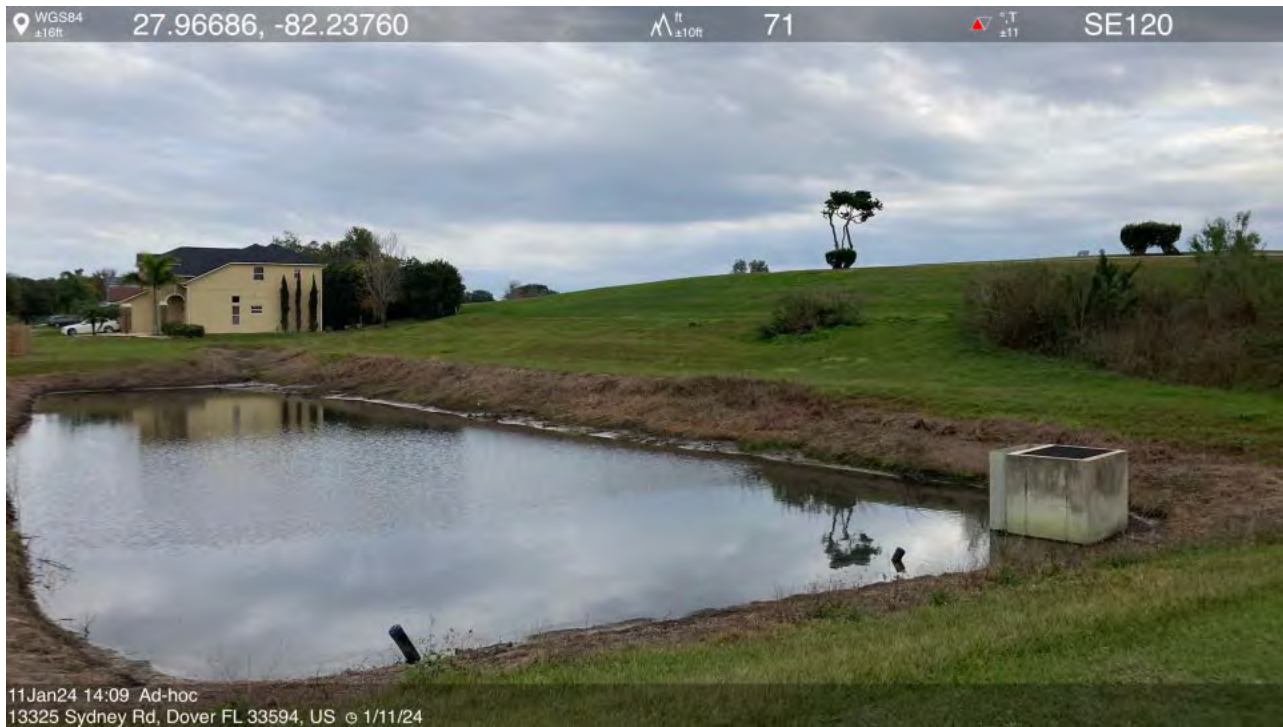
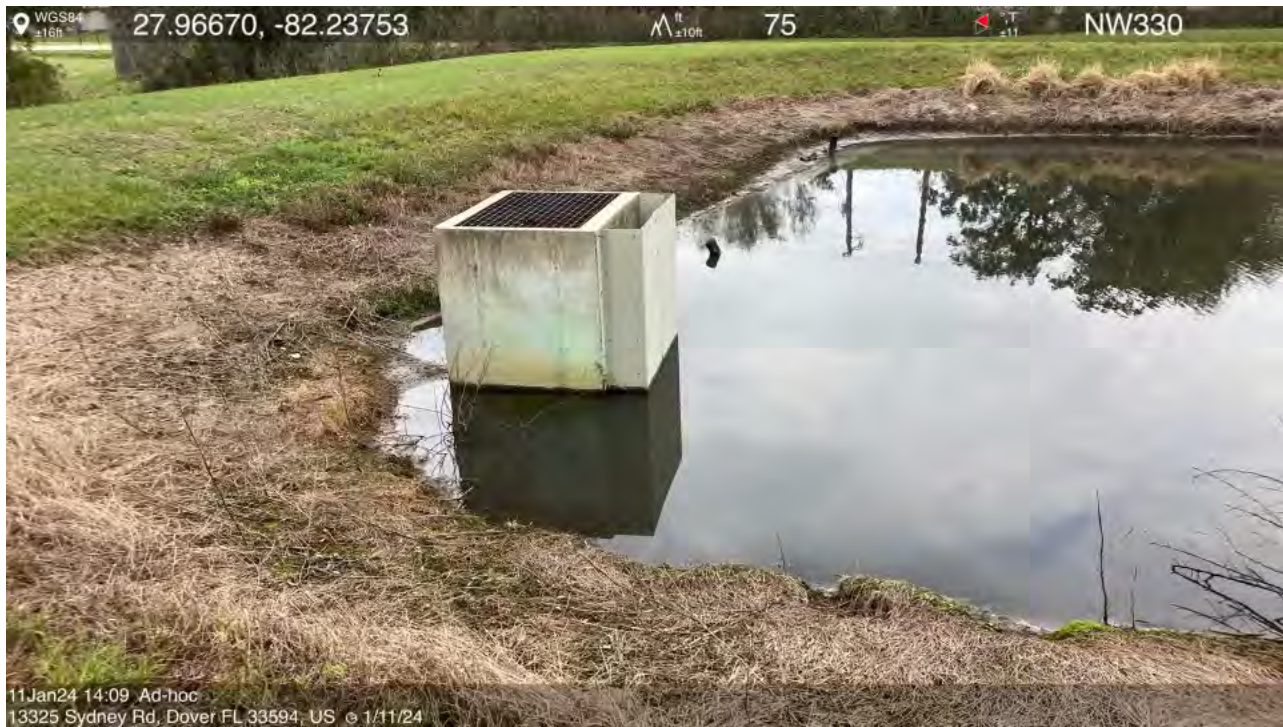
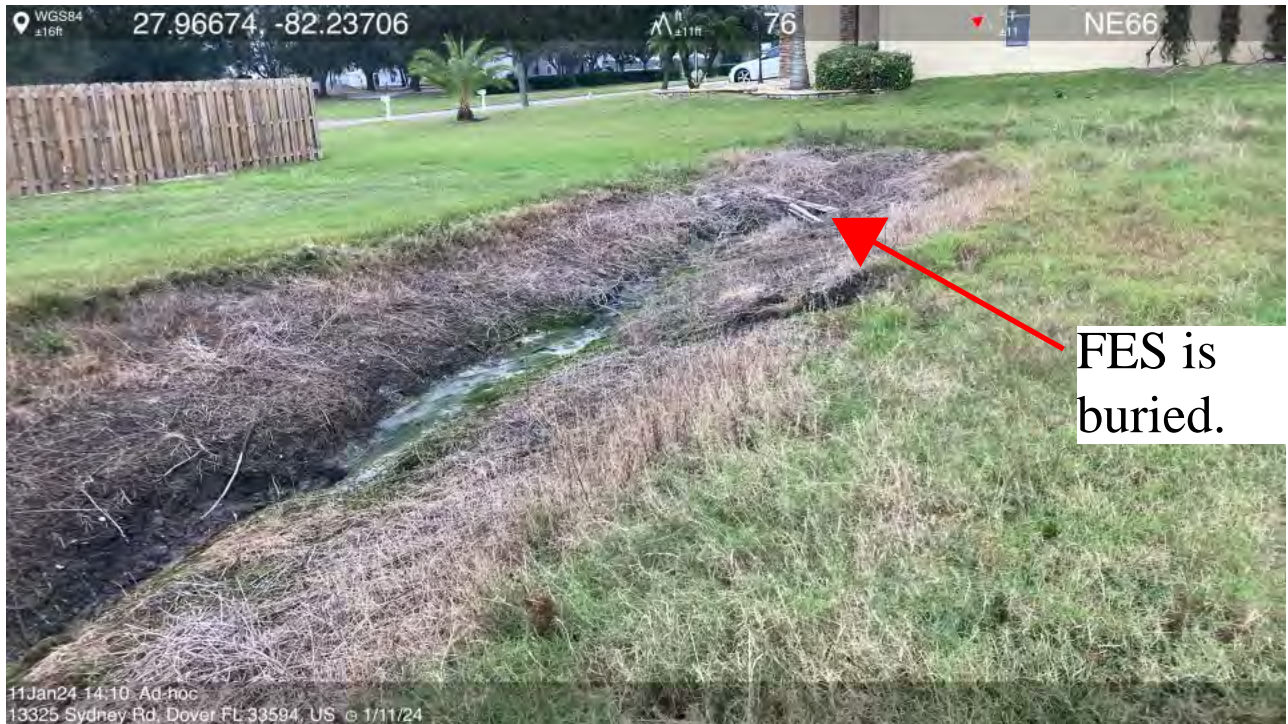
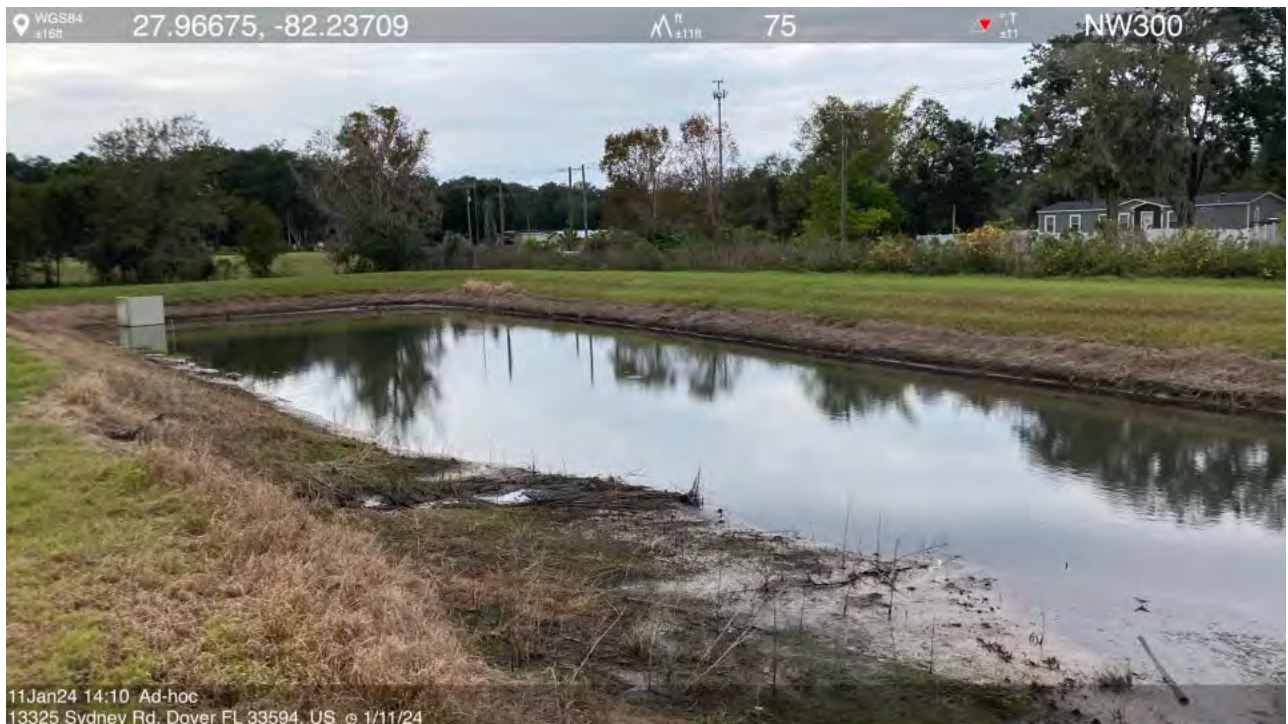
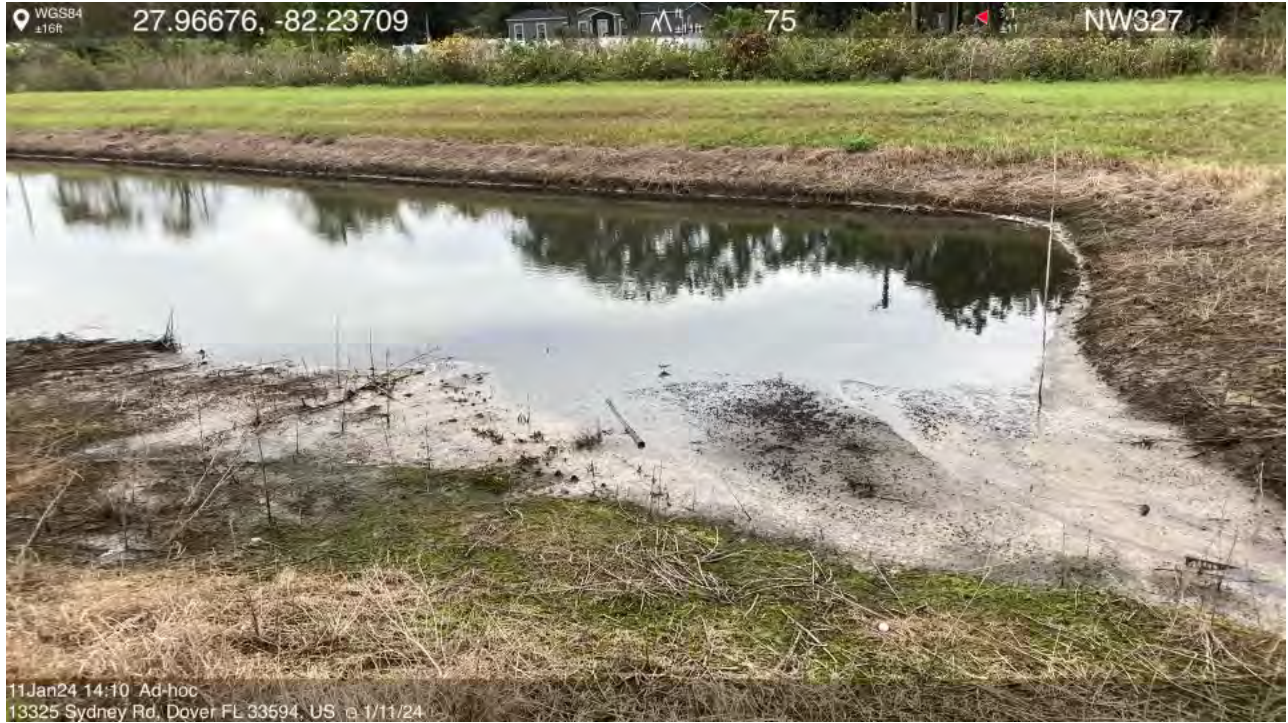
CDD POND EVALUATION			
INSPECTION DATE:	1/11/2024	PERMIT NUMBER:	24679.003
INSPECTED BY:	Jerry Whited	POND PERIMETER:	573 ft
POND NUMBER:	1300	POND AREA:	12,949 sq ft
Full Pond Access:	Yes	Trash Observed:	Yes
Benifitial Vegetaion Present:	No	Water Quality:	Below Average
Tailwater Issue Observed:	No	Water Quality Notes:	Algae
Observed Depth:	2' 9"	Observed Temperature:	67.28
POND ELEVATION ANALYSIS			
Treatment Type:	Dry Filter	Design Bottom Elevation:	66
Weir/Orifice Elevation:	67.4	Observed Bottom Elevation:	63.65
Skimmer Bottom Elevation:	66.9	Elevation Difference:	-2.35
Pond Elevation Notes: Pond elevation was observed to be approximately 2.35' more than design elevation. The difference in the design elevation does not appear to have an impact on pond functionality and it's not recommended to fill in the pond at this time. Monitor.			
BANK EROSION AND SCOUR			
Severity Ranking:	NA		
Type of Erosion:	None

Bank Erosion Notes: No erosion or shoreline defects observed.			
CONDITION OF POND STRUCTURES (CONTROL STRUCTURES, MITERED END SECTIONS, INLETS)			
Severity Ranking:	N/A		
Type of Damage:	None		
Structures Notes: One control struture with skimmer observed in operational condition with no defects. One ADS section in East coner of the pond is called out in the plans but must be submerged or under vegetation as it is not visable.

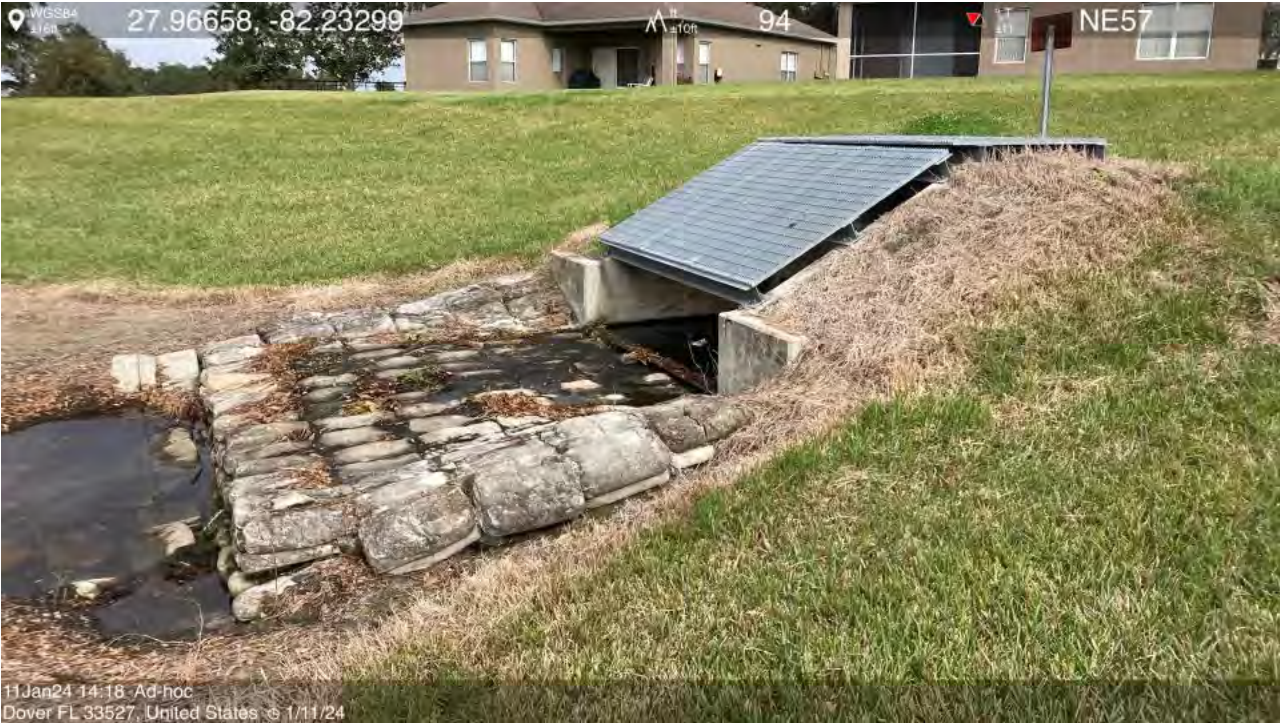
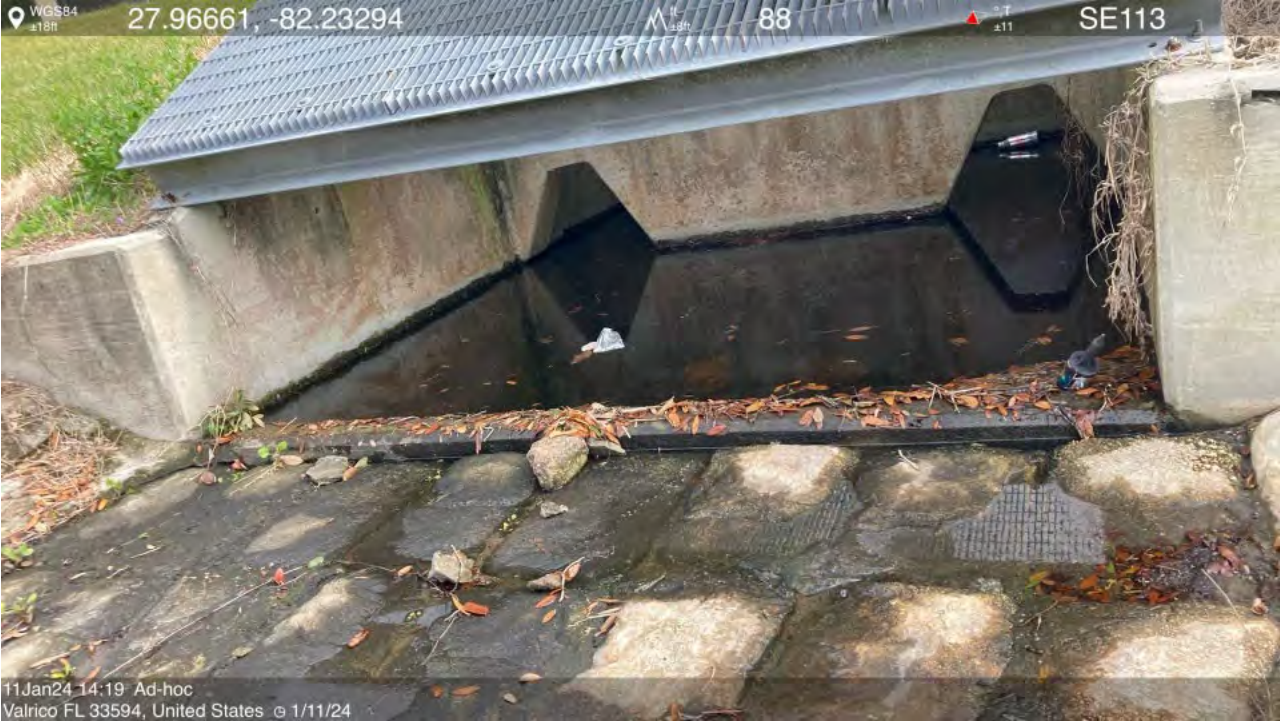
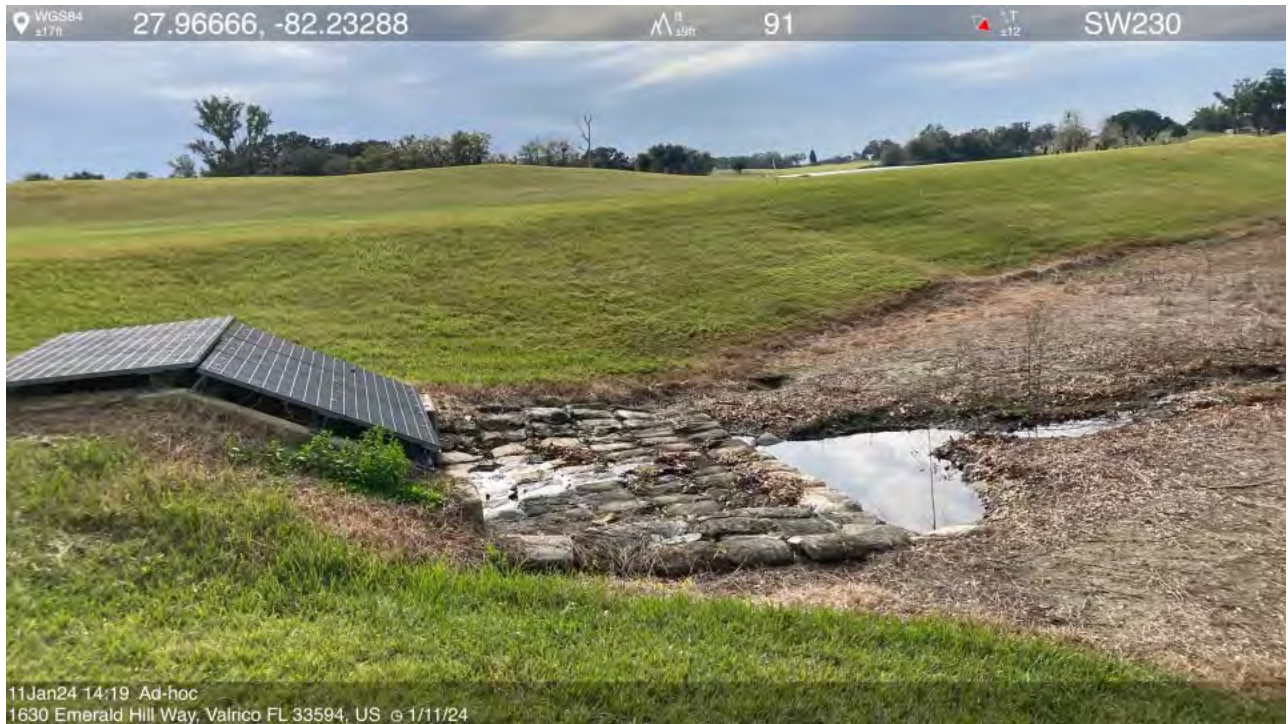
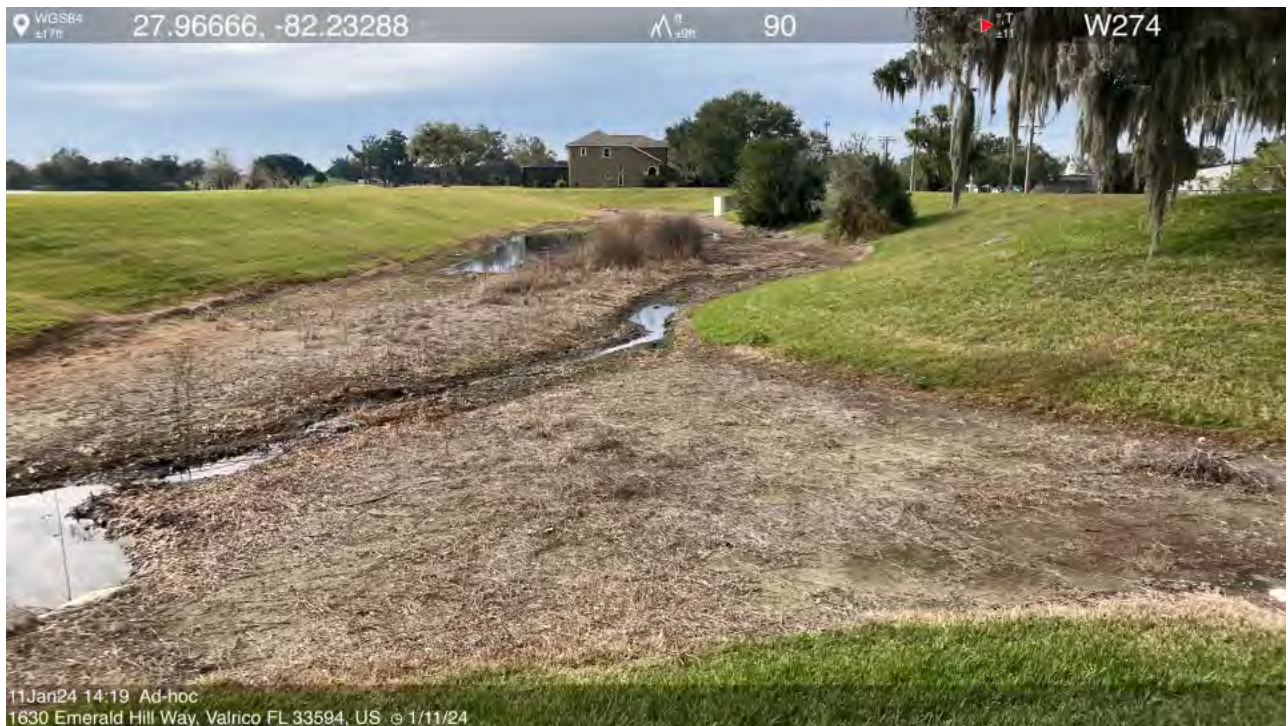
CDD POND EVALUATION			
INSPECTION DATE:	1/11/2024	PERMIT NUMBER:	24679.003
INSPECTED BY:	Jerry Whited	POND PERIMETER:	885 ft
POND NUMBER:	1350	POND AREA:	19,032 sq ft
Full Pond Access:	Yes	Trash Observed:	Yes
Beneficial Vegetaion Present:	No	Water Quality:	NA
Tailwater Issue Observed:	No	Water Quality Notes:	Dry Pond
Observed Depth:	0	Observed Temperature:	NA
POND ELEVATION ANALYSIS			
Treatment Type:	Dry Filter	Design Bottom Elevation:	80.1
Weir/Orifice Elevation:	81.1	Observed Bottom Elevation:	80.1
Skimmer Bottom Elevation:	80.6	Elevation Difference:	0
Pond Elevation Notes: This is a dry pond.			
BANK EROSION AND SCOUR			
Severity Ranking:	NA		
Type of Erosion:	None		
Bank Erosion Notes: No erosion or shoreline defects observed.			
CONDITION OF POND STRUCTURES (CONTROL STRUCTURES, MITERED END SECTIONS, INLETS)			
Severity Ranking:	N/A		
Type of Damage:	None		
Structures Notes: One FES with grates observed to be in operational condition with no defects. One control structure with skimmer observed to be in operational condition with no defects.
