**DIAMOND HILL
COMMUNITY DEVELOPMENT DISTRICT**

**FEBRUARY 12, 2024
AGENDA PACKAGE**

- 1.0 ERP PERMIT INFORMATION
- 2.0 PERMIT INSPECTION HISTORY
- 3.0 RECONCILIATION OF CURRENT DEFECT OBSERVATIONS
- 4.0 POND ELEVATION SUMMARY
- 5.0 INSPECTION REPORTS & PICTURES

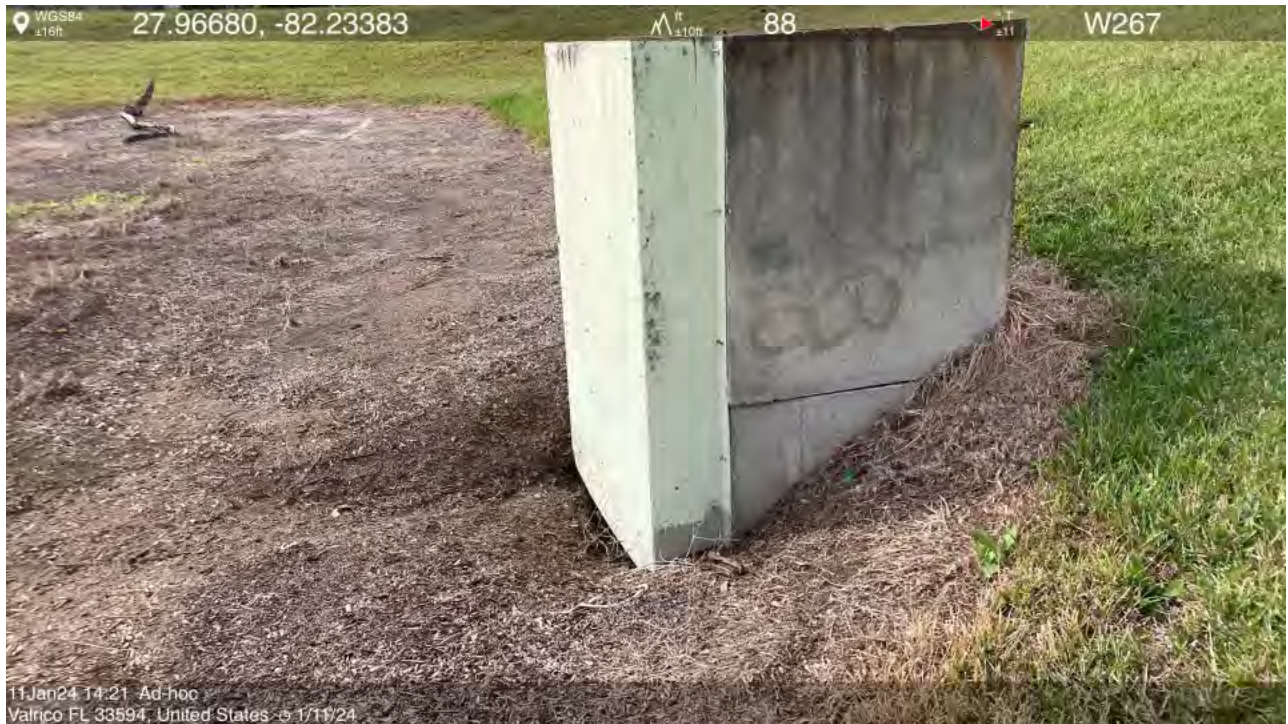
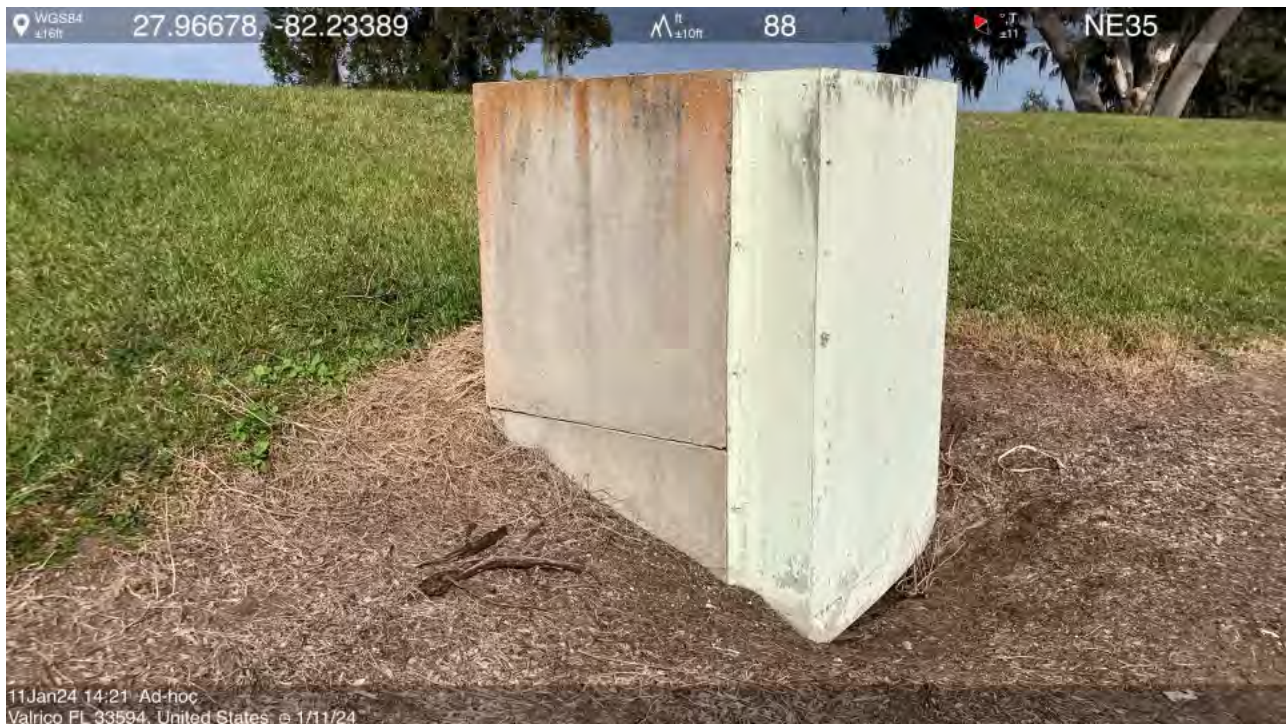
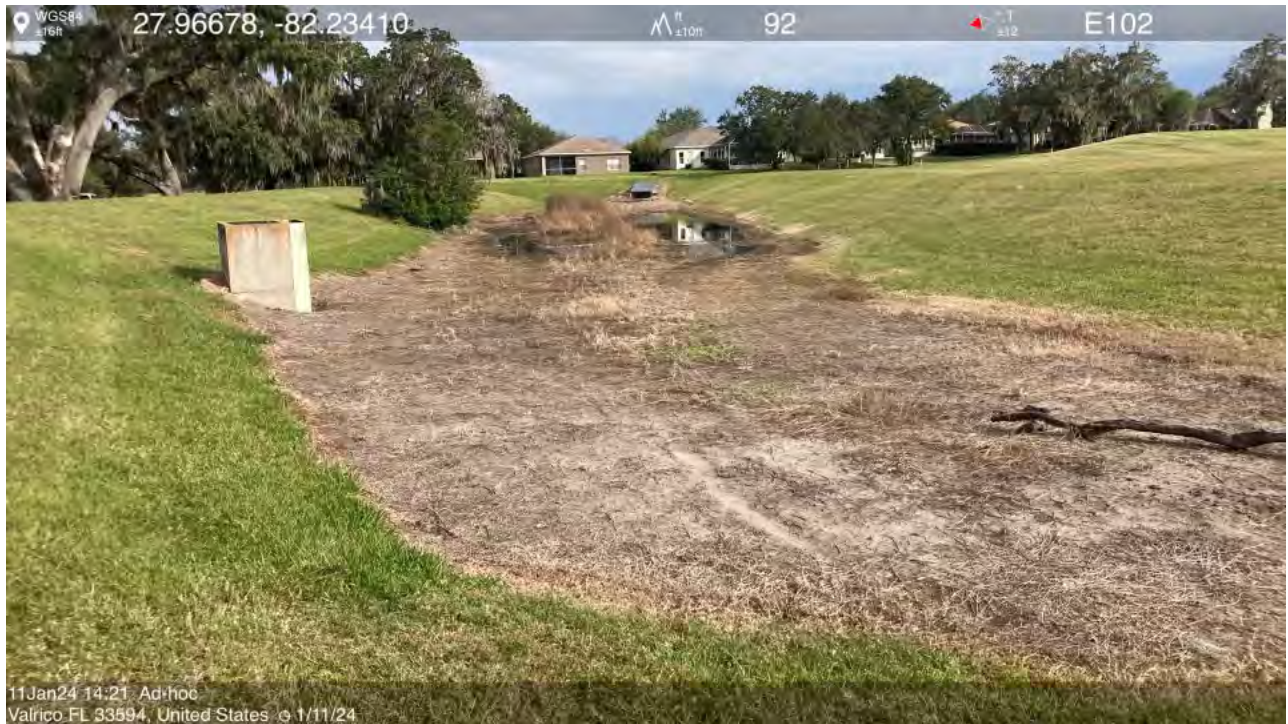
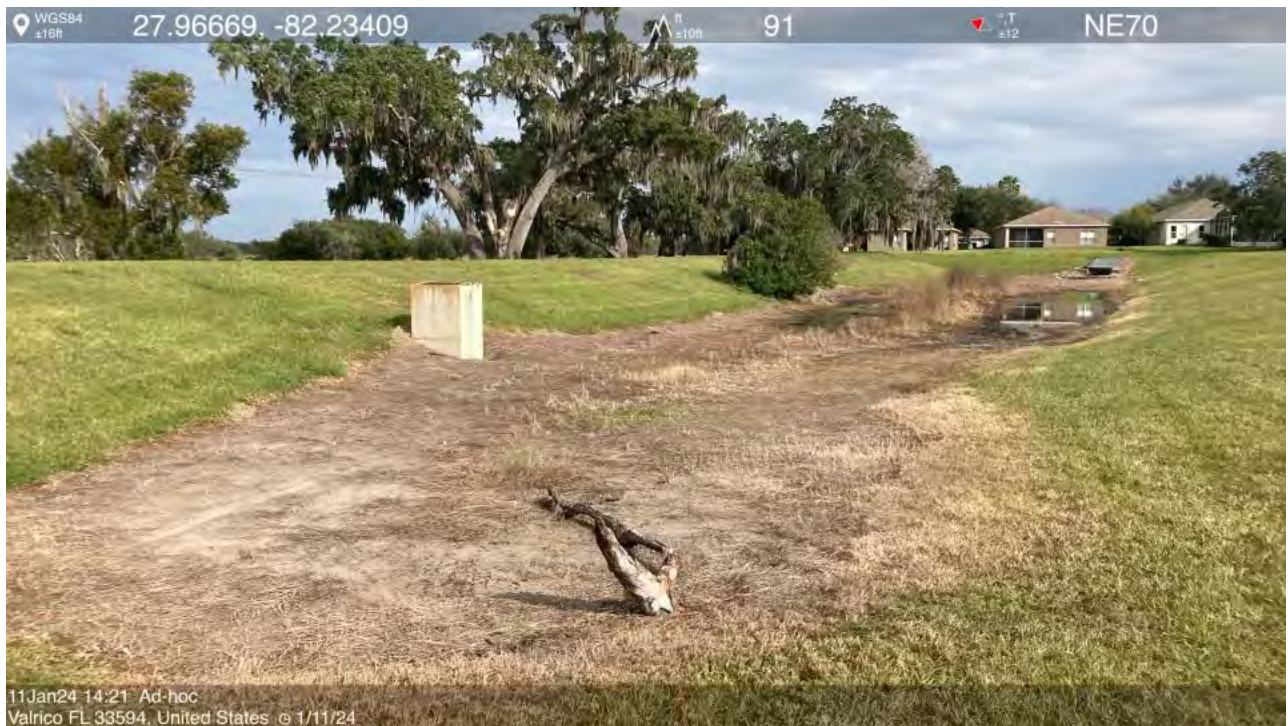
CDD POND EVALUATION			
INSPECTION DATE:	1/11/2024	PERMIT NUMBER:	24679.003
INSPECTED BY:	Jerry Whited	POND PERIMETER:	885 ft
POND NUMBER:	1350	POND AREA:	19,032 sq ft
Full Pond Access:	Yes	Trash Observed:	Yes
Beneficial Vegetaion Present:	No	Water Quality:	NA
Tailwater Issue Observed:	No	Water Quality Notes:	Dry Pond
Observed Depth:	0	Observed Temperature:	NA
POND ELEVATION ANALYSIS			
Treatment Type:	Dry Filter	Design Bottom Elevation:	80.1
Weir/Orifice Elevation:	81.1	Observed Bottom Elevation:	80.1
Skimmer Bottom Elevation:	80.6	Elevation Difference:	0
Pond Elevation Notes: This is a dry pond.			
BANK EROSION AND SCOUR			
Severity Ranking:	NA		
Type of Erosion:	None		
Bank Erosion Notes: No erosion or shoreline defects observed.			
CONDITION OF POND STRUCTURES (CONTROL STRUCTURES, MITERED END SECTIONS, INLETS)			
Severity Ranking:	N/A		
Type of Damage:	None		
Structures Notes: One FES with grates observed to be in operational condition with no defects. One control structure with skimmer observed to be in operational condition with no defects.

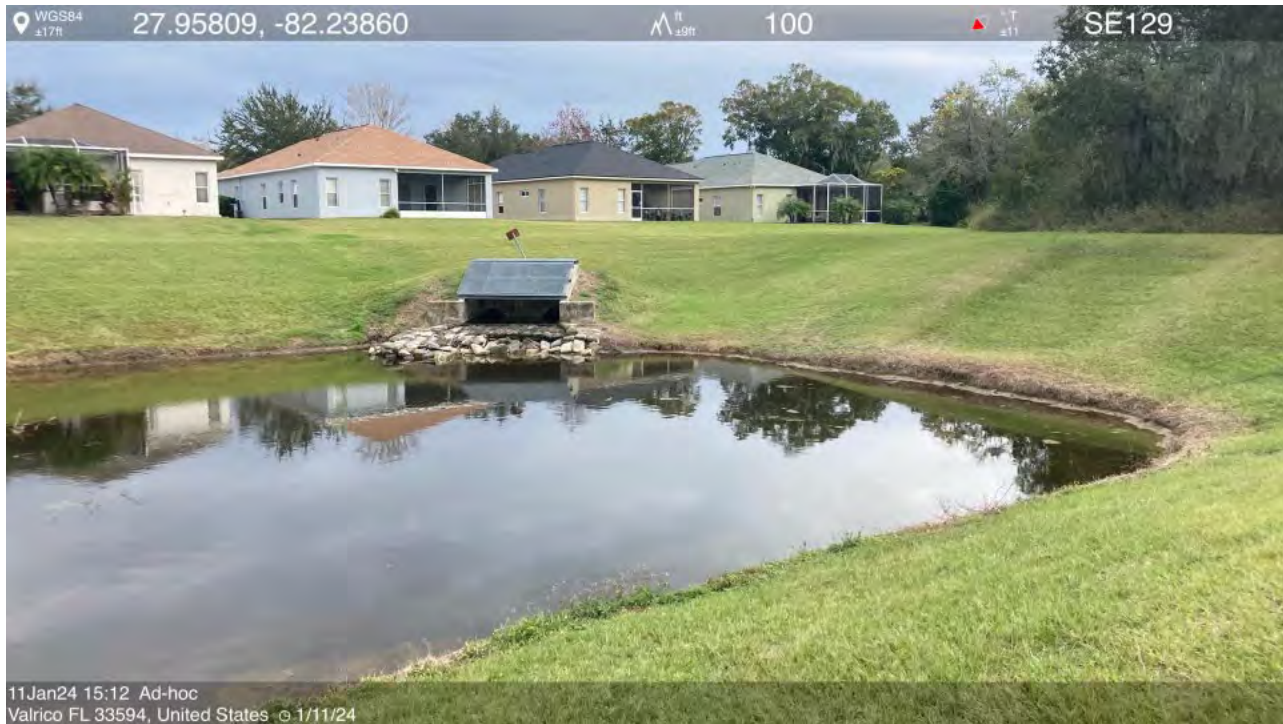
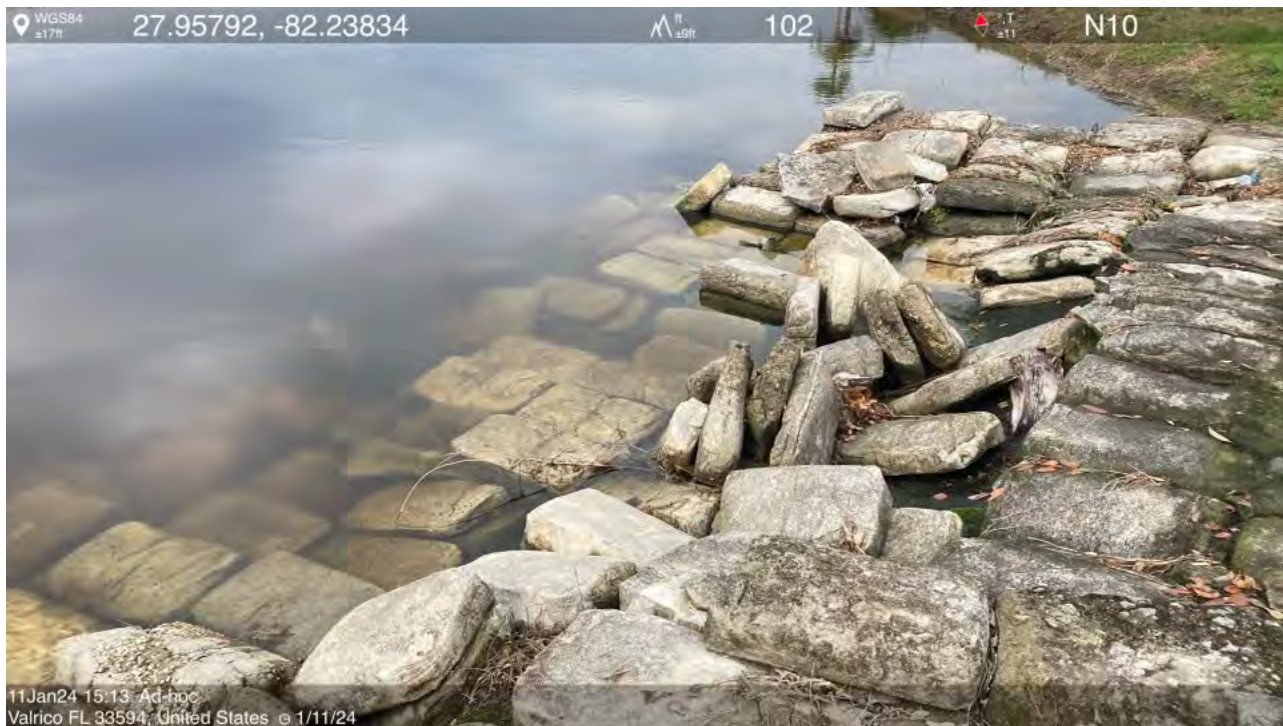
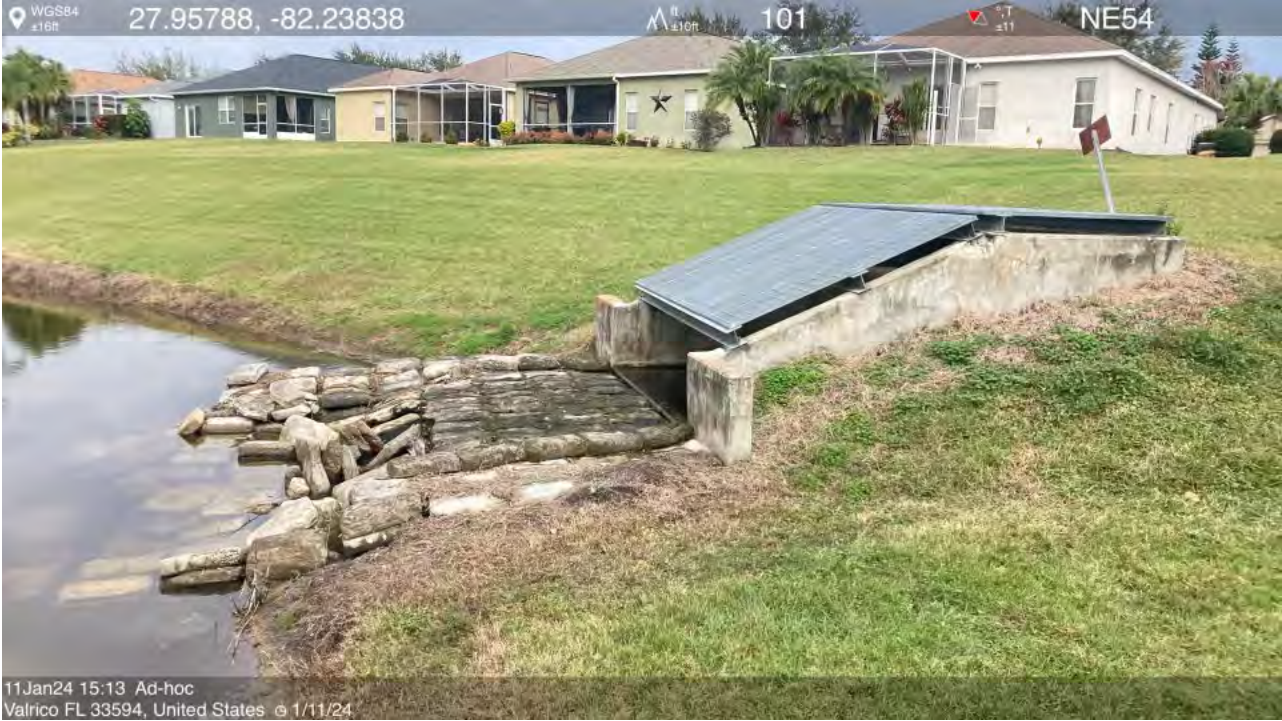
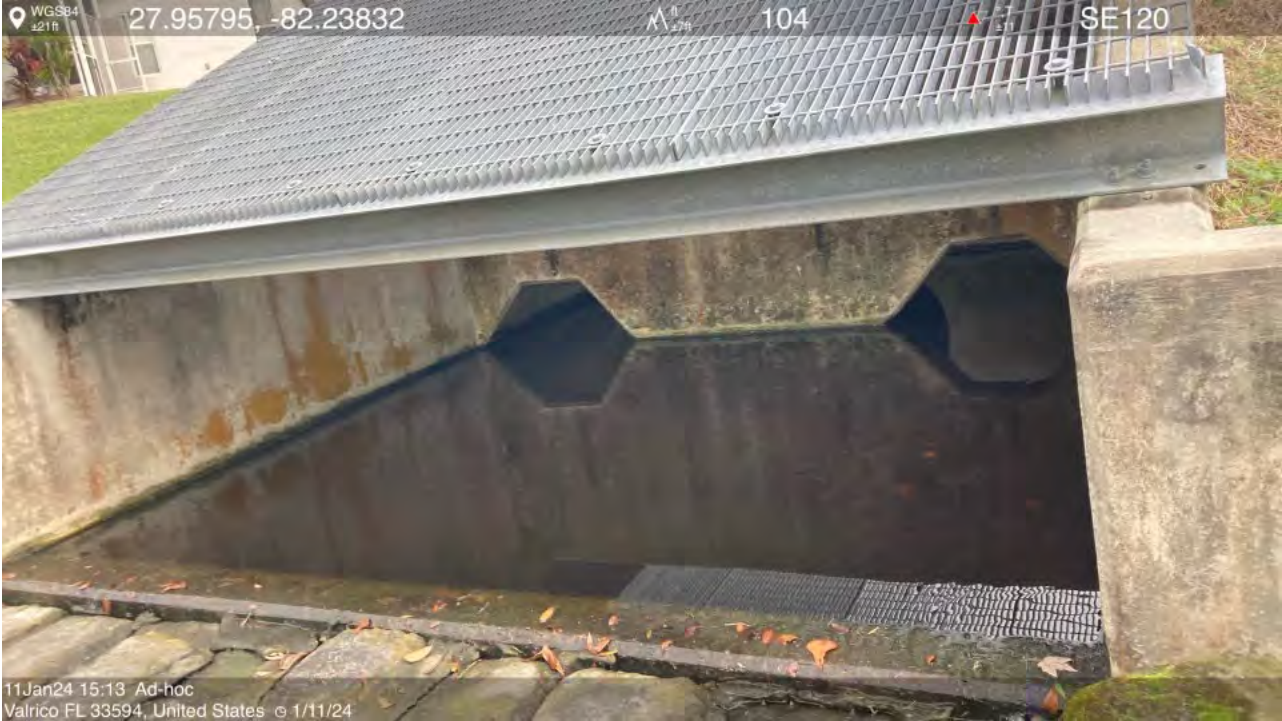
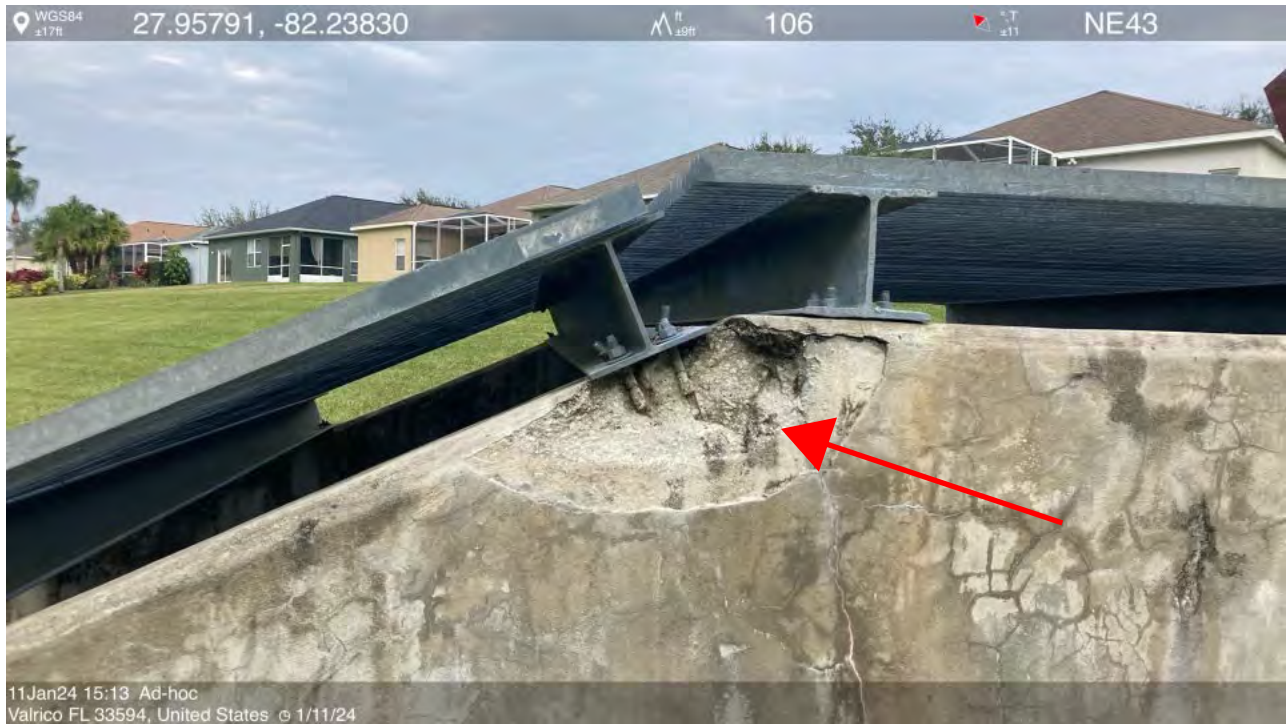
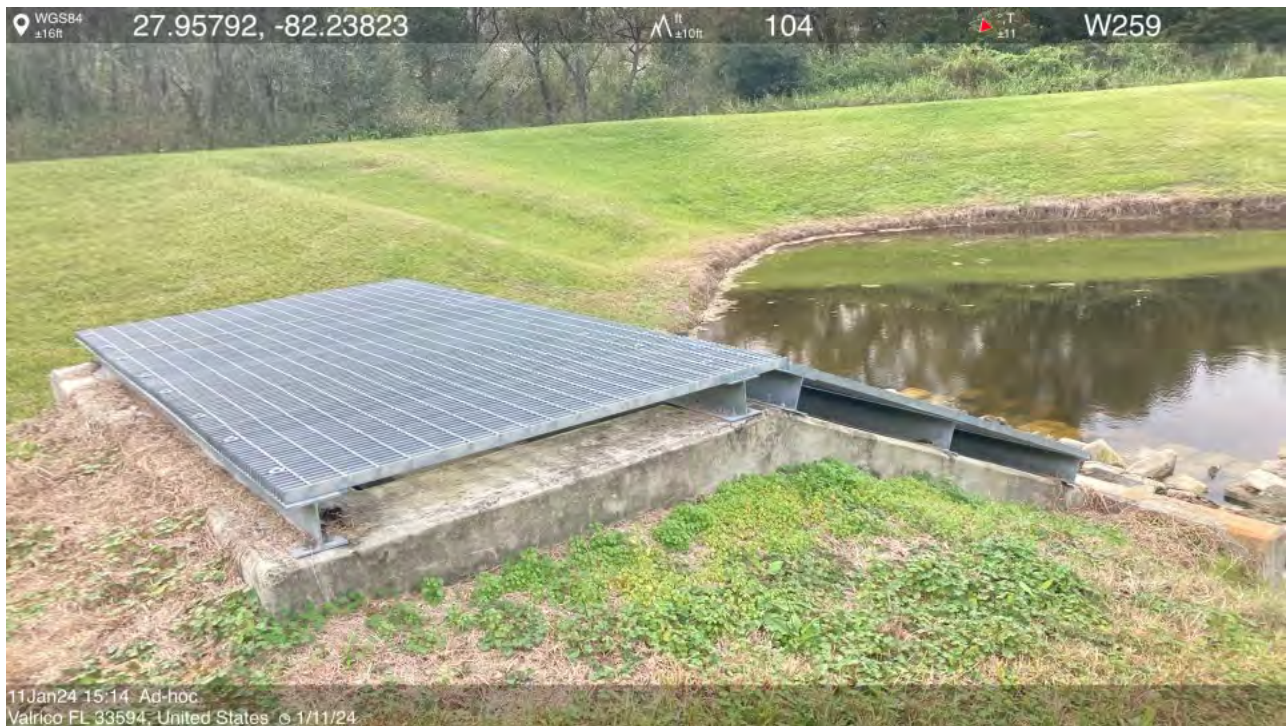
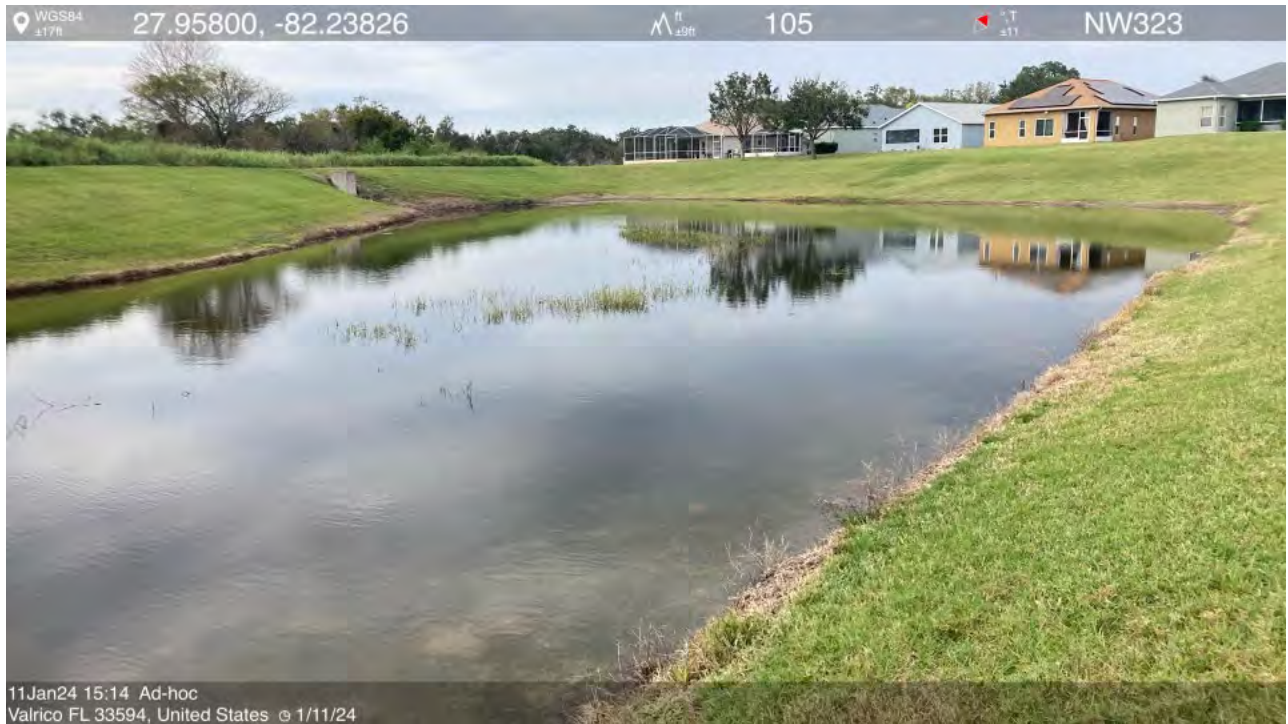
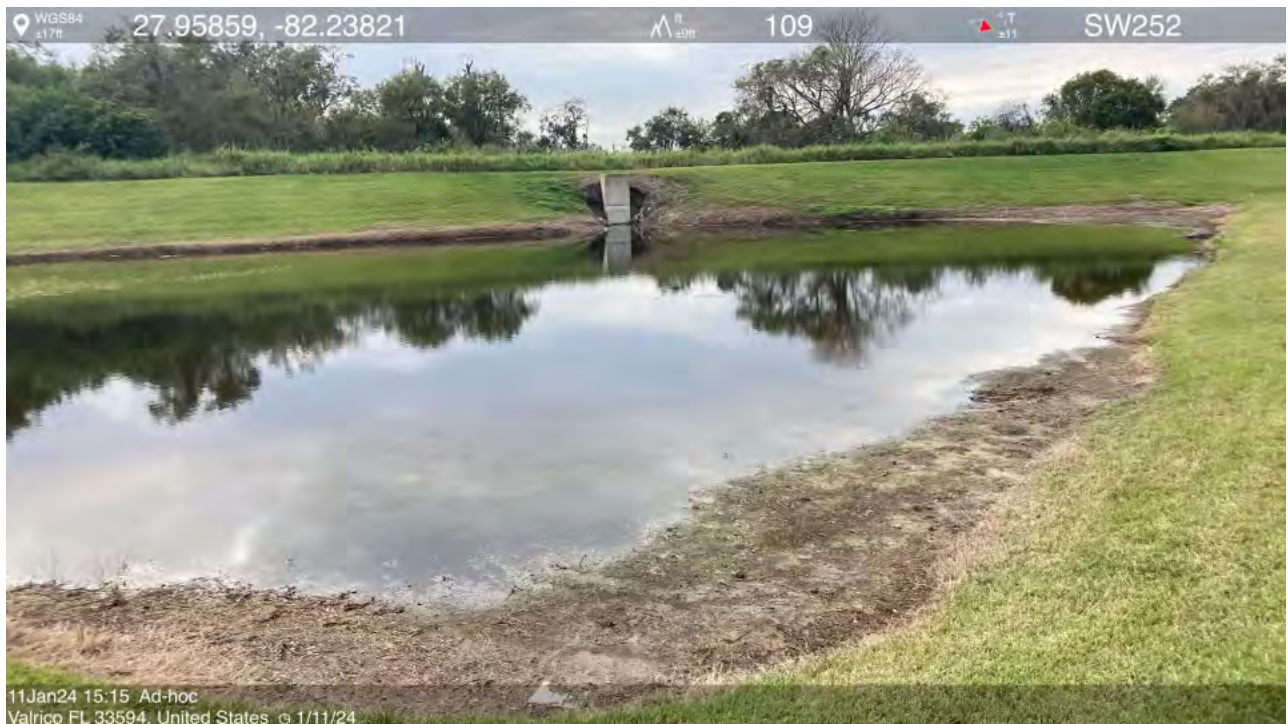
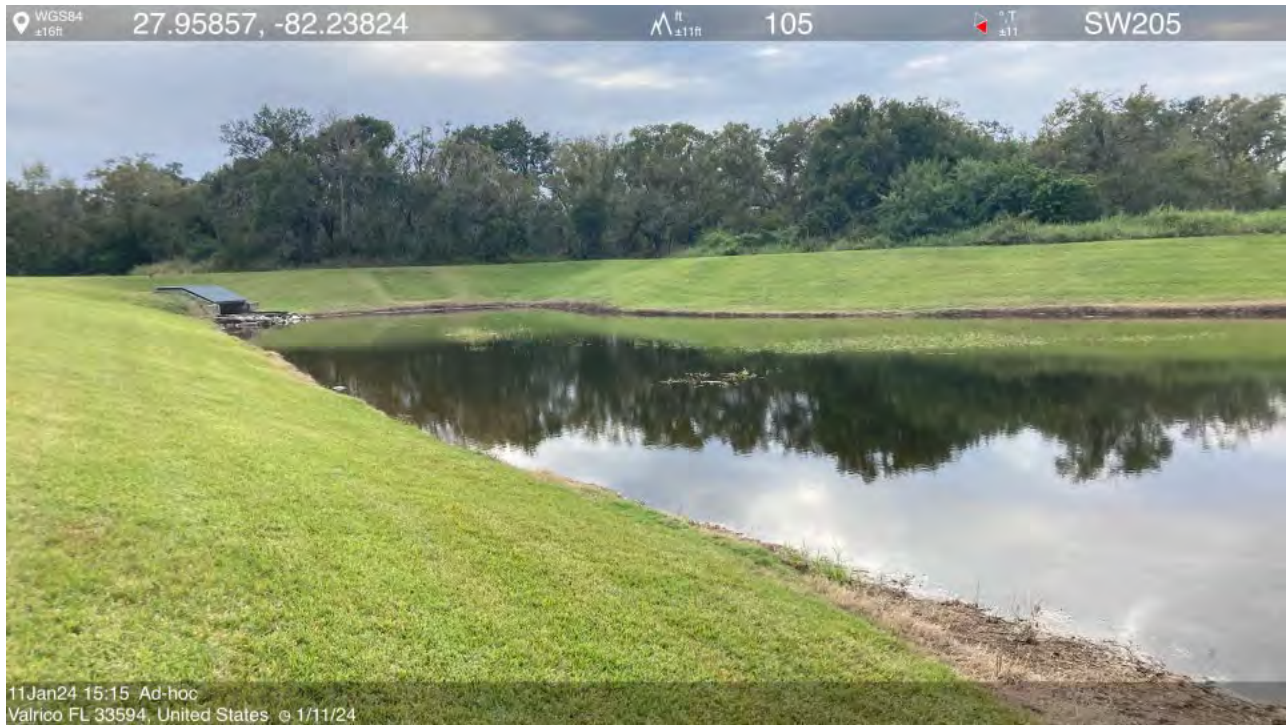
CDD POND EVALUATION			
INSPECTION DATE:	1/11/2024	PERMIT NUMBER:	24679.003
INSPECTED BY:	Jerry Whited	POND PERIMETER:	815.27 ft
POND NUMBER:	1400	POND AREA:	32,622.11 sq ft
Full Pond Access:	Yes	Trash Observed:	No
Benifitial Vegetaion Present:	No	Water Quality:	Average
Tailwater Issue Observed:	No	Water Quality Notes:	NA
Observed Depth:	2' 6"	Observed Temperature:	65.12 Degrees
POND ELEVATION ANALYSIS			
Treatment Type:	Dry Filter	Design Bottom Elevation:	97
Weir/Orifice Elevation:	98.4	Observed Bottom Elevation:	95.90
Skimmer Bottom Elevation:	97.9	Elevation Difference:	-1.10
Pond Elevation Notes: Pond elevation was observed to be approximately 1.10' more than design elevation. The elevation difference does not appear to affect the functionality of the pond.			
BANK EROSION AND SCOUR			
Severity Ranking:	Minor		
Type of Erosion:	Water Level Fluctuation		
Bank Erosion Notes: Minor erosion around control structure. Seasonal high water table at lowest point during inspection and exposed banks are expected this time of year.

CONDITION OF POND STRUCTURES (CONTROL STRUCTURES, MITERED END SECTIONS, INLETS)			
Severity Ranking:	Minor		
Type of Damage:	Concrete damage on structure.		
Structures Notes: One FES with grate observed to be in operational condition however there is a section of concrete that is broken off exposing some of the grate hardware. One control structure with skimmer observed to be in operational condition.

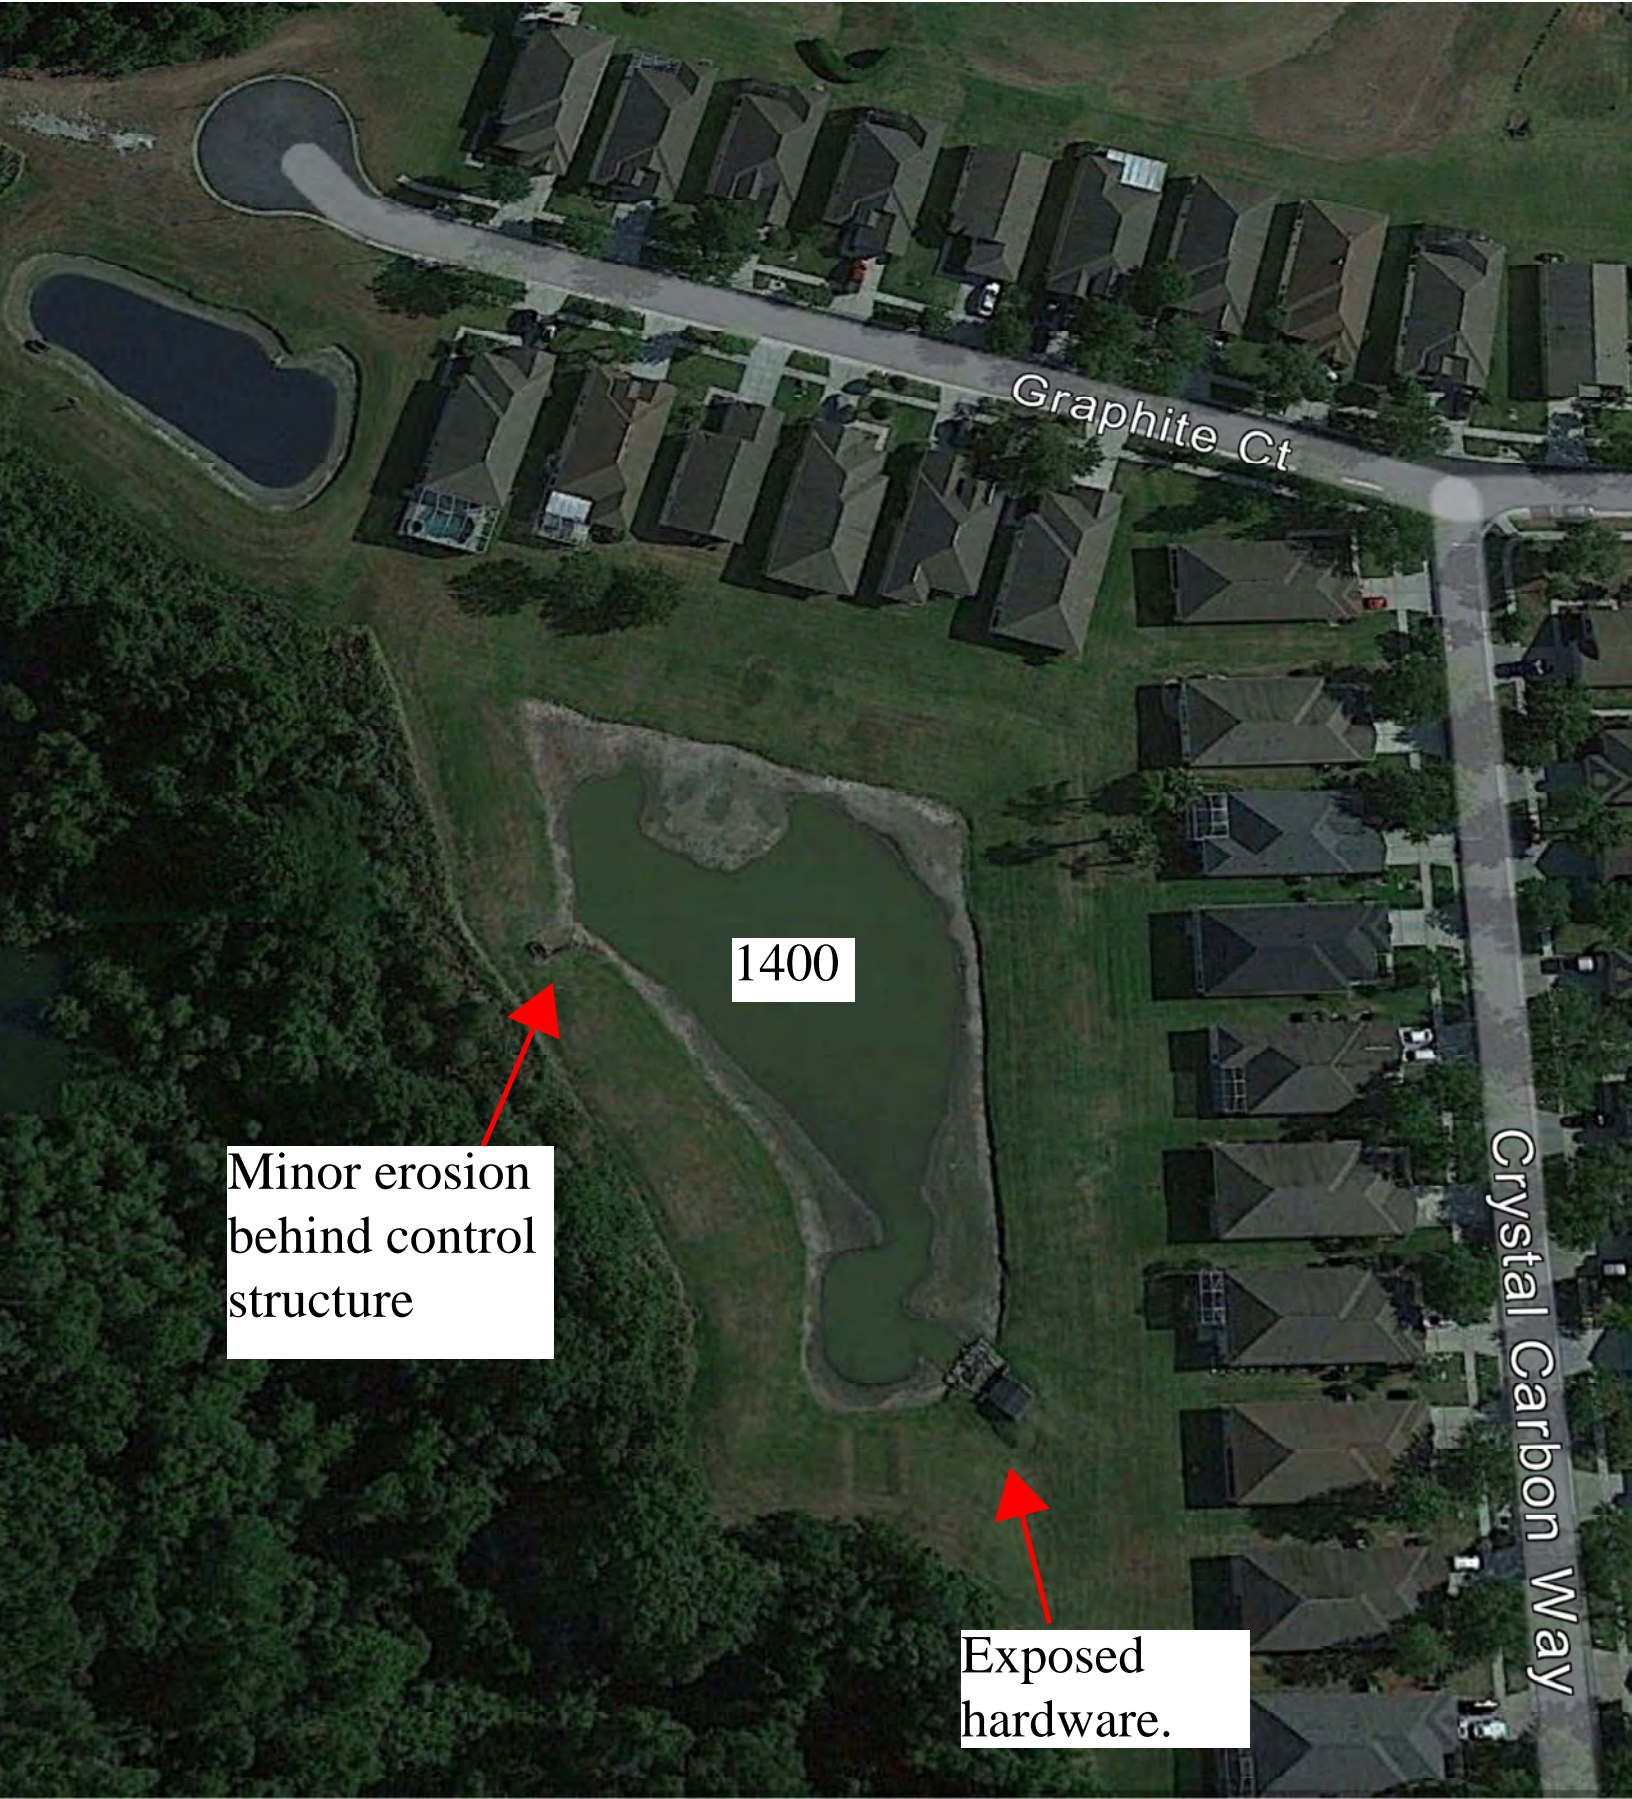
1400

Minor erosion behind control structure

Exposed hardware.

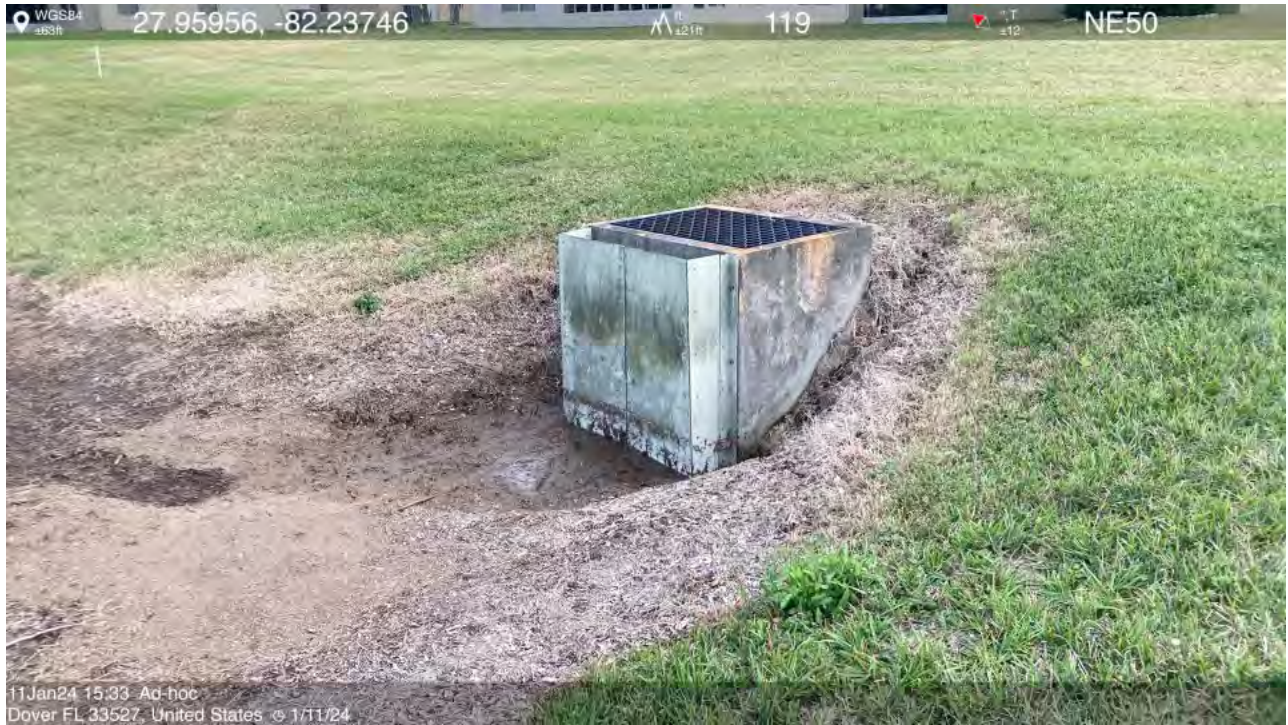
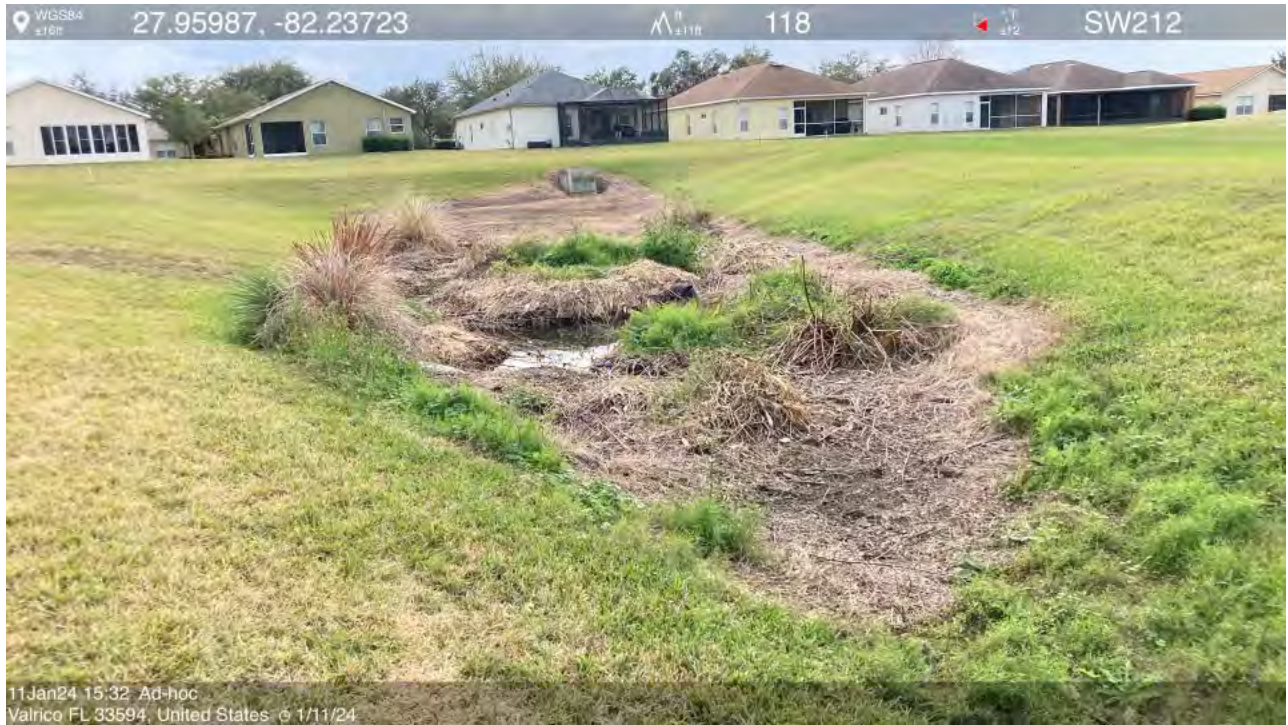
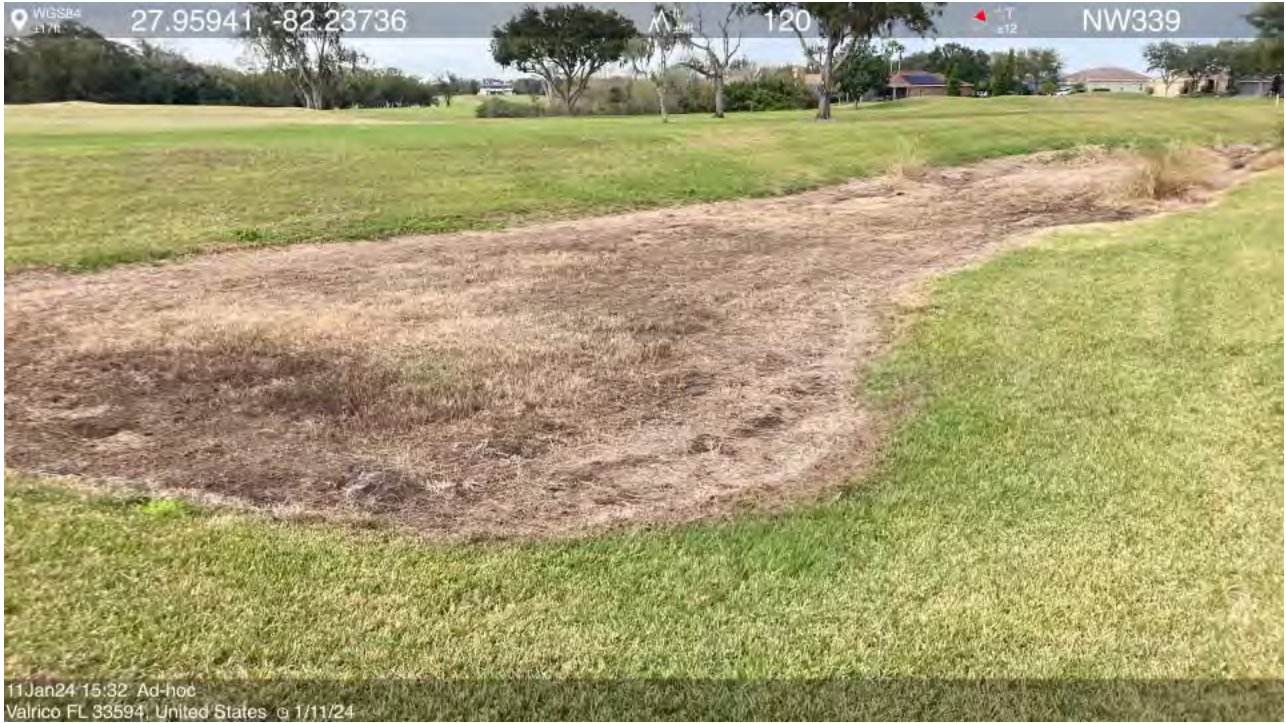
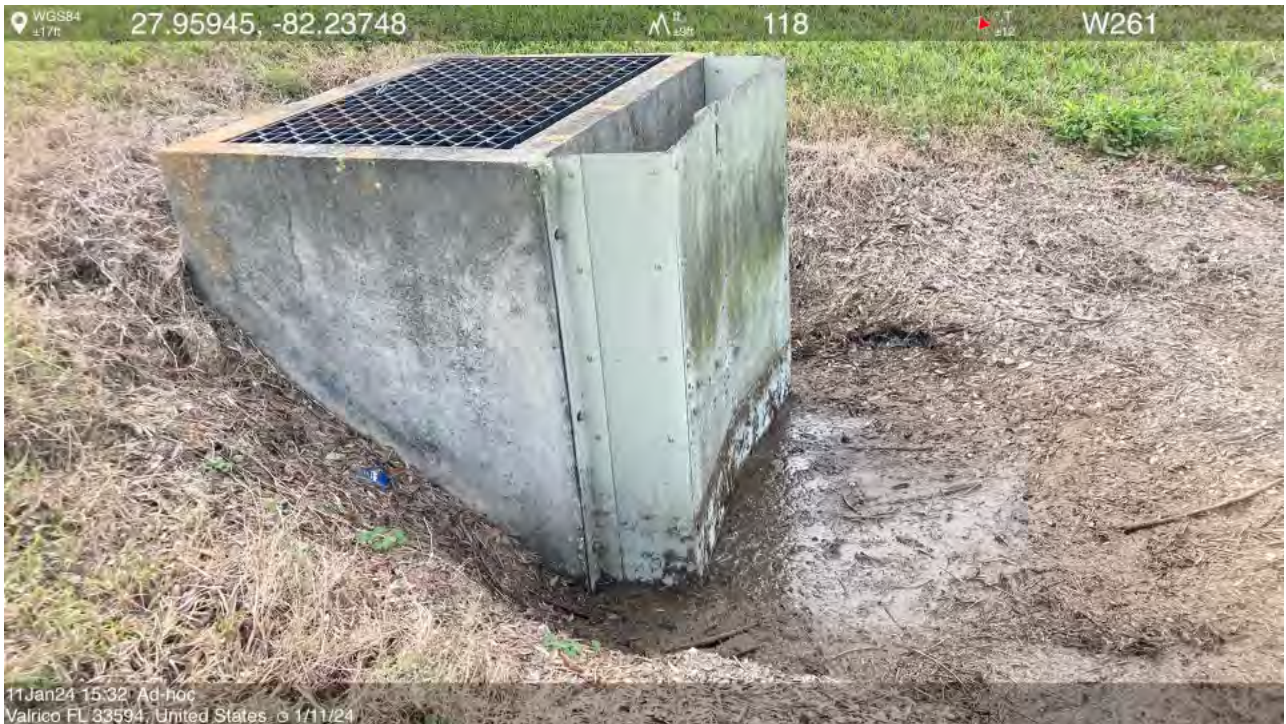
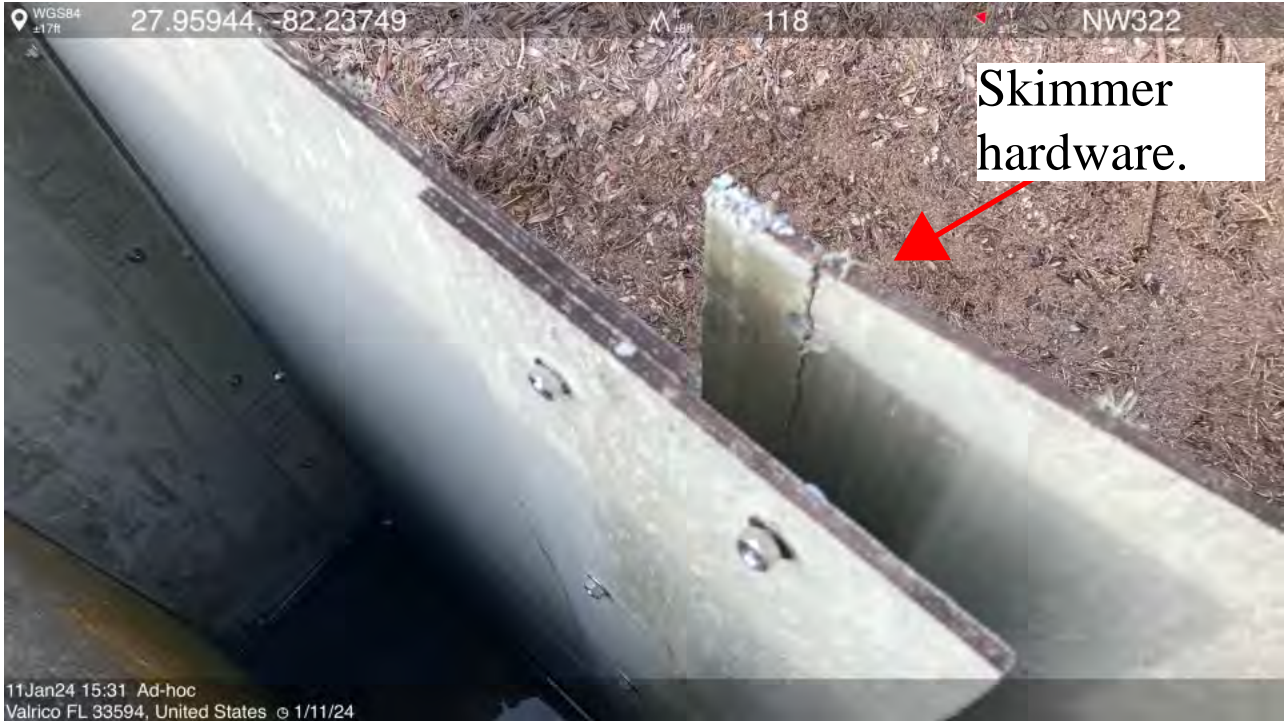
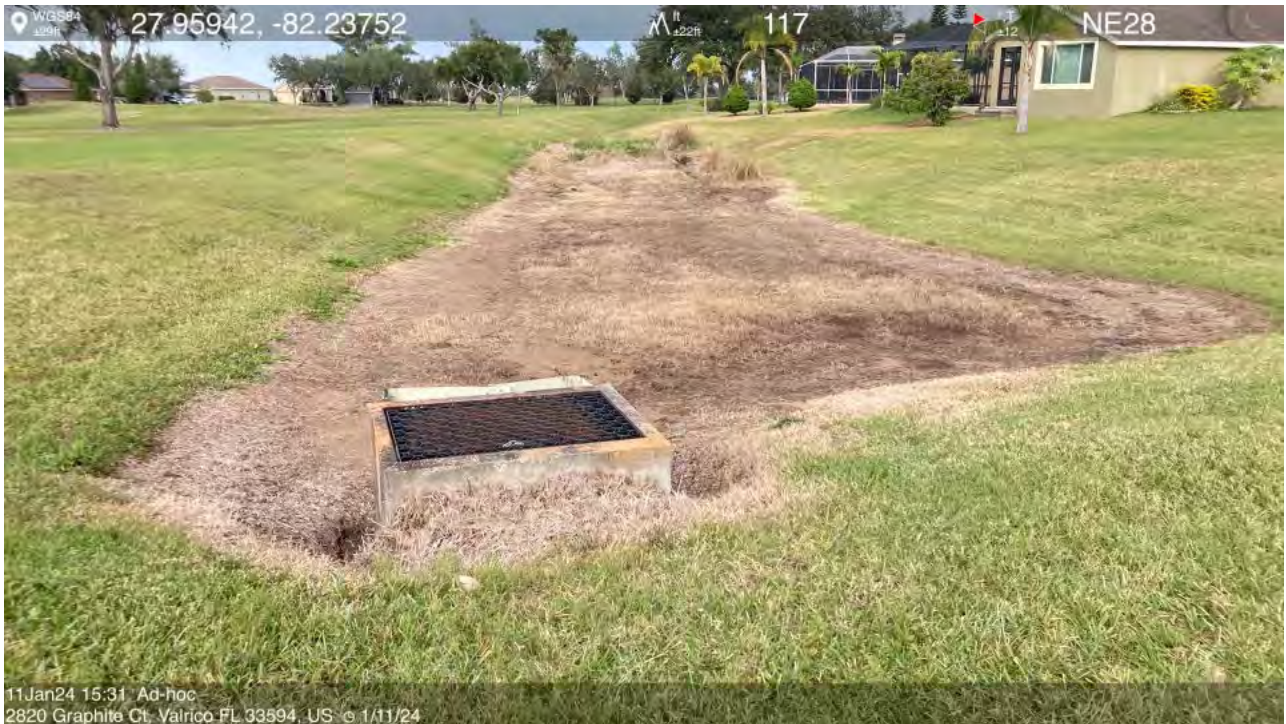
CDD POND EVALUATION			
INSPECTION DATE:	1/11/2024	PERMIT NUMBER:	24679.003
INSPECTED BY:	Jerry Whited	POND PERIMETER:	398 ft
POND NUMBER:	1450	POND AREA:	6,744 sq ft
Full Pond Access:	Yes	Trash Observed:	No
Beneficial Vegetaion Present:	NA	Water Quality:	NA
Tailwater Issue Observed:	No	Water Quality Notes:	Dry Pond
Observed Depth:	NA	Observed Temperature:	NA
POND ELEVATION ANALYSIS			
Treatment Type:	Dry (NA)	Design Bottom Elevation:	110
Weir/Orifice Elevation:	110	Observed Elevation:	110
Skimmer Bottom Elevation:	109.5	Elevation Difference:	0
Pond Elevation Notes: This is a dry pond.			
BANK EROSION AND SCOUR			
Severity Ranking:	NA		
Type of Erosion:	None		
Bank Erosion Notes: Dry Pond - no erosion or shoreline defects observed.			
CONDITION OF POND STRUCTURES (CONTROL STRUCTURES, MITERED END SECTIONS, INLETS)			
Severity Ranking:	Minor		
Type of Damage:	Skimmer Repair		
Structures Notes: One control structure observed with a skimmer that has connection hardware that has failed. Hardware should be replaced on skimmer. One FES observed in operational condition with no defects.
