**DIAMOND HILL
COMMUNITY DEVELOPMENT DISTRICT**

**FEBRUARY 12, 2024
AGENDA PACKAGE**

- 1.0 ERP PERMIT INFORMATION
- 2.0 PERMIT INSPECTION HISTORY
- 3.0 RECONCILIATION OF CURRENT DEFECT OBSERVATIONS
- 4.0 POND ELEVATION SUMMARY
- 5.0 INSPECTION REPORTS & PICTURES

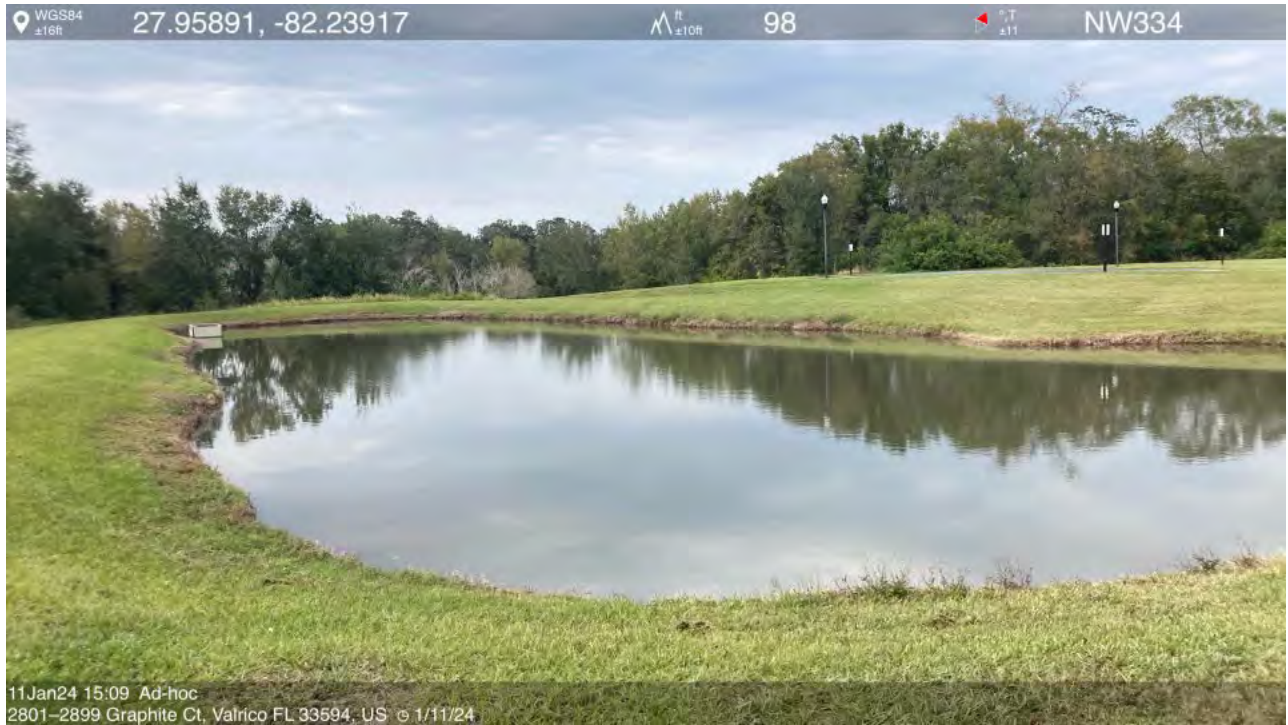
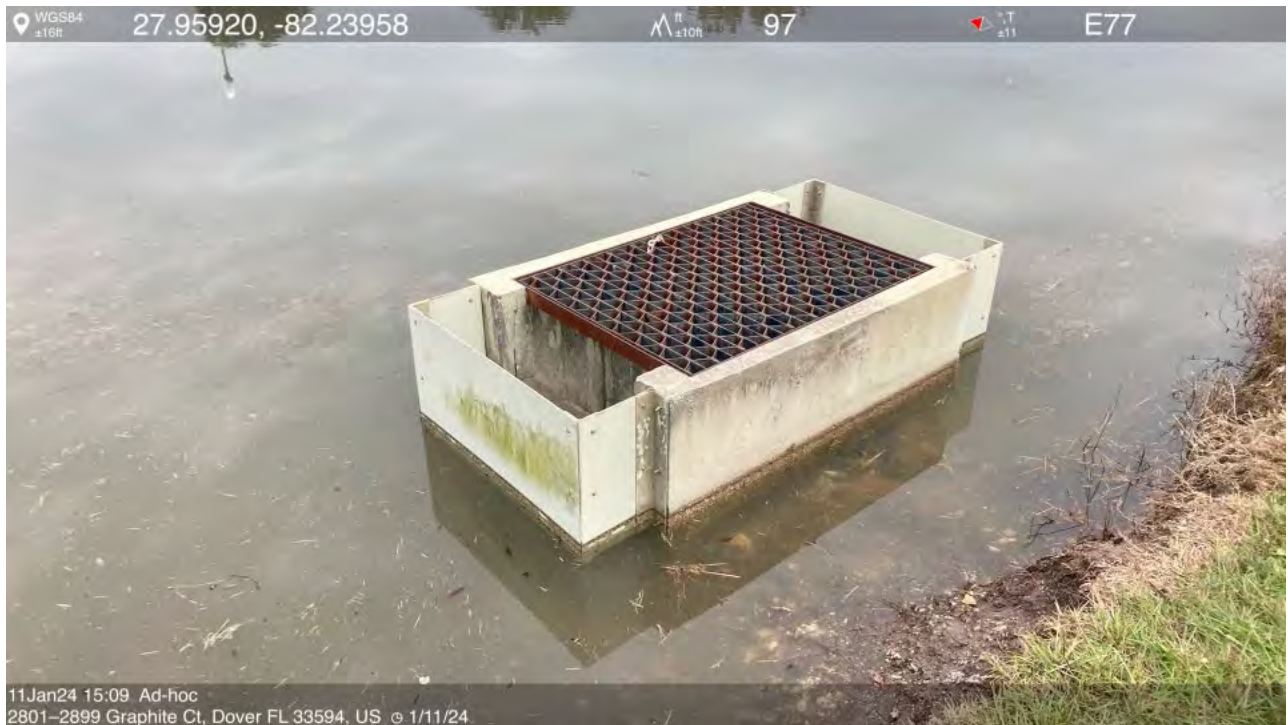
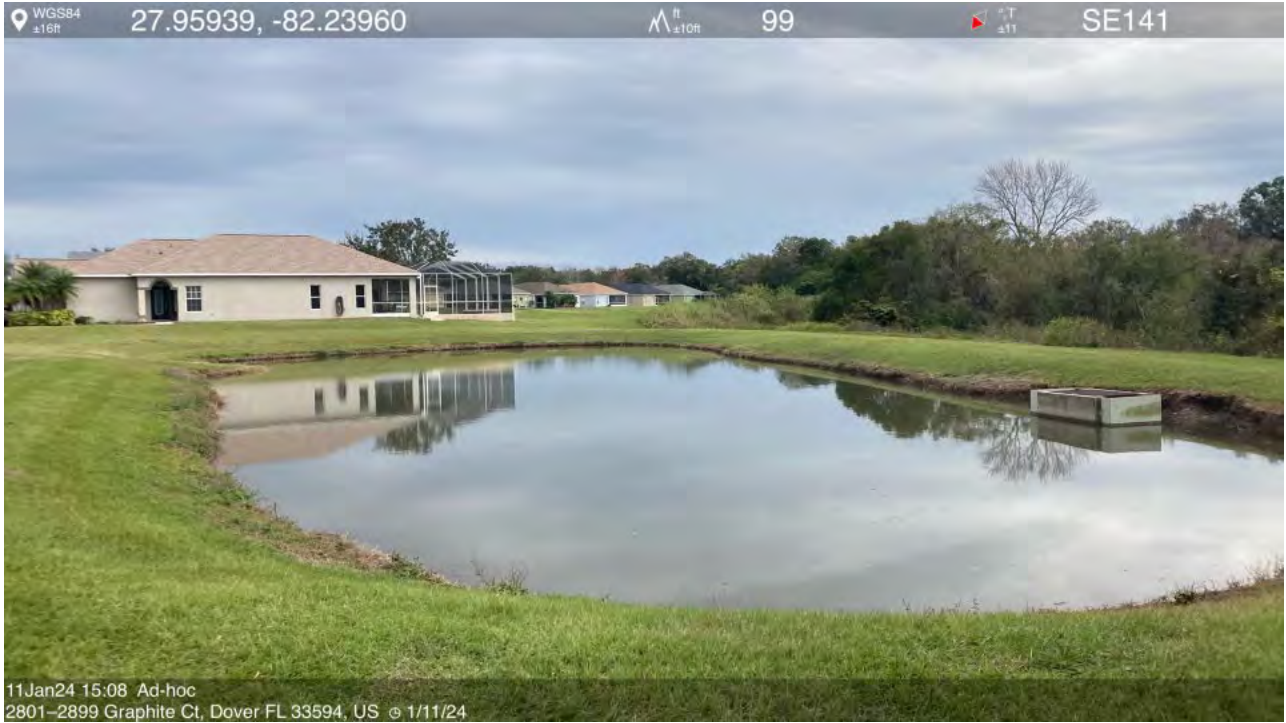
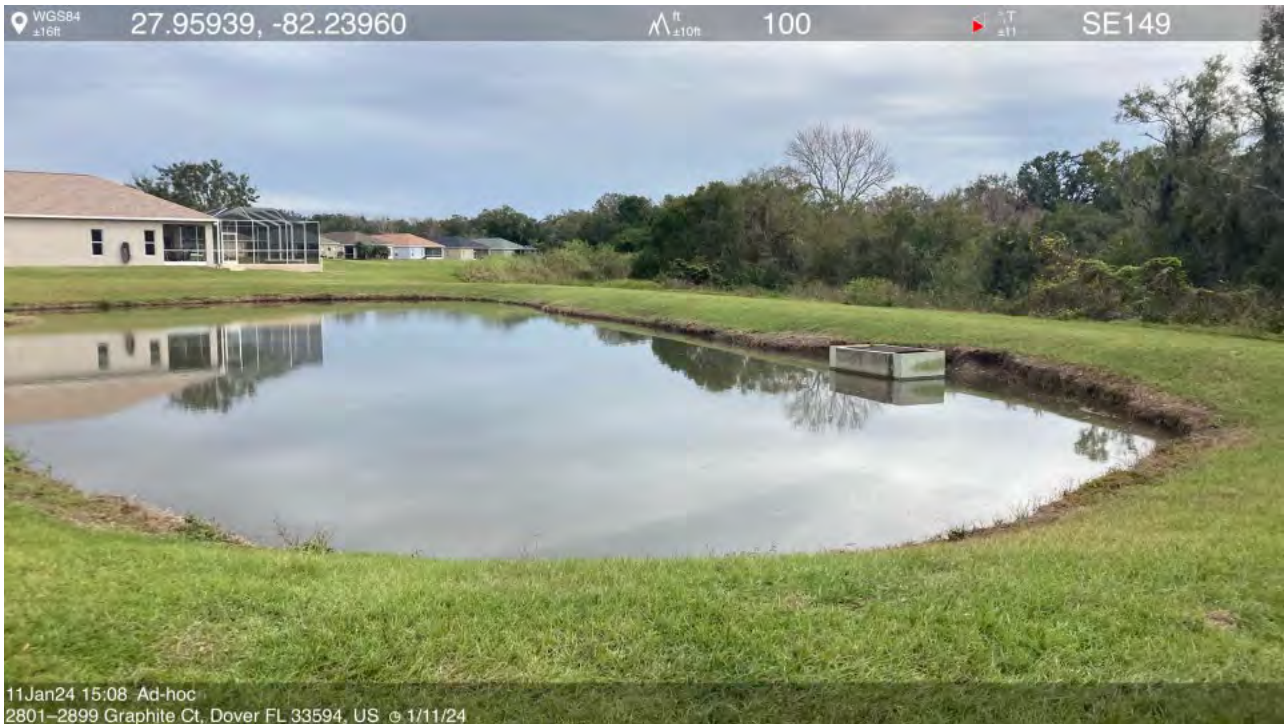
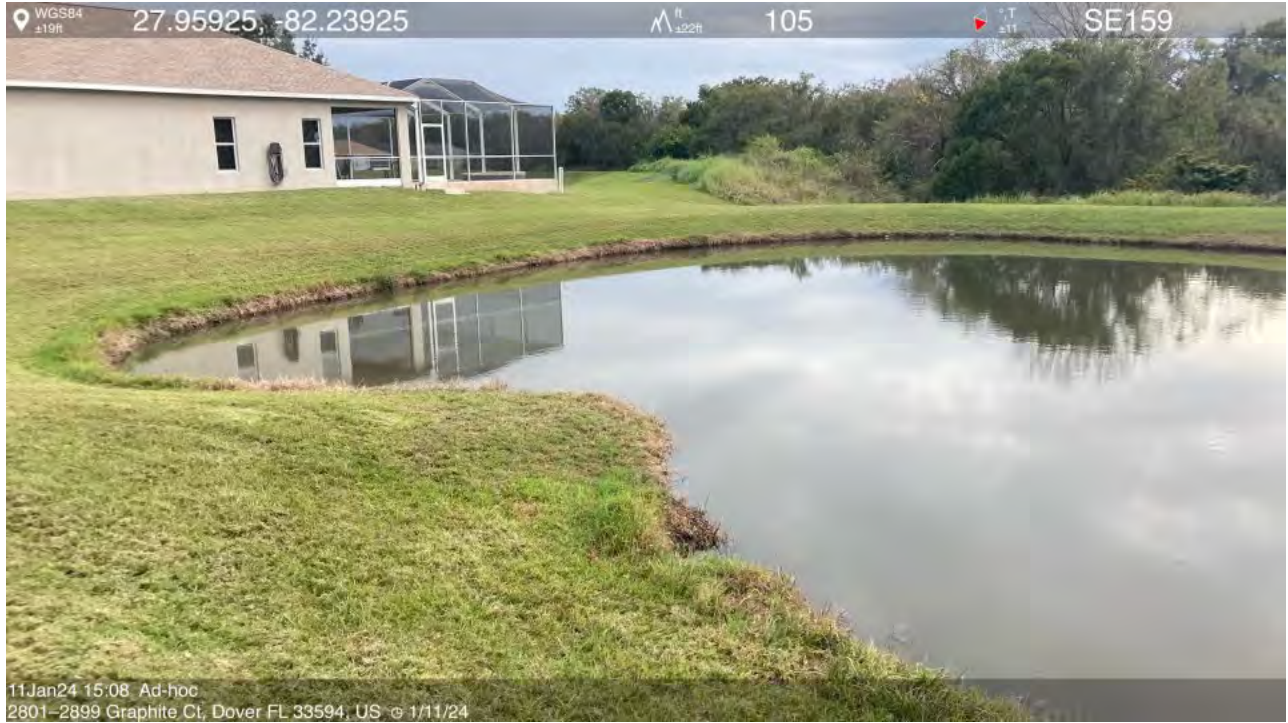
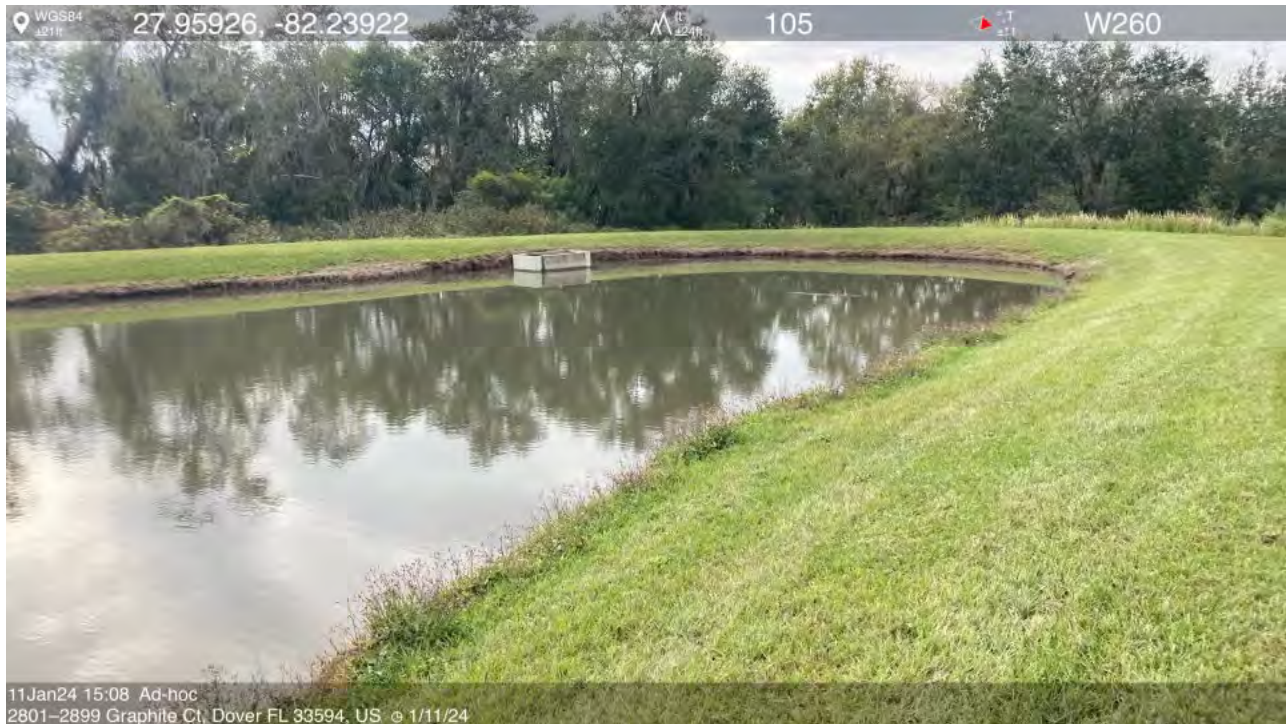
CDD POND EVALUATION			
INSPECTION DATE:	1/11/2024	PERMIT NUMBER:	24679.003
INSPECTED BY:	Jerry Whited	POND PERIMETER:	441 ft
POND NUMBER:	1475	POND AREA:	10,374 sq ft
Full Pond Access:	Yes	Trash Observed:	No
Beneficial Vegetaion Present:	No	Water Quality:	Average
Tailwater Issue Observed:	No	Water Quality Notes:	NA
Observed Depth:	4' 2"	Observed Temperature:	66.92
POND ELEVATION ANALYSIS			
Treatment Type:	Dry Filter	Design Bottom Elevation:	99.4
Weir/Orifice Elevation:	104.4	Observed Bottom Elevation:	100.15
Skimmer Bottom Elevation:	103.9	Elevation Difference:	0.75
Pond Elevation Notes: The pond elevation was observed to be approximately 0.75" less than the design elevation. The elevation difference does not appear to affect the functionality of the pond.			
BANK EROSION AND SCOUR			
Severity Ranking:	NA		
Type of Erosion:	None		
Bank Erosion Notes: No erosion or shoreline defects observed.			
CONDITION OF POND STRUCTURES (CONTROL STRUCTURES, MITERED END SECTIONS, INLETS)

Severity Ranking:	N/A		
Type of Damage:	None		
Structures Notes: One control structure with two skimmers observed to be in operational condition with no defects. One FES completely submerged from view.

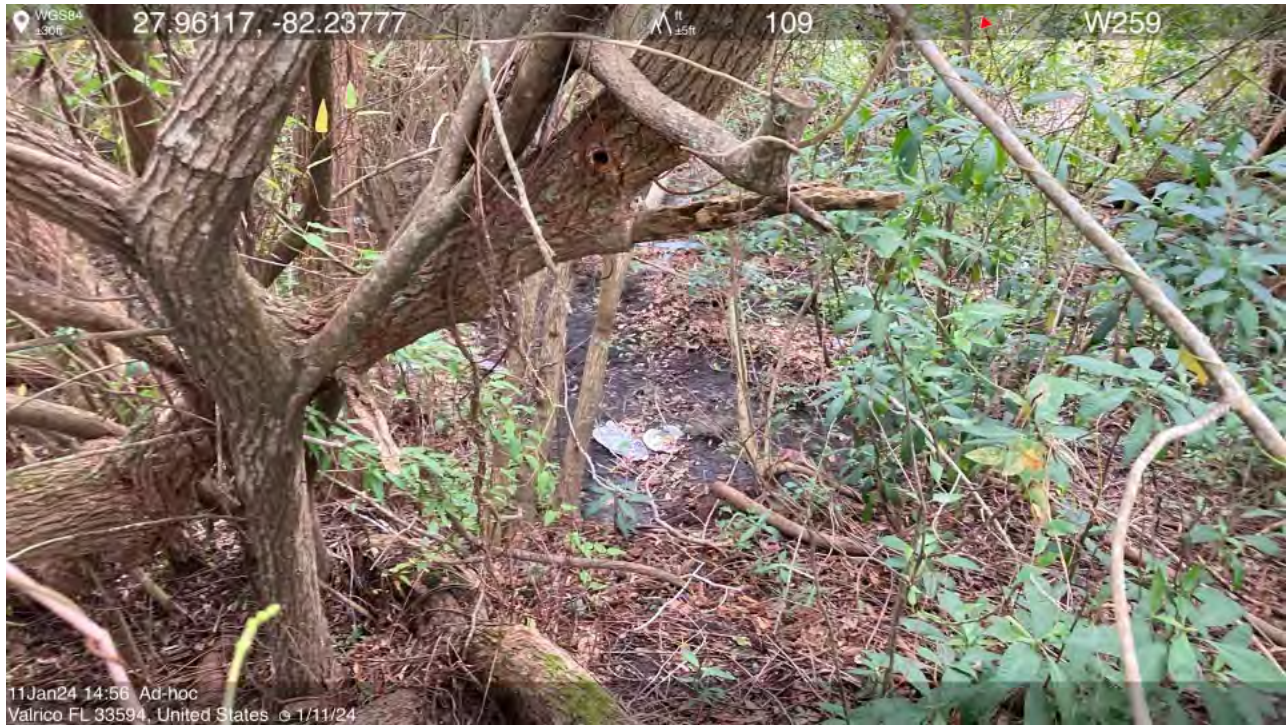
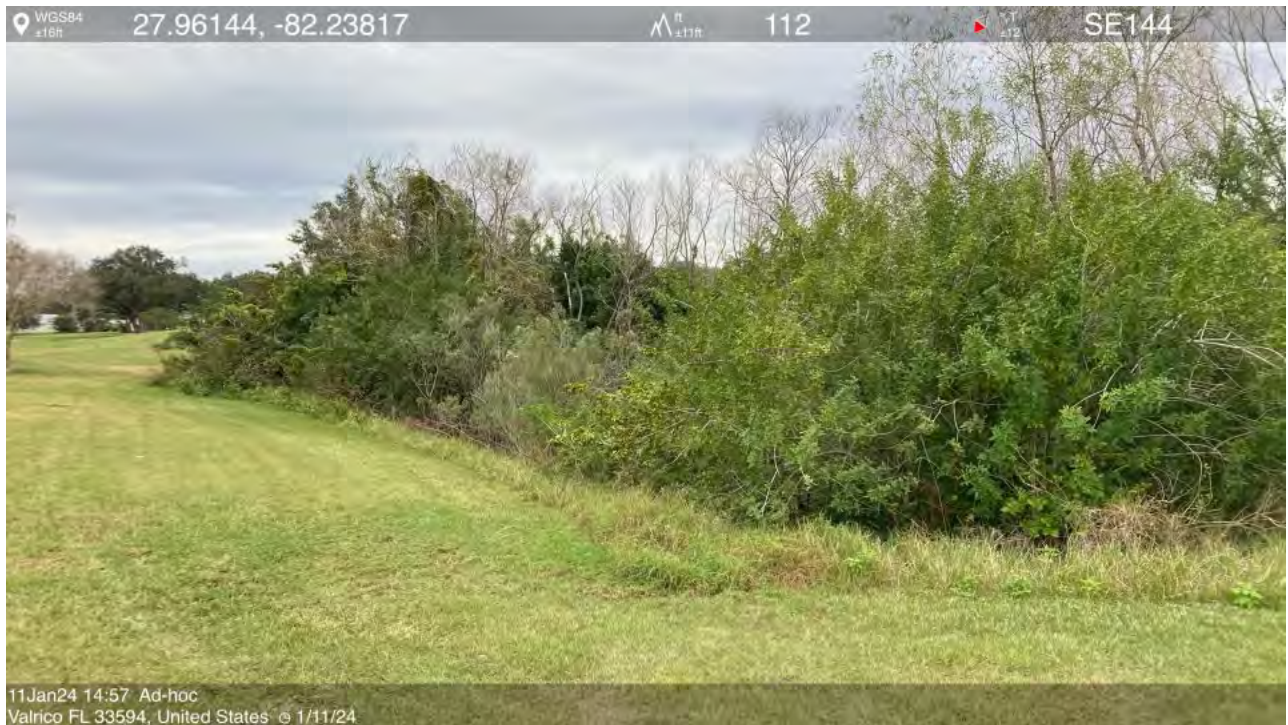
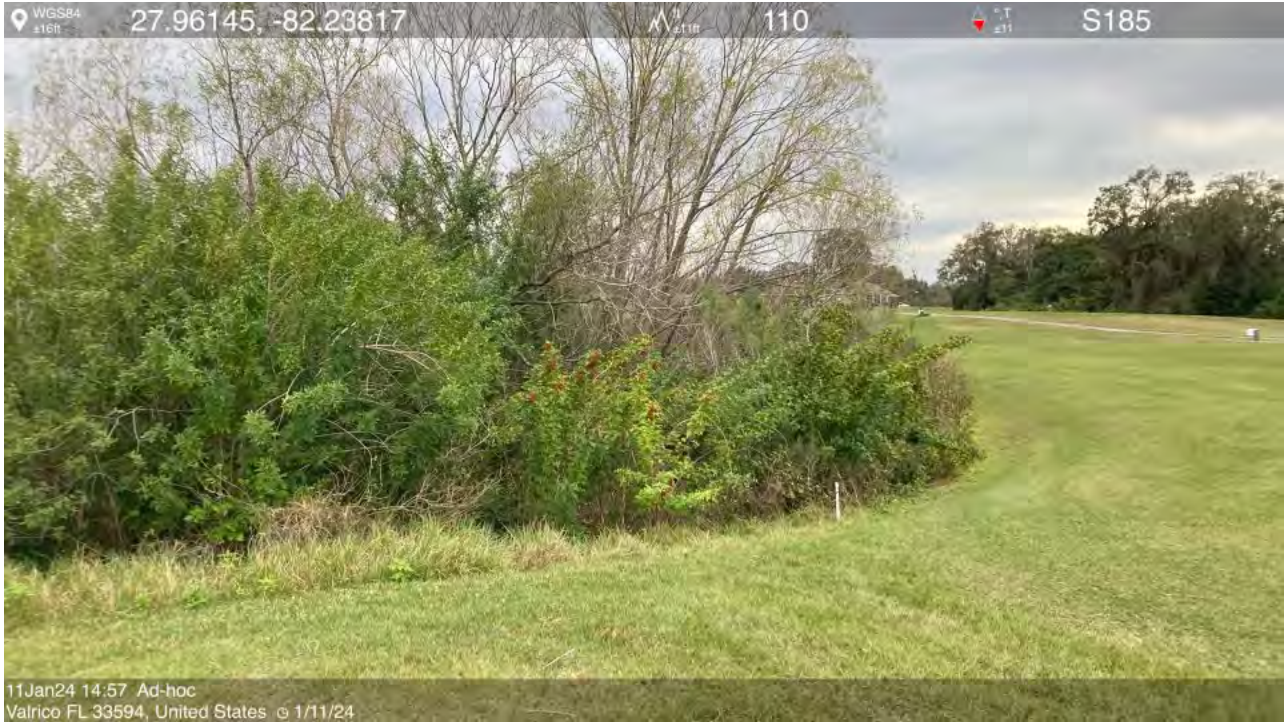
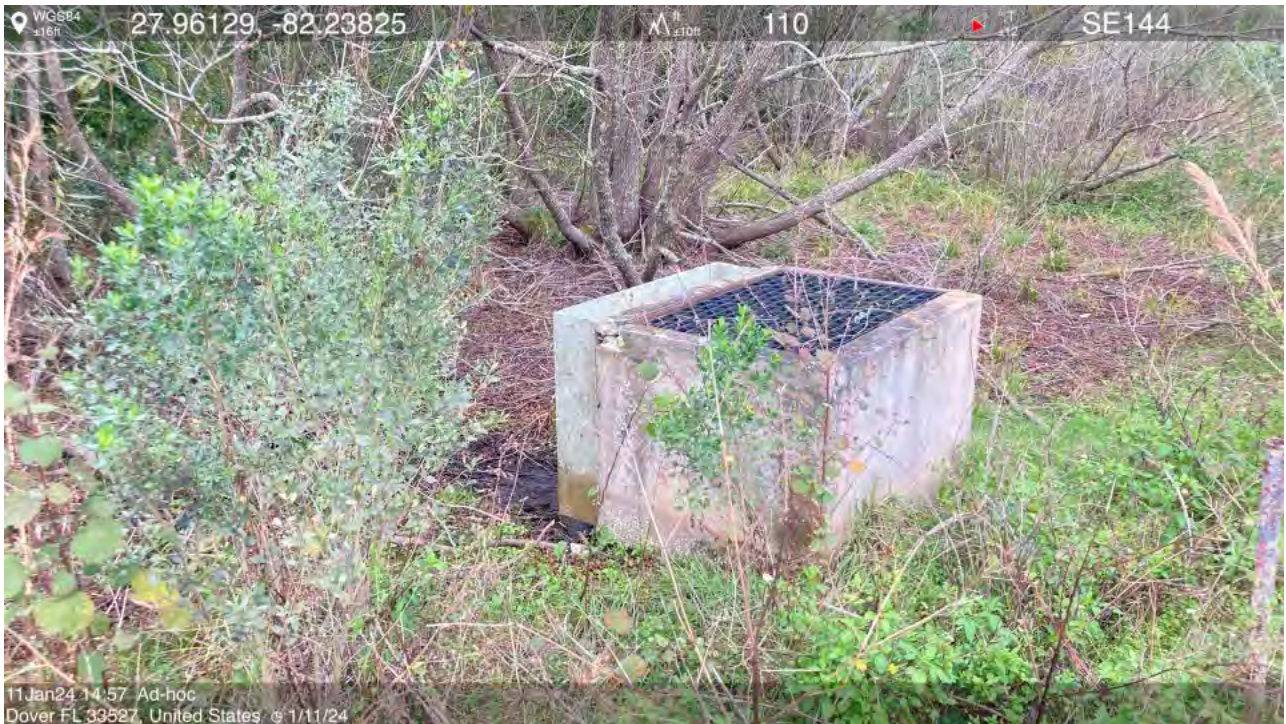
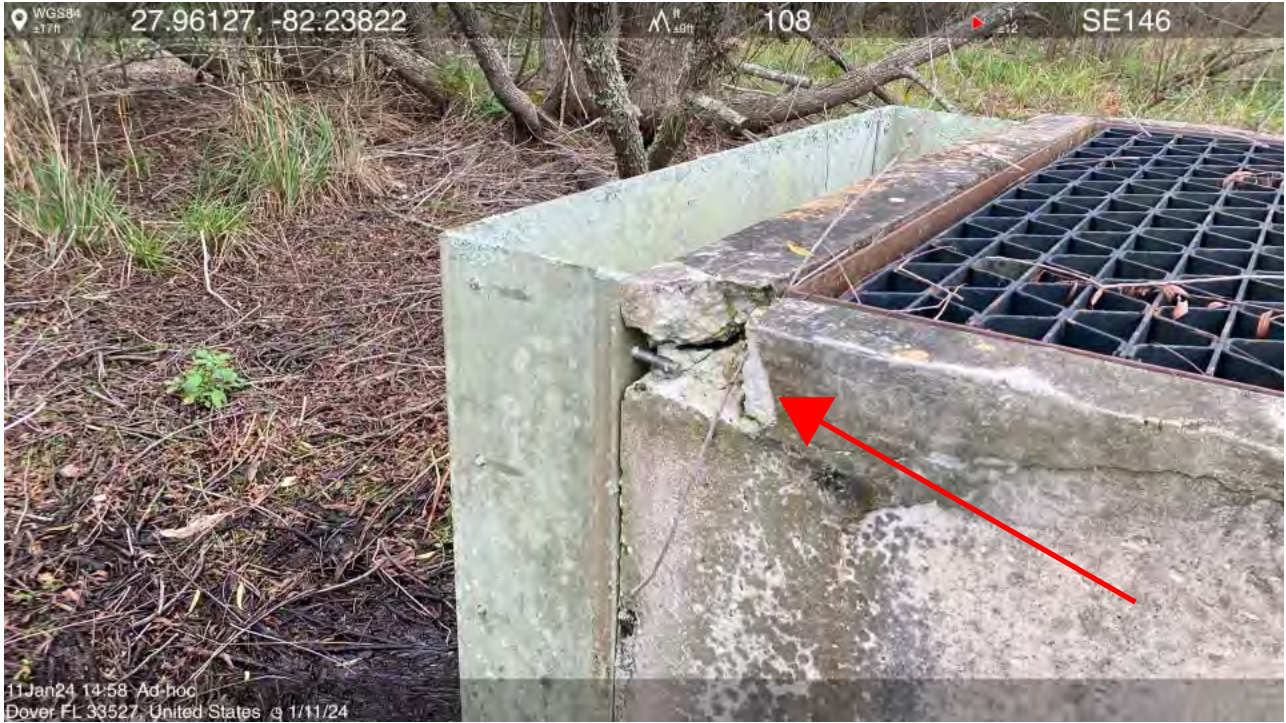
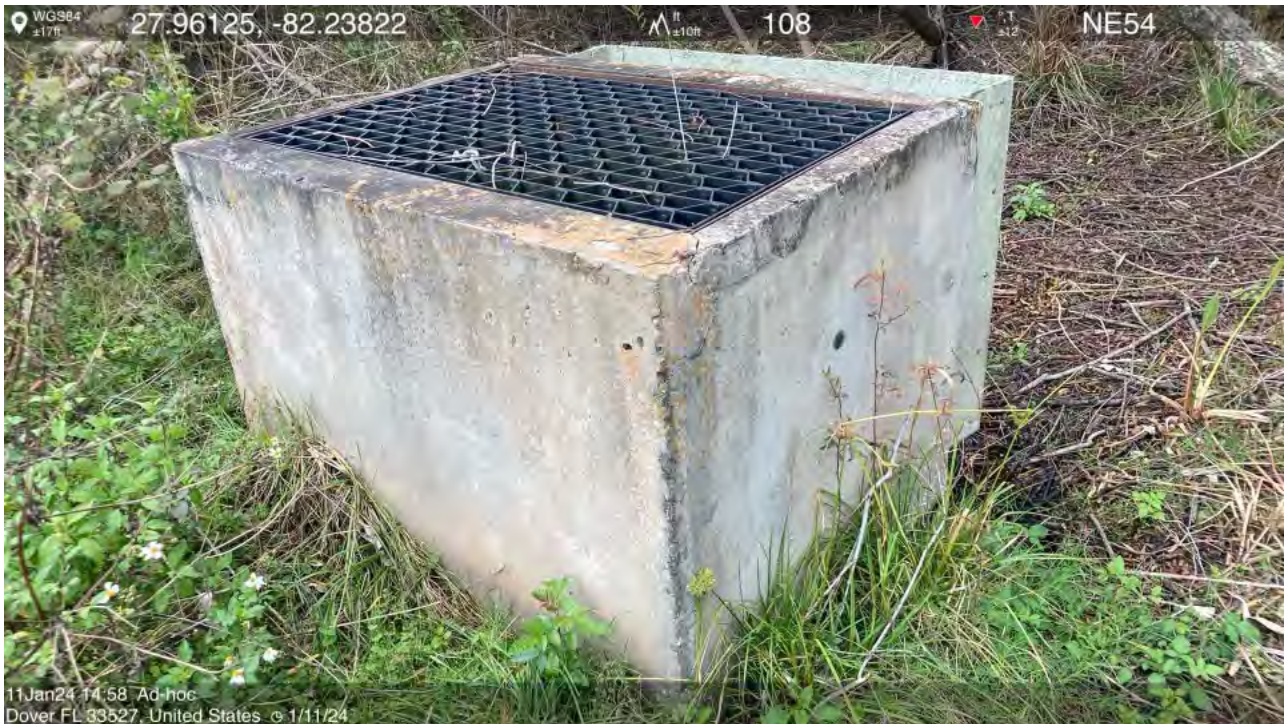
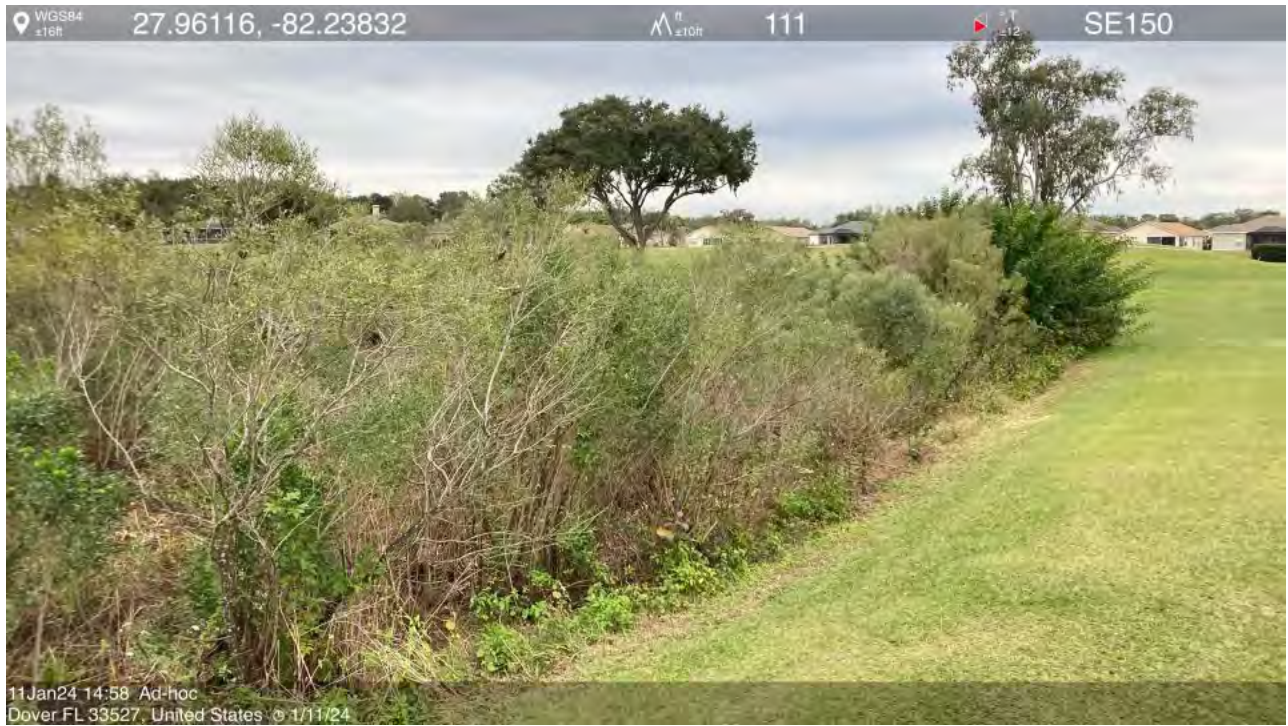
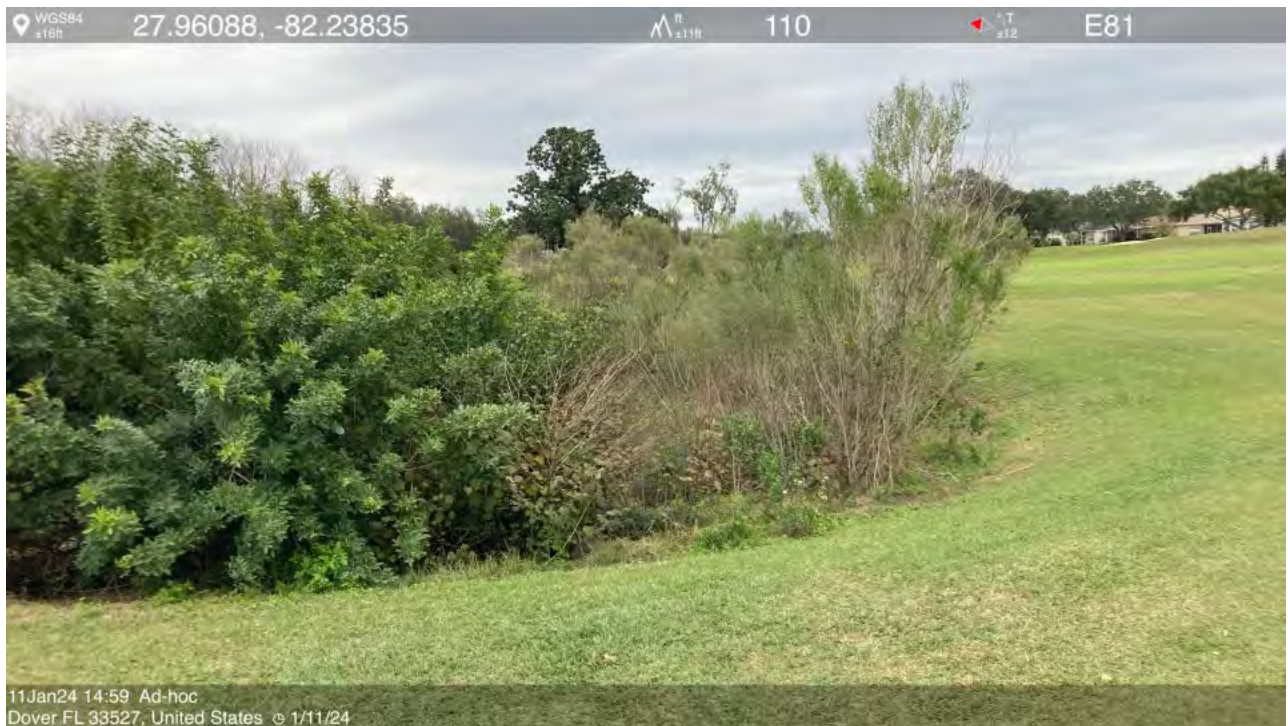
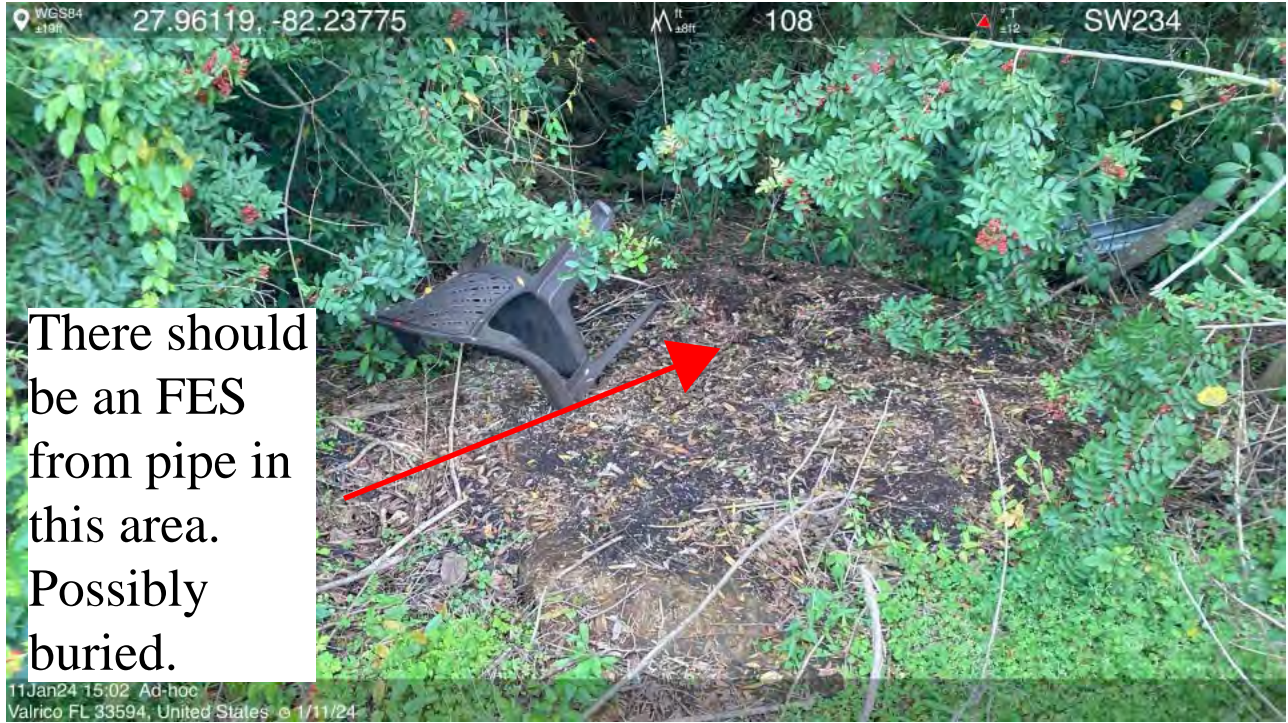
CDD POND EVALUATION			
INSPECTION DATE:	1/11/2024	PERMIT NUMBER:	24679.003
INSPECTED BY:	Jerry Whited	POND PERIMETER:	620 ft
POND NUMBER:	1500	POND AREA:	21,733 sq ft
Full Pond Access:	Yes	Trash Observed:	Yes
Benifitial Vegetaion Present:	Np	Water Quality:	NA
Tailwater Issue Observed:	No	Water Quality Notes:	NA
Observed Depth:	0	Observed Temperature:	NA
POND ELEVATION ANALYSIS			
Treatment Type:	Dry Filter	Design Bottom Elevation:	100
Weir/Orifice Elevation:	102.1	Observed Bottom Elevation:	100
Skimmer Bottom Elevation:	101.6	Elevation Difference:	0
Pond Depth Notes: This is a dry pond.			
BANK EROSION AND SCOUR			
Severity Ranking:	NA		
Type of Erosion:	None		
Bank Erosion Notes: Dry pond. No erosion or shoreline defects observed.			
CONDITION OF POND STRUCTURES (CONTROL STRUCTURES, MITERED END SECTIONS, INLETS)			
Severity Ranking:	Moderate		
Type of Damage:	FES covered and concrete failing.		
Structures Notes: FES on NE side of pond appears to have been covered up or buried by debris. There is a need to uncover the FES to avoid issues with the curb inlets flooding the adjacent streets. Historical records show this pond was not overgrown like this until after 2016. One control structure observed to have cracks in the concrete and skimmer hardware is completely exposed on one side. Vegetation must be cleared to provide access to MES & Control Structure. Recommend full pond quarterly maintenance.

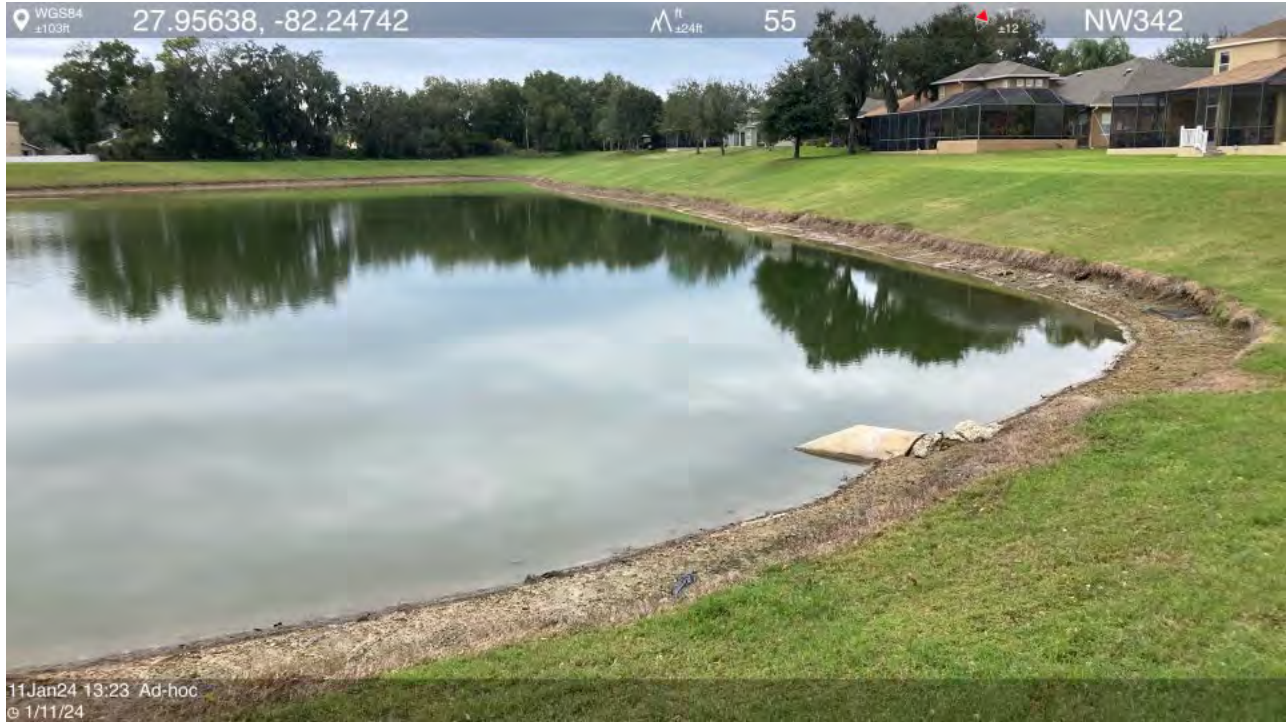
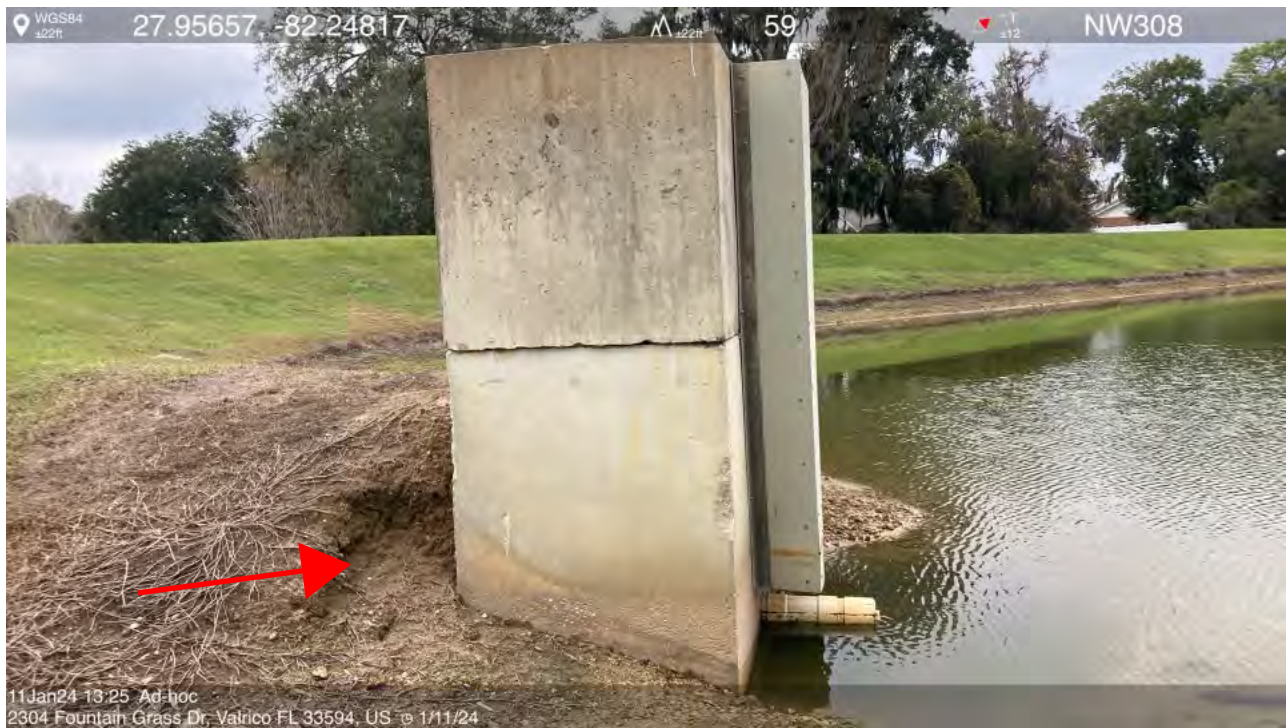
CONDITION OF POND STRUCTURES (CONTROL STRUCTURES, MITERED END SECTIONS, INLETS)			
Severity Ranking:	Minor		
Type of Damage:	Control Structure		
Structures Notes: One control structure with skimmer observed. One of the grates is rusted and warped topping the control structure. Some cracks in concrete structure. Behind structure is eroding away and will soon expose pipe. Two FES's observed in operational condition with no defects. There is a control structure (525 in plans) that is adjacent to pond 40 and has a broken skimmer in need of repair.

Skimmer
Repair.

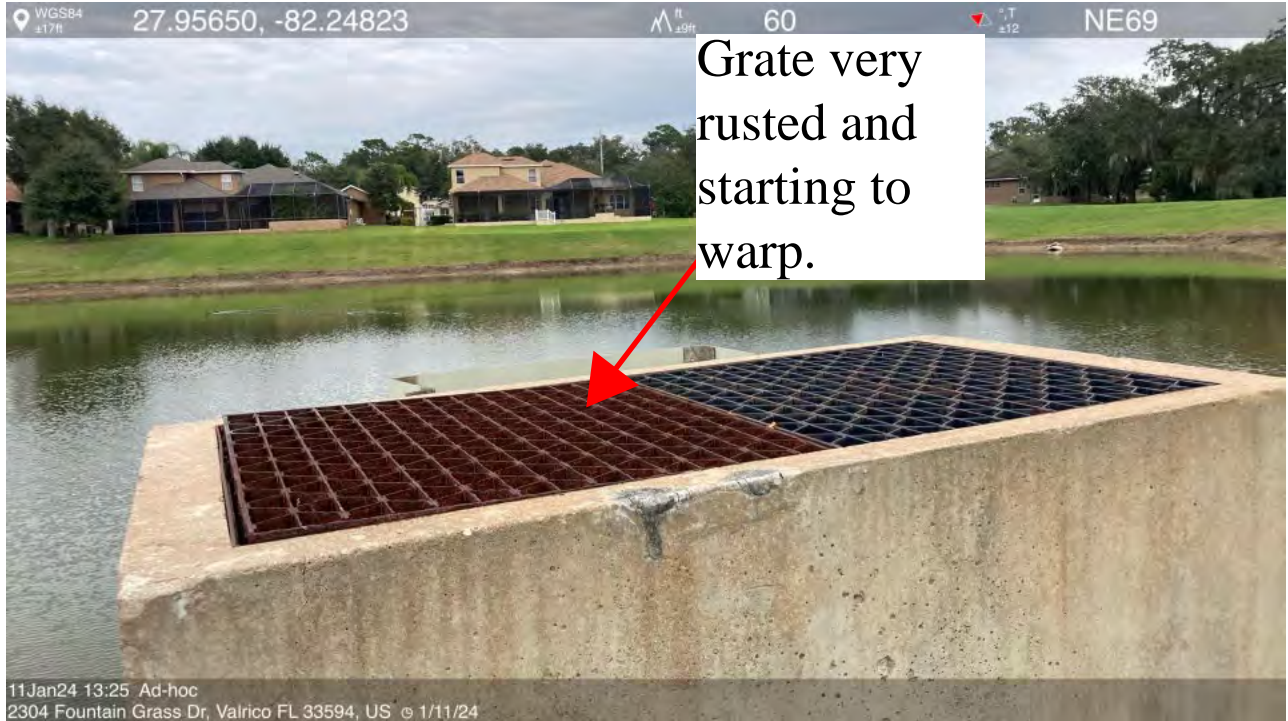
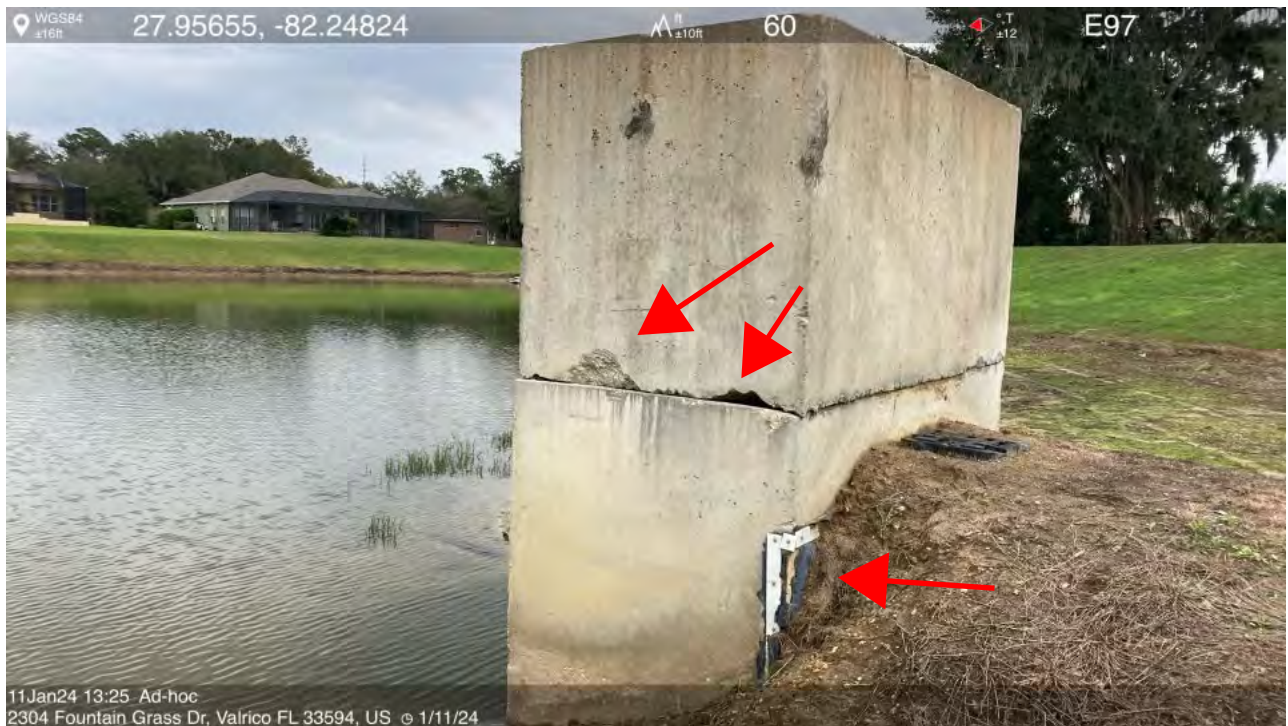
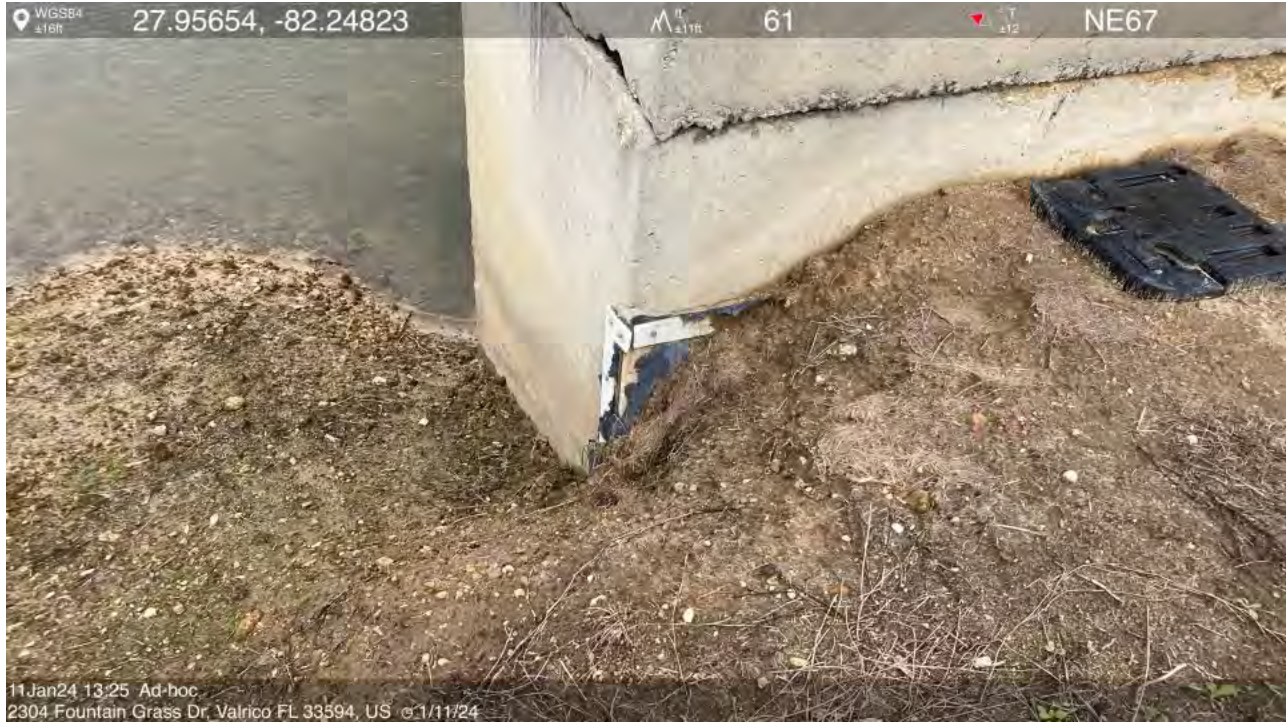
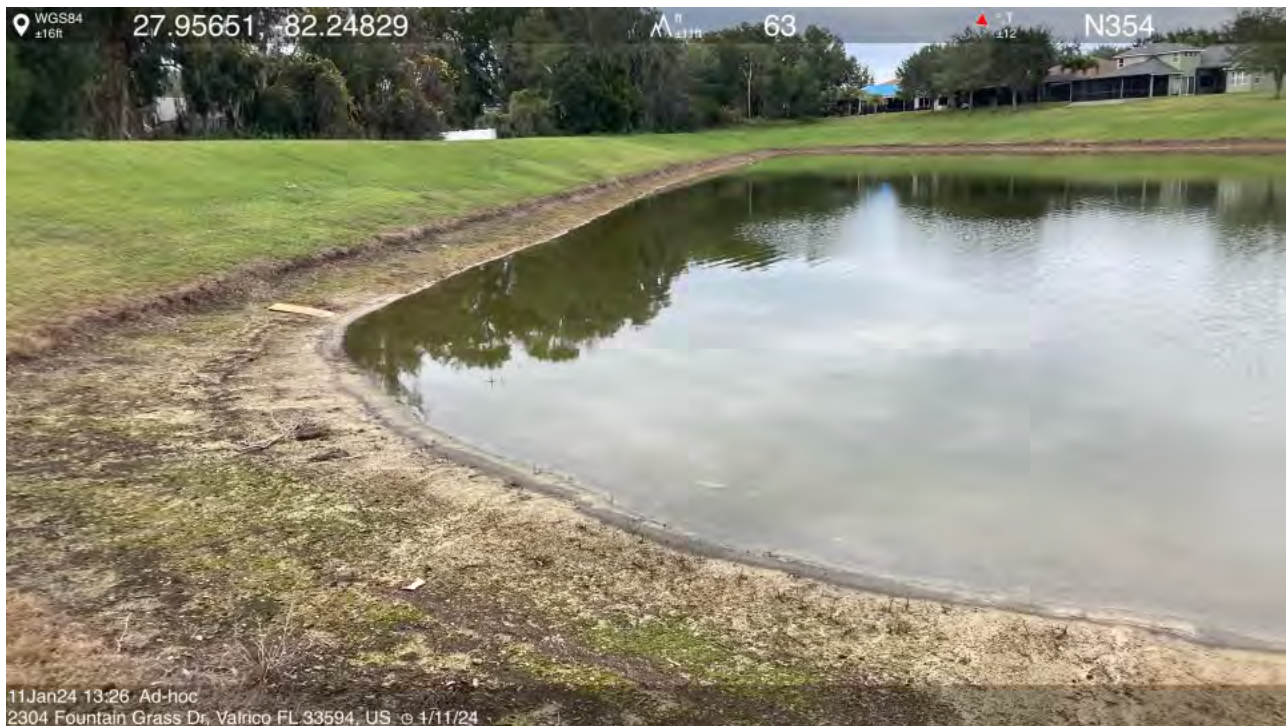
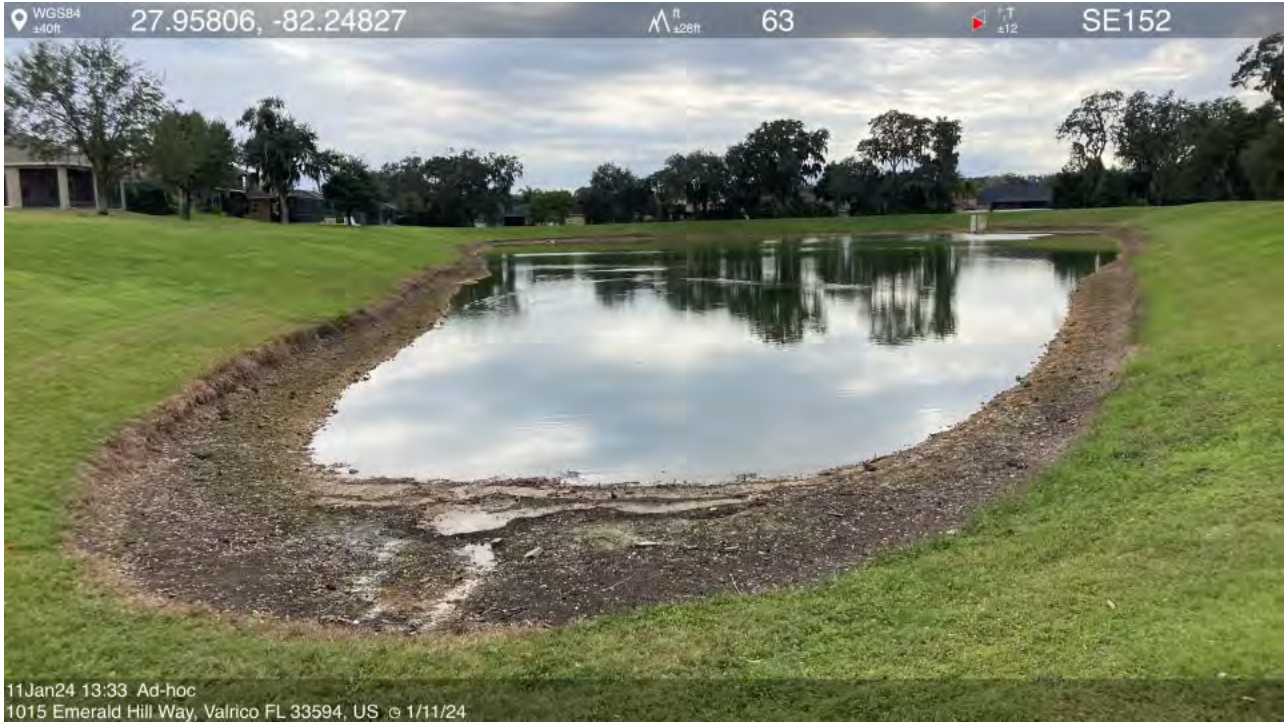
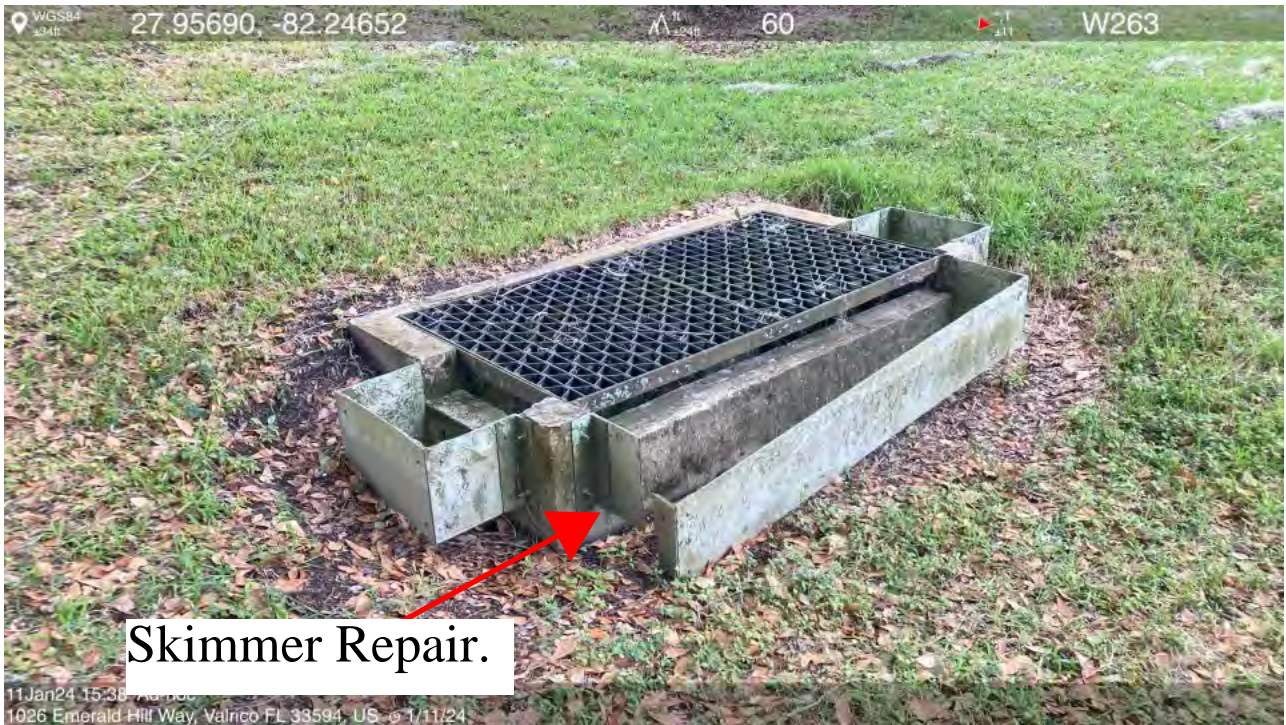
40

Control
Struture.
