**DIAMOND HILL
COMMUNITY DEVELOPMENT DISTRICT**

**FEBRUARY 12, 2024
AGENDA PACKAGE**

- 1.0 ERP PERMIT INFORMATION
- 2.0 PERMIT INSPECTION HISTORY
- 3.0 RECONCILIATION OF CURRENT DEFECT OBSERVATIONS
- 4.0 POND ELEVATION SUMMARY
- 5.0 INSPECTION REPORTS & PICTURES

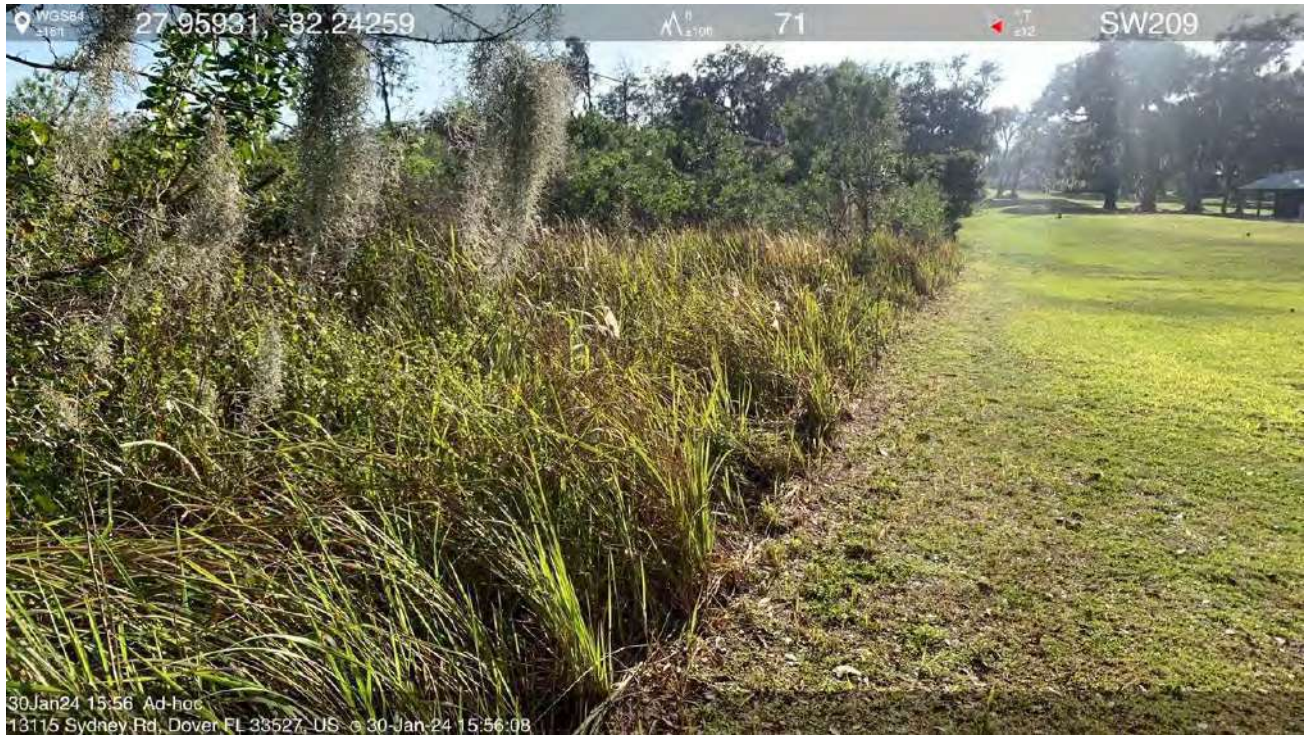
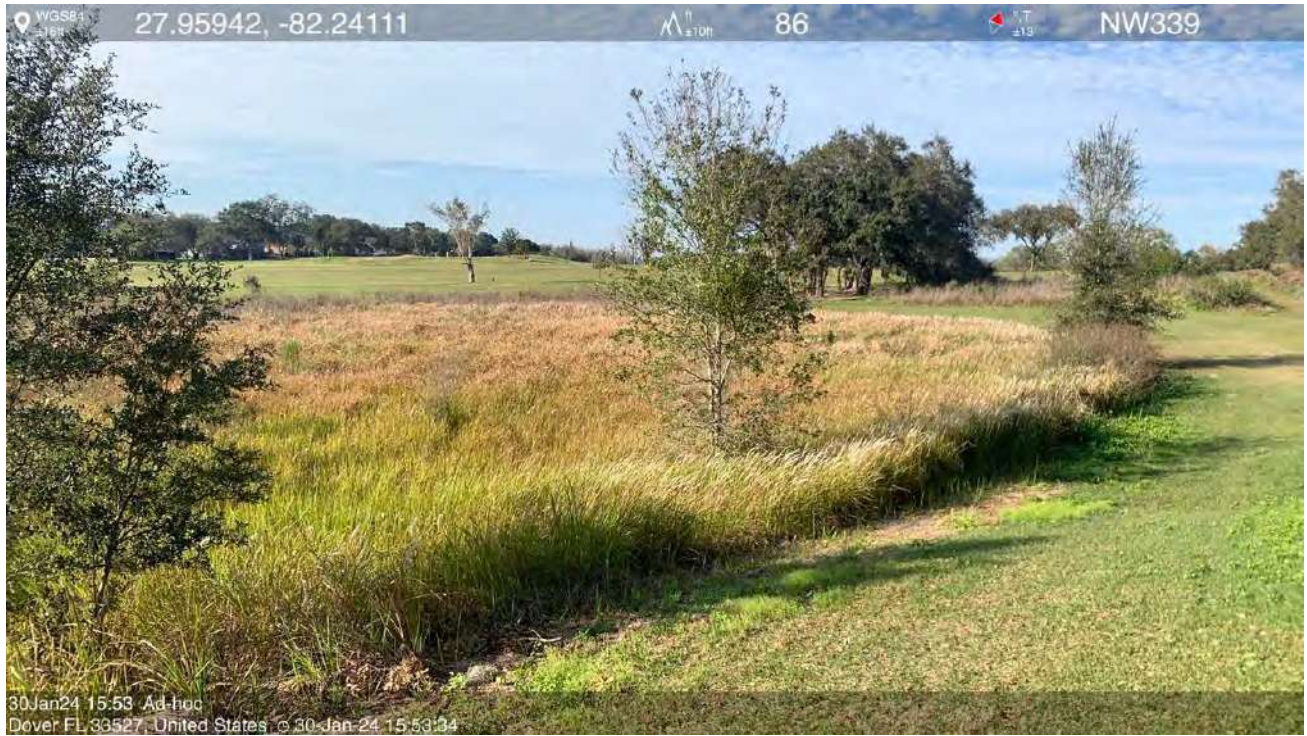
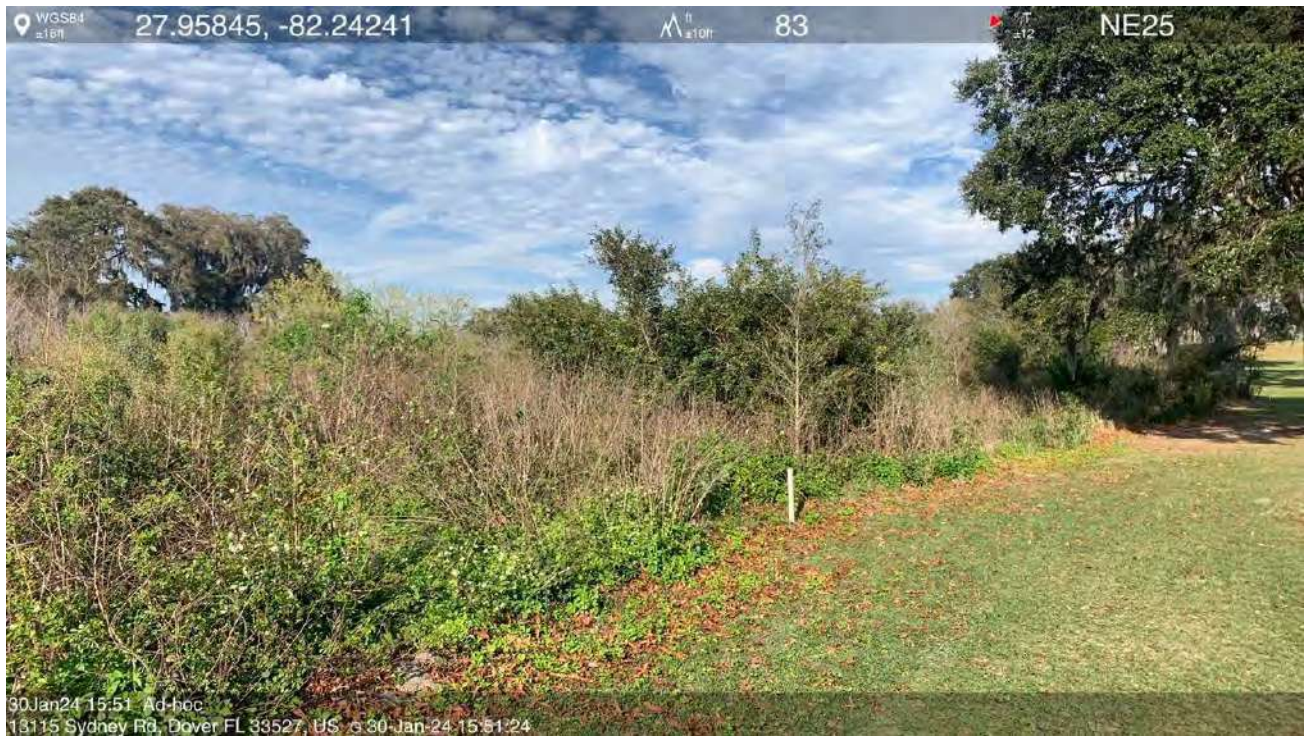
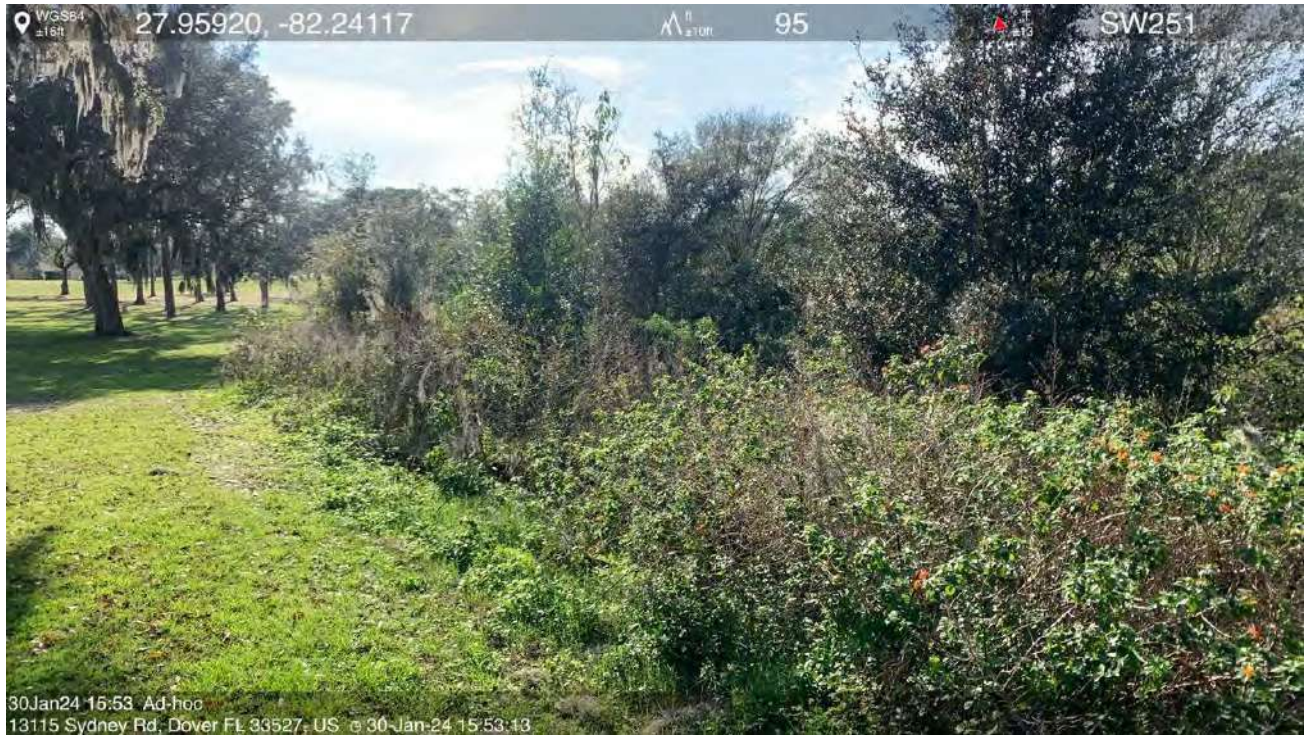
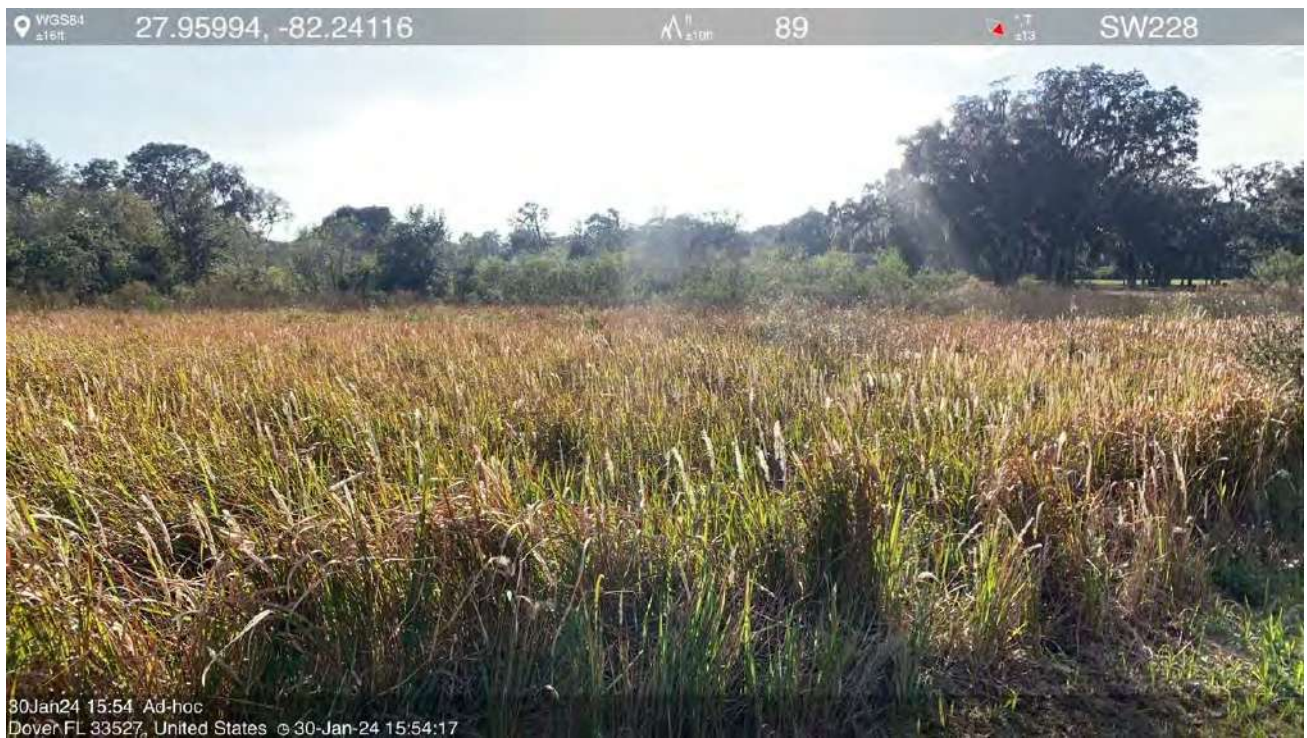
CDD POND EVALUATION			
INSPECTION DATE:	1/30/2024	PERMIT NUMBER:	24679.003
INSPECTED BY:	Jerry Whited	POND PERIMETER:	2,190 ft
POND NUMBER:	1600	POND AREA:	234,643 sq ft
Full Pond Access:	No	Trash Observed:	No
Benifitial Vegetaion Present:	No	Water Quality:	NA
Tailwater Issue Observed:	No	Water Quality Notes:	NA
Observed Depth:	0	Observed Temperature:	NA
POND ELEVATION ANALYSIS			
Treatment Type:	Dry Filter	Design Bottom Elevation:	60
Weir/Orifice Elevation:	71.5	Observed Bottom Elevation:	60
Skimmer Bottom Elevation:	71	Elevation Difference:	0
Pond Elevation Notes: This is a dry pond.			
BANK EROSION AND SCOUR			
Severity Ranking:	NA		
Type of Erosion:	None		
Bank Erosion Notes: No erosion or pond bank defects observed.			
CONDITION OF POND STRUCTURES (CONTROL STRUCTURES, MITERED END SECTIONS, INLETS)			
Severity Ranking:	Access		
Type of Damage:	Grate Inlet		
Structures Notes: There is one grate inlet that is not accessible due to vegetation overgrowth. From historical records it looks like the area stopped being maintained or mowed in 2016-17. The lack of maintenance the golf course is doing is effecting our access as well. Grate inlet needs to be uncovered. Vegetation must be cleared to provide access. Access needs to be maintained regularly. Recommend full pond quarterly maintenance.

Inlet grate is buried in vegetation, need access.

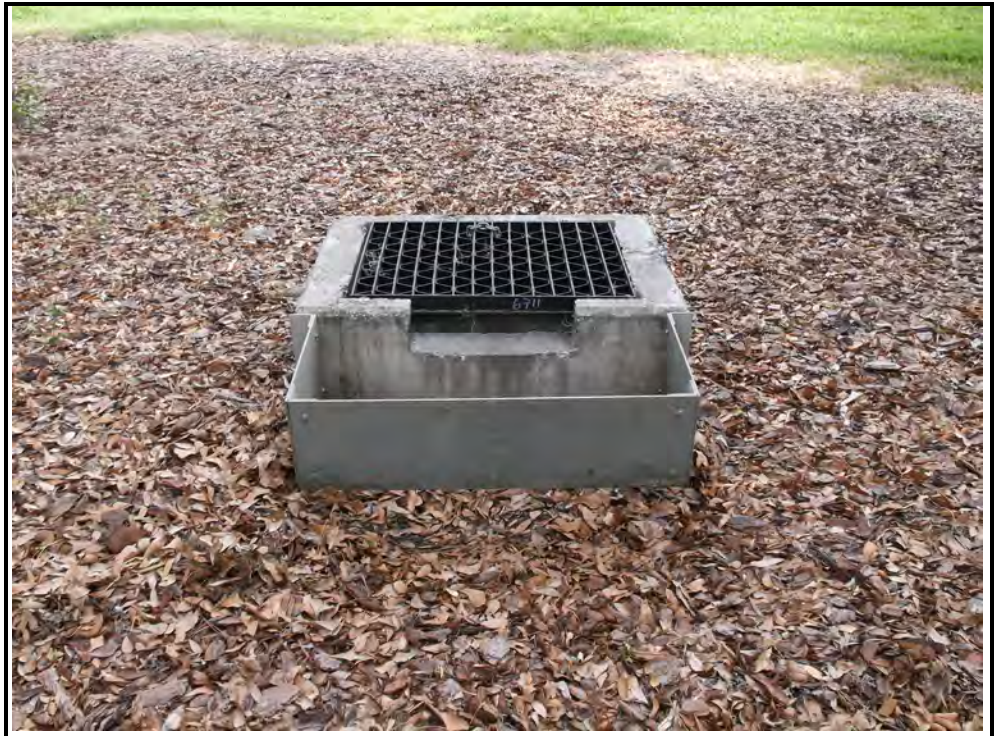
Comments: View of the NW entrance pond control structure

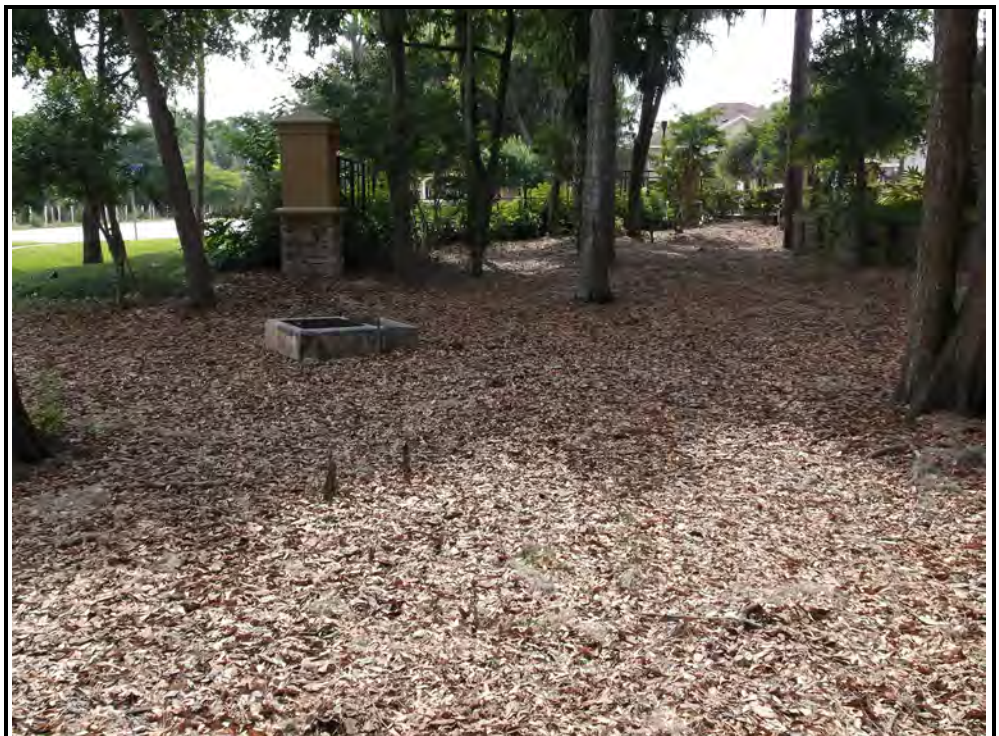
Comments: Easterly view of the NE entrance pond

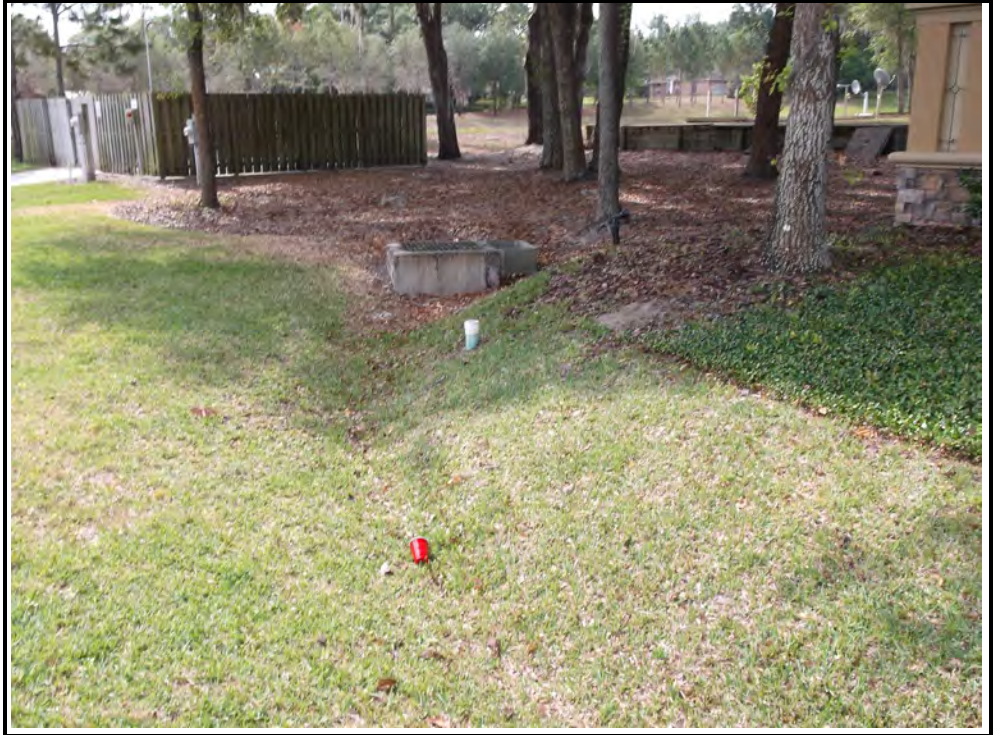
Comments: Easterly view of the NE entrance pond

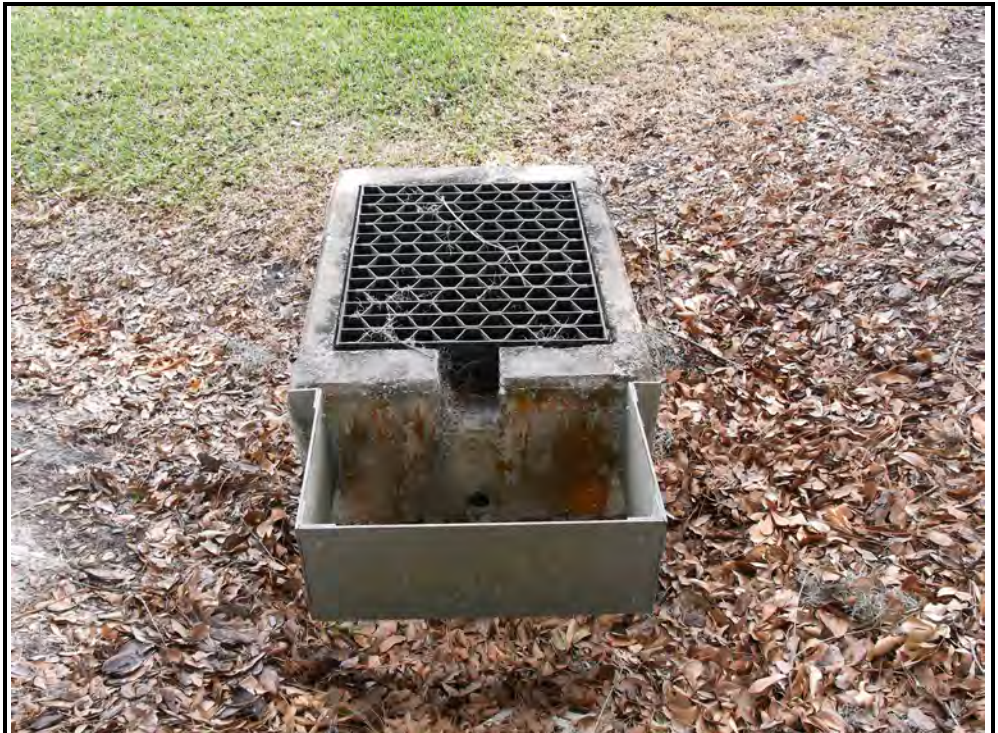
Comments: View of the control structure within the NE entrance pond

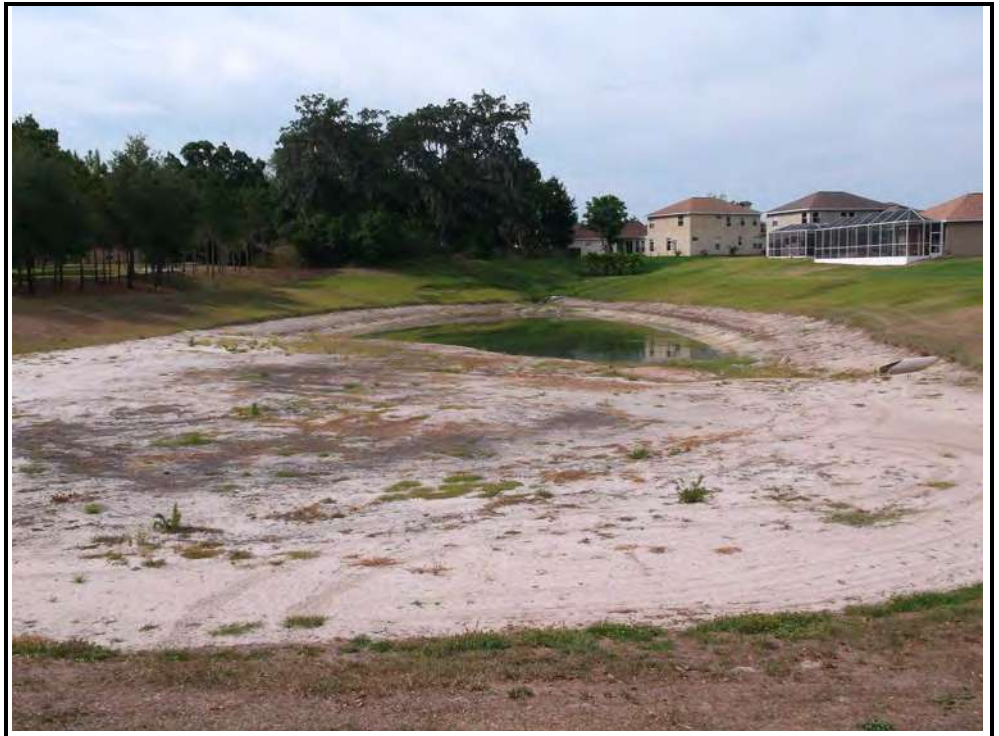
Comments: Southerly view of Pond 10

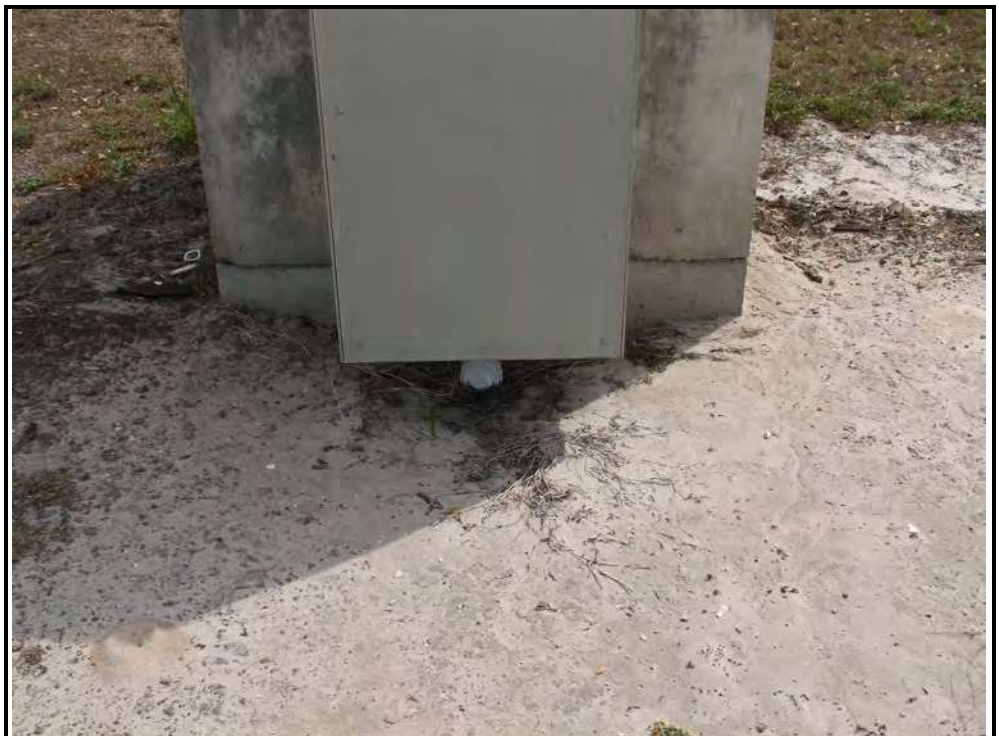
Comments: View of the control structure within the Pond 10

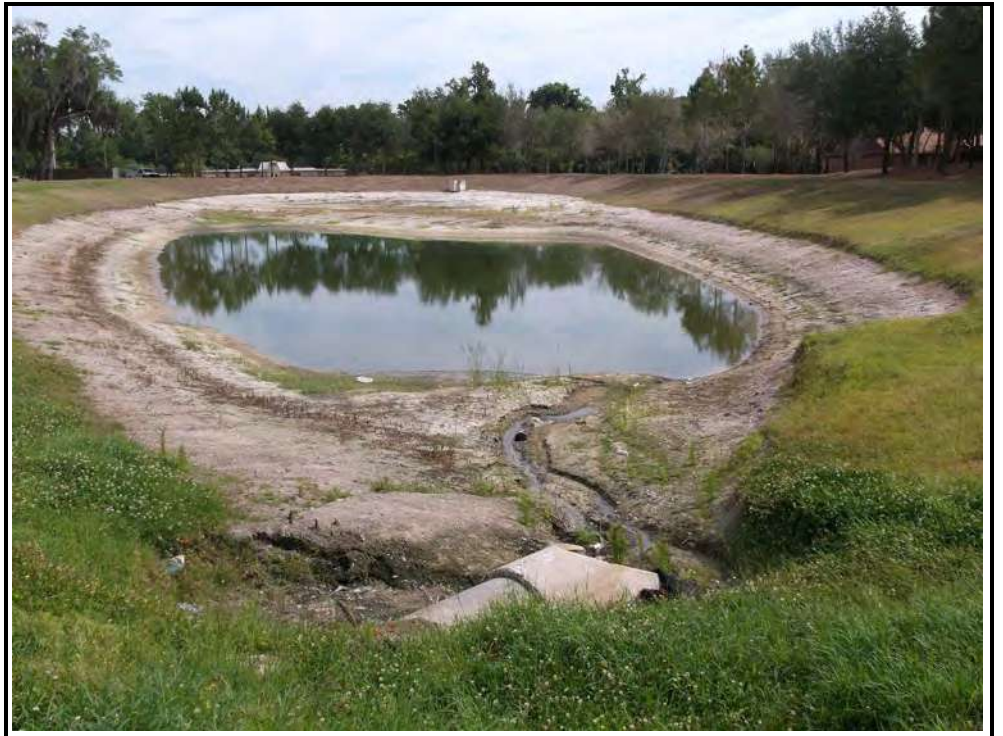
Comments: Northerly view of Pond 10

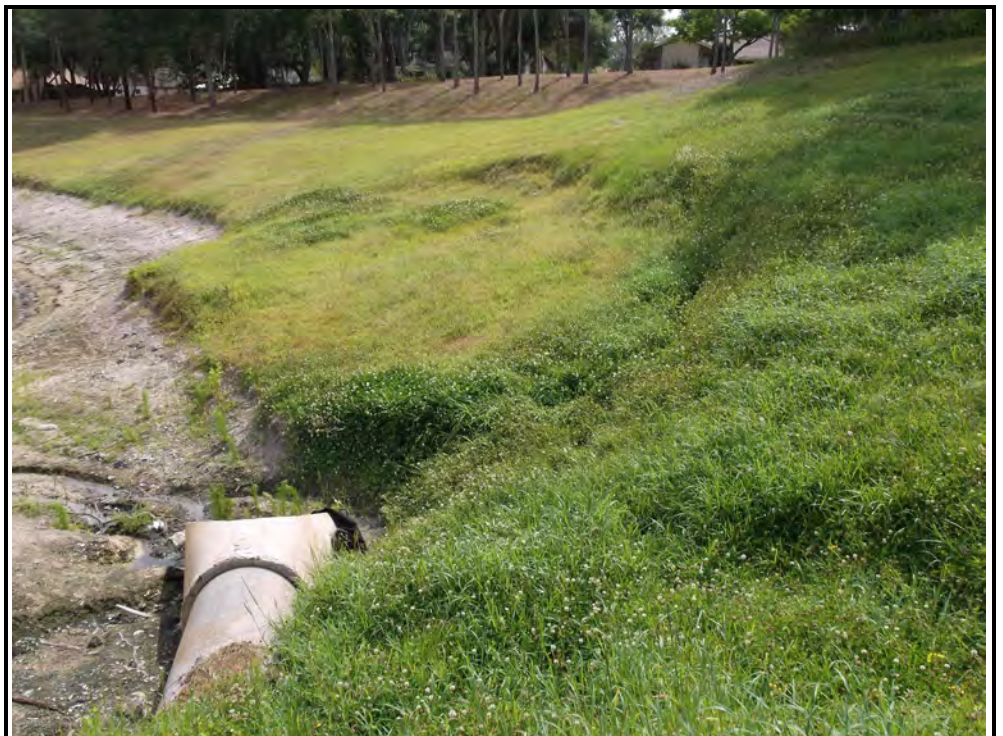
Comments: View of the excessive erosion within the south end of Pond 10

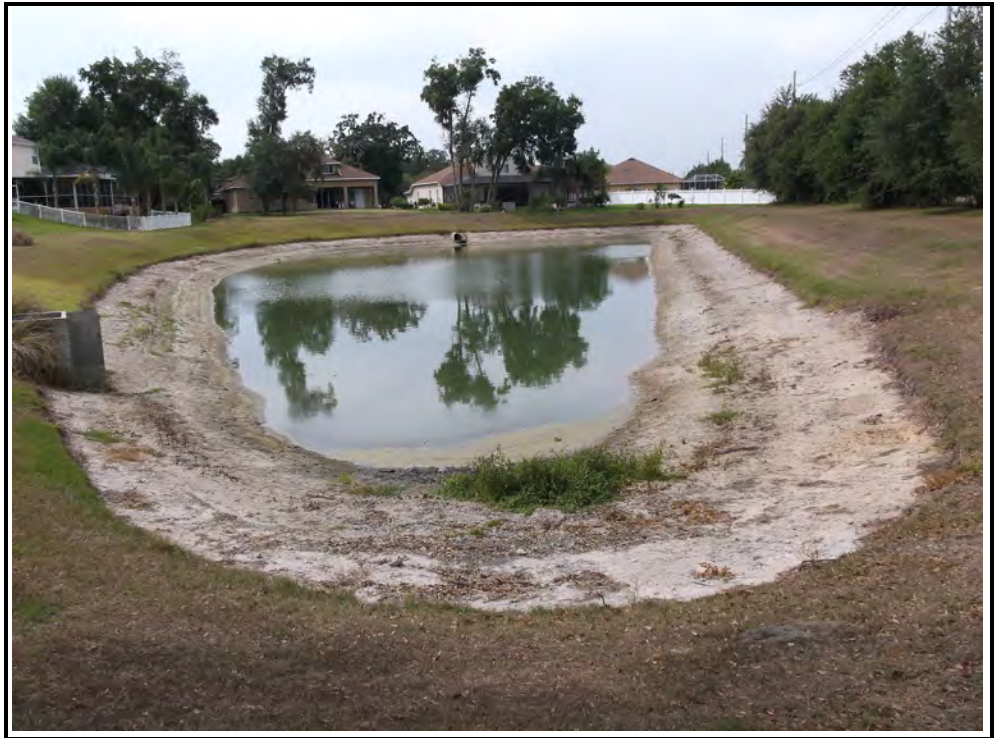
Comments: Southerly view of Pond 20

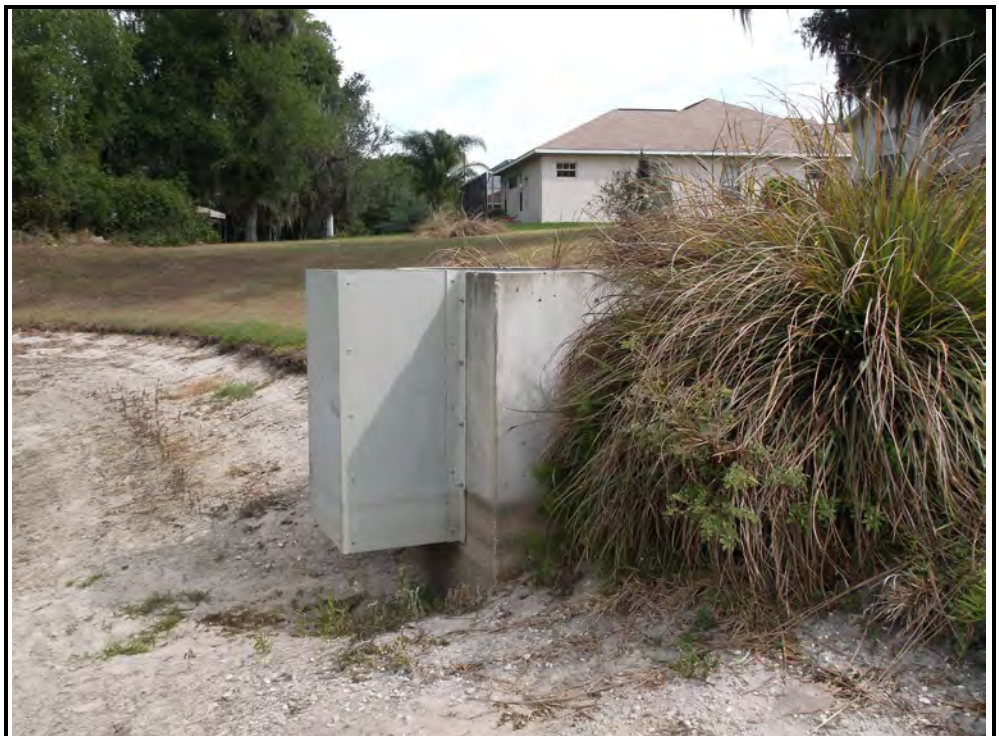
Comments: View of the control structure within Pond 20

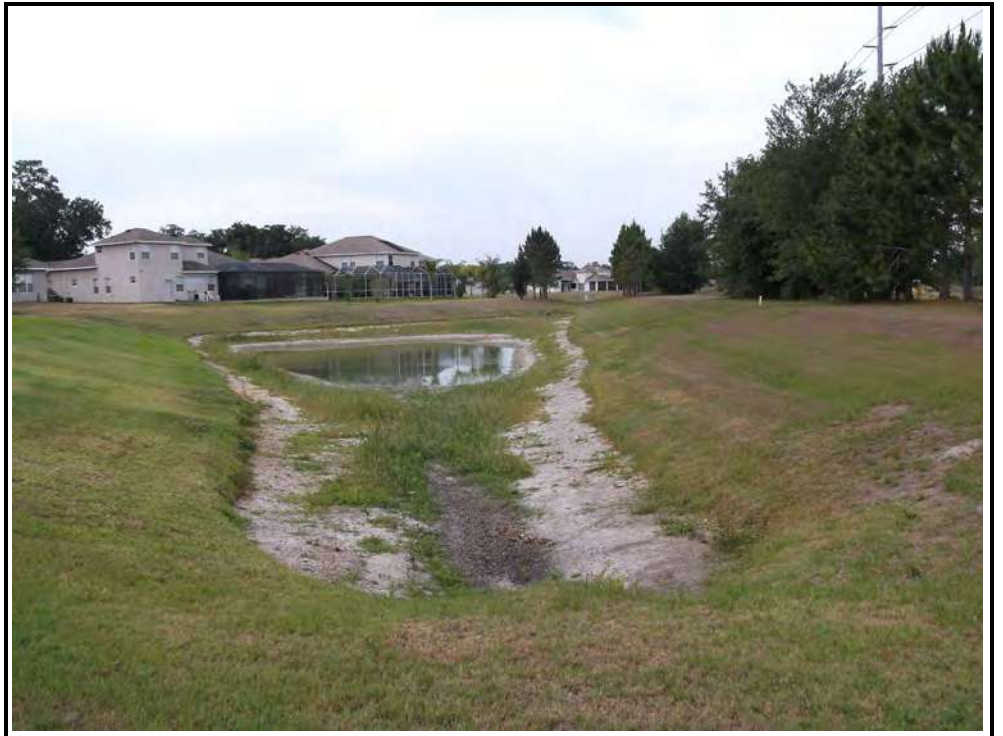
Comments: Southerly view of north end of Pond 30

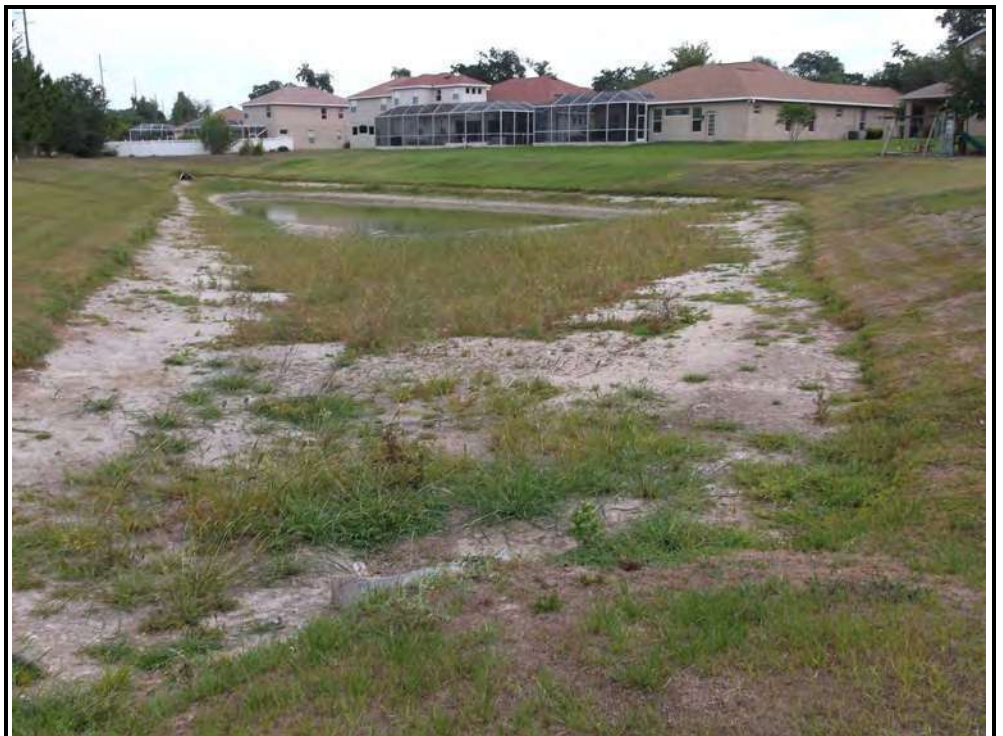
Comments: Northerly view of the north pond of Pond 30

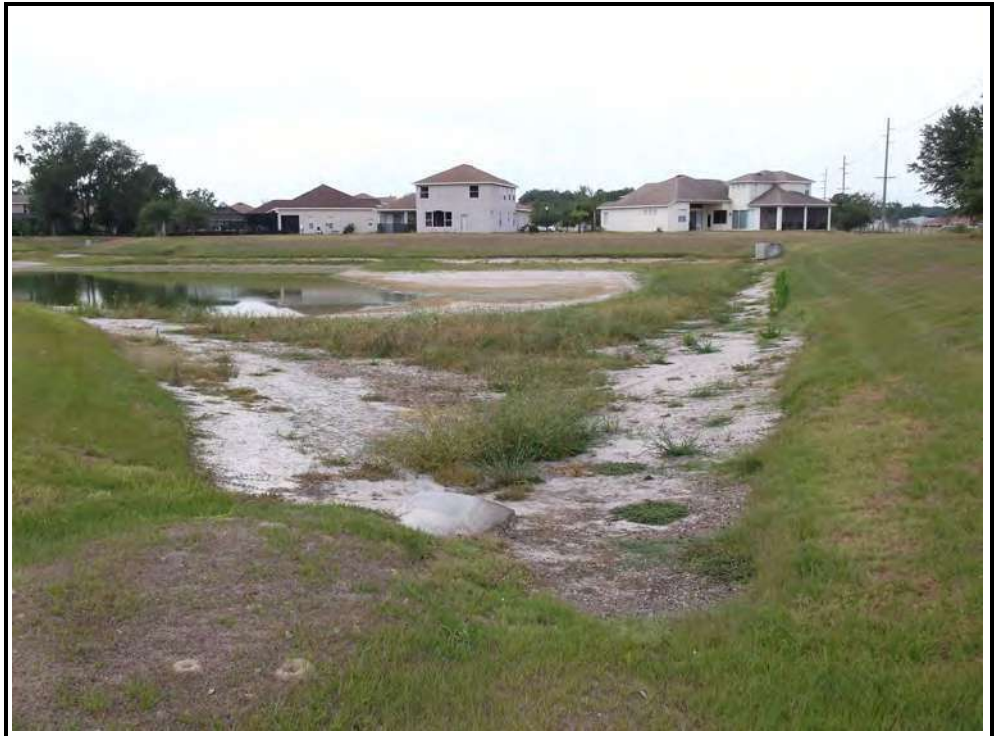
Comments: Southerly view of south pond of Pond 30

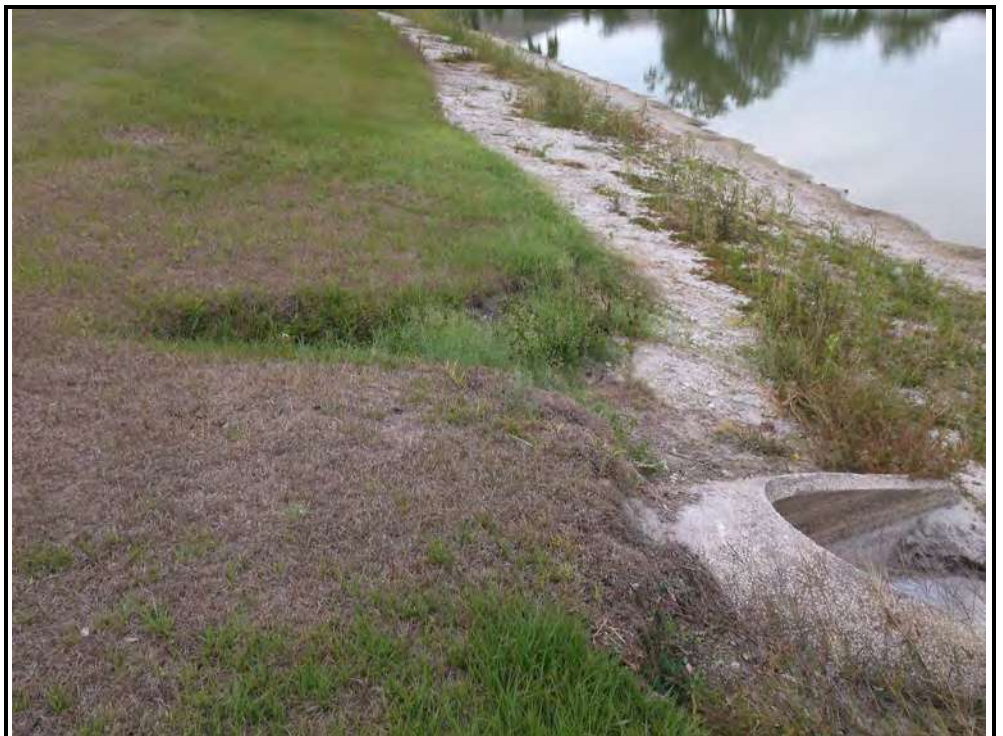
Comments: View of erosion along the slope of Pond 30

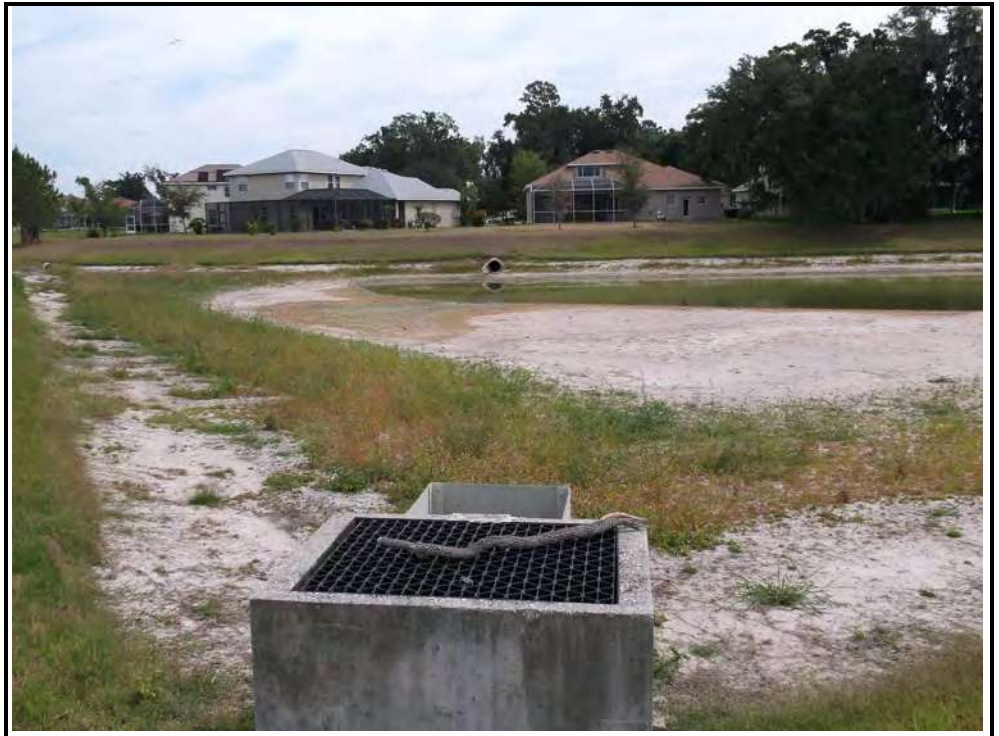
Comments: Northerly view of south pond of Pond 30

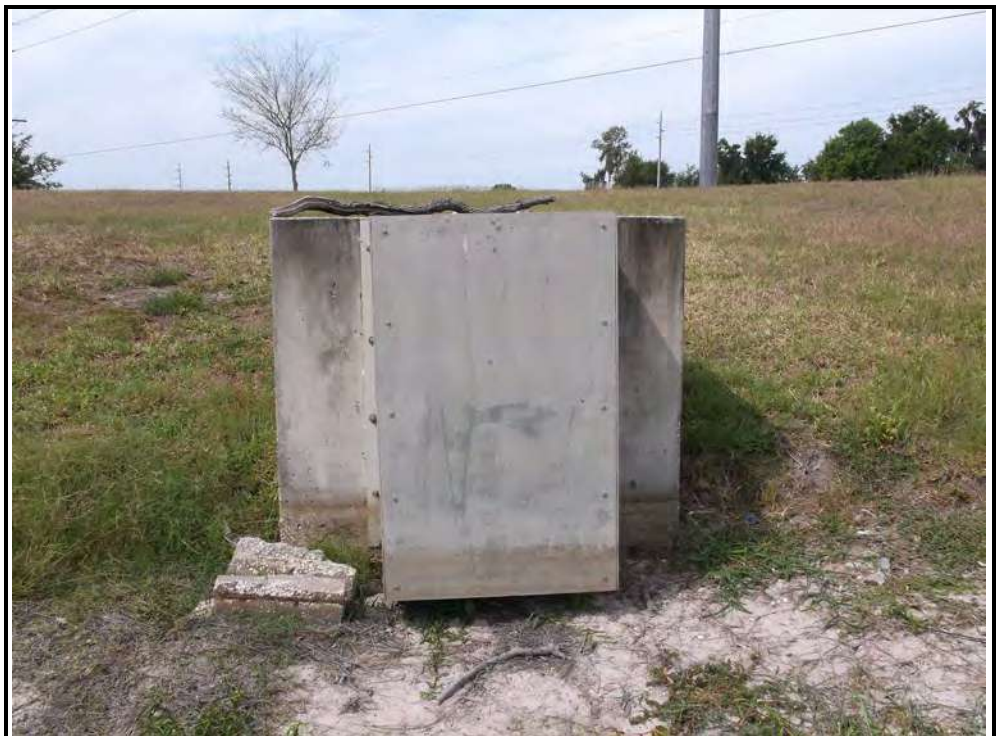
Comments: View of control structure OCS 301

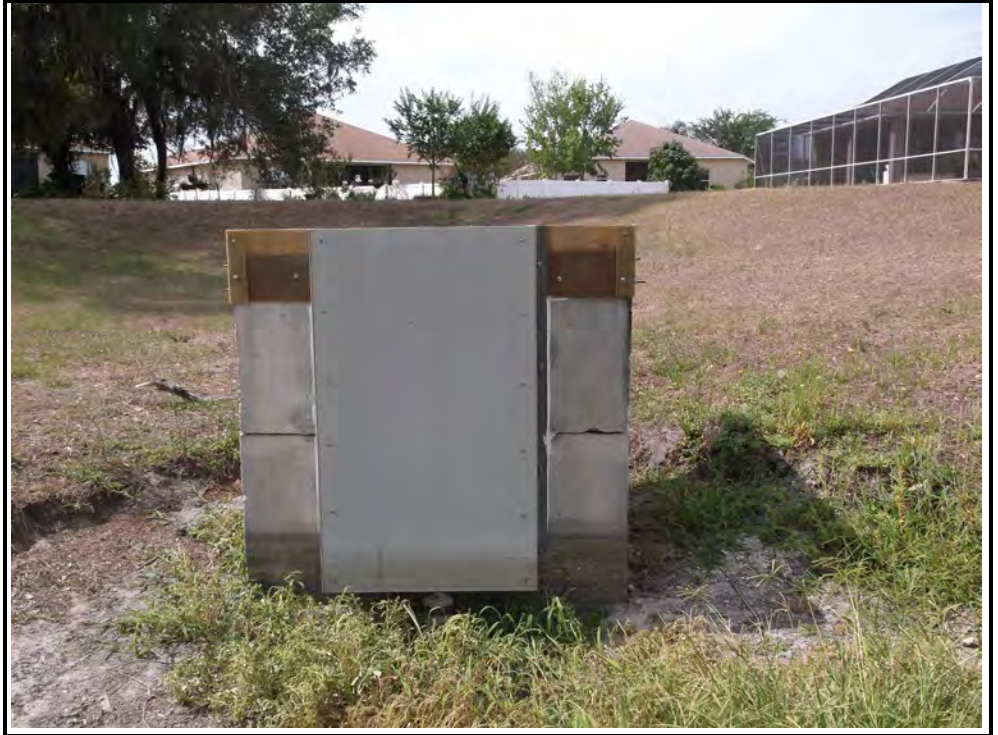
Comments: Southerly view of control structure OCS 300 within Pond 30

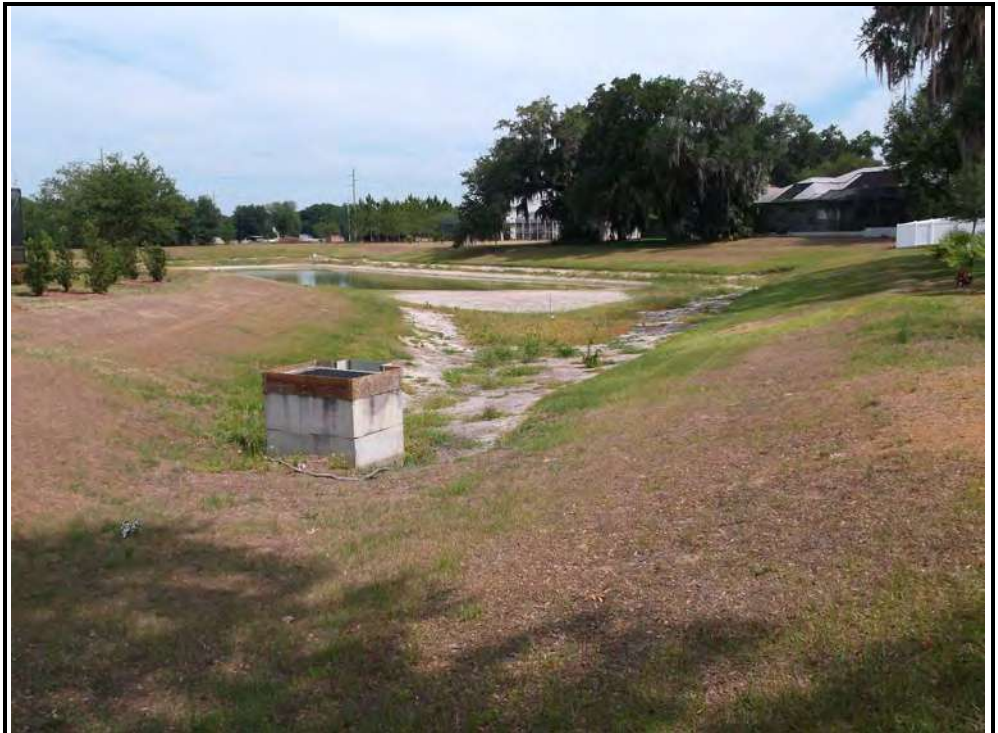
Comments: Northerly view of the south pond of Pond 30

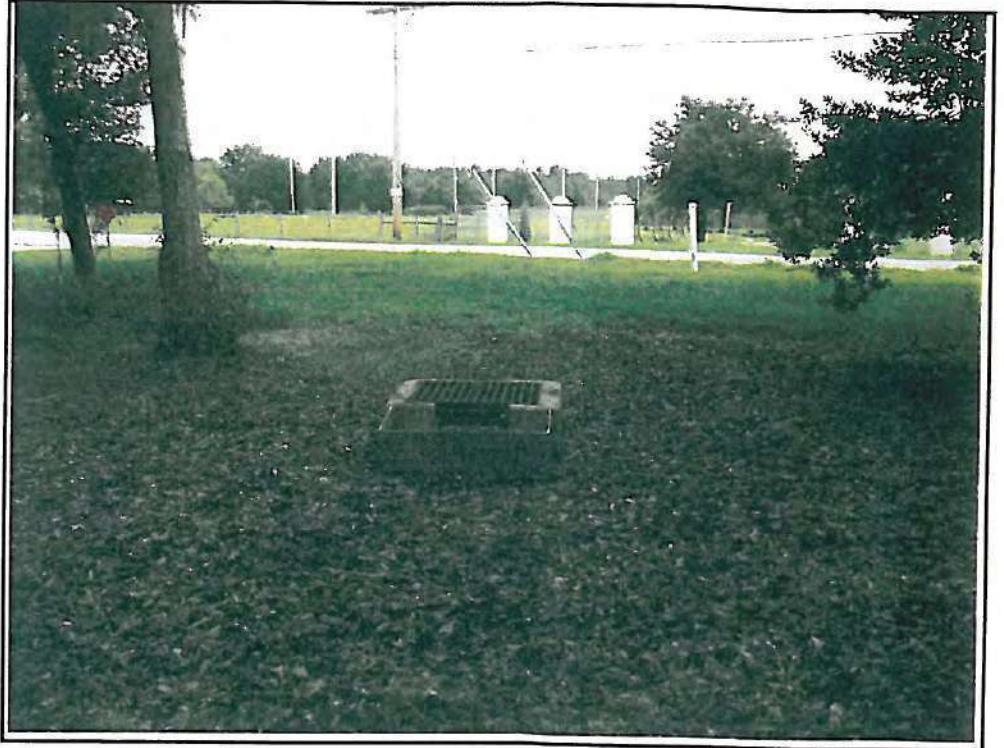
Comments: View of the NW entrance pond

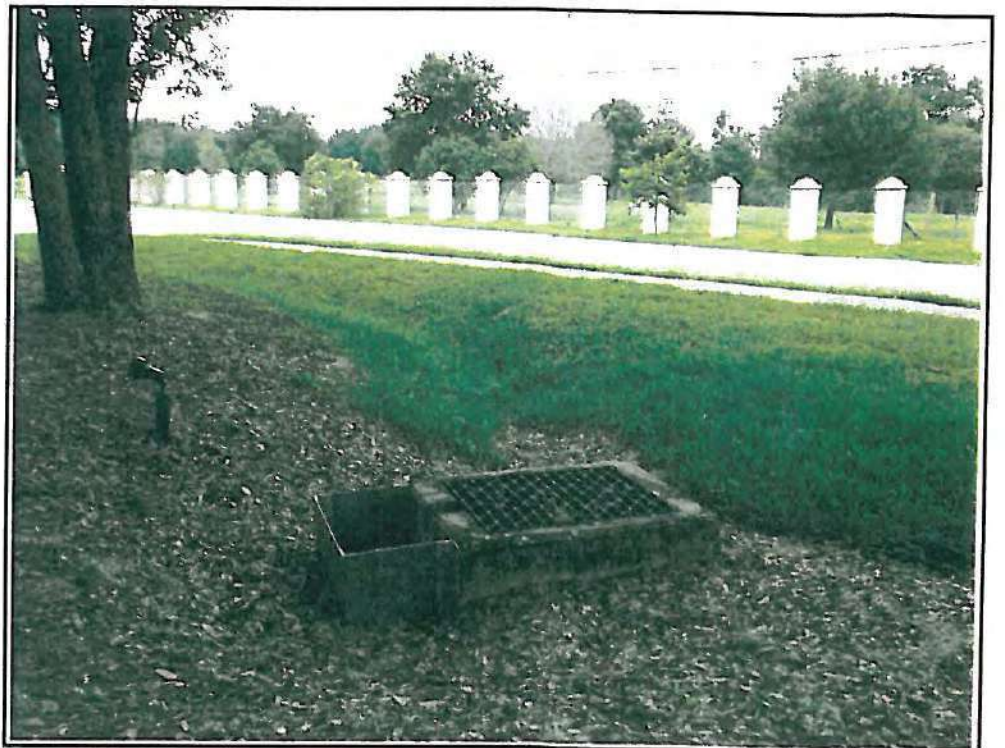
Comments: Northwestern view of NE entrance pond

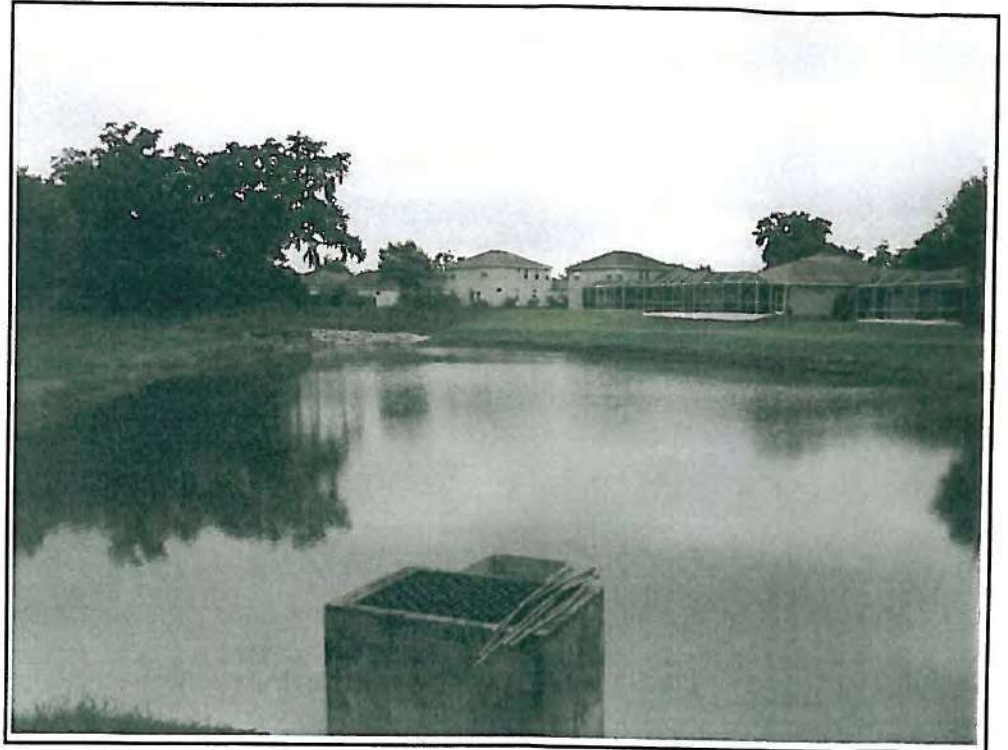
Comments: Southerly view of Pond 10 (CDD # 1)

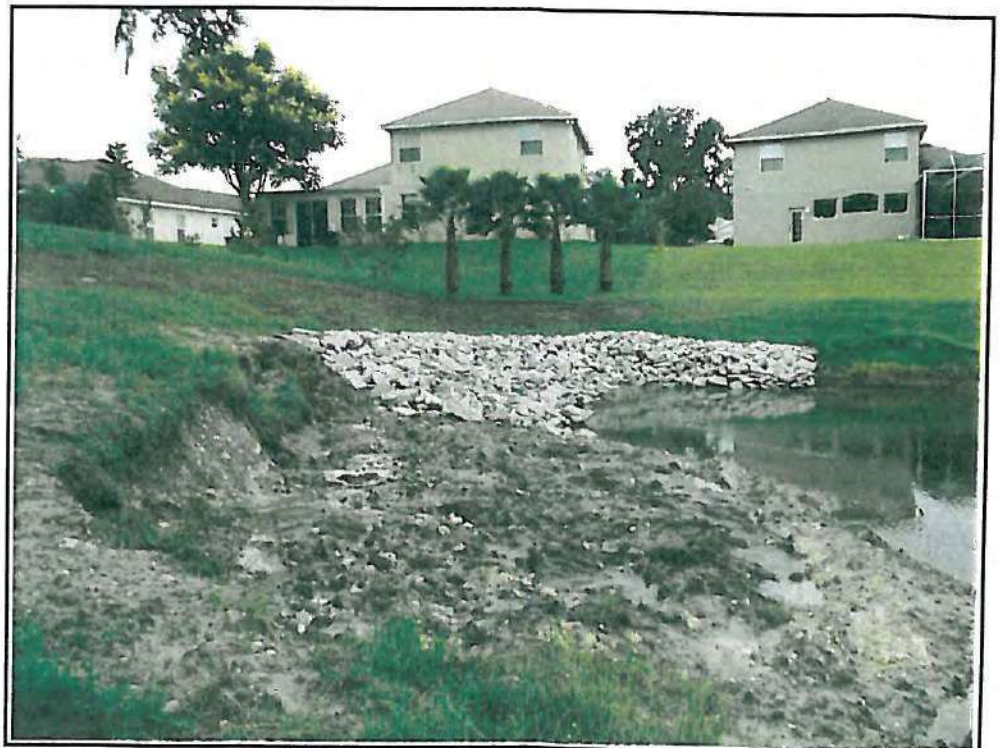
Comments: Westerly view of the south end of Pond 10 (CDD # 1) erosion issue

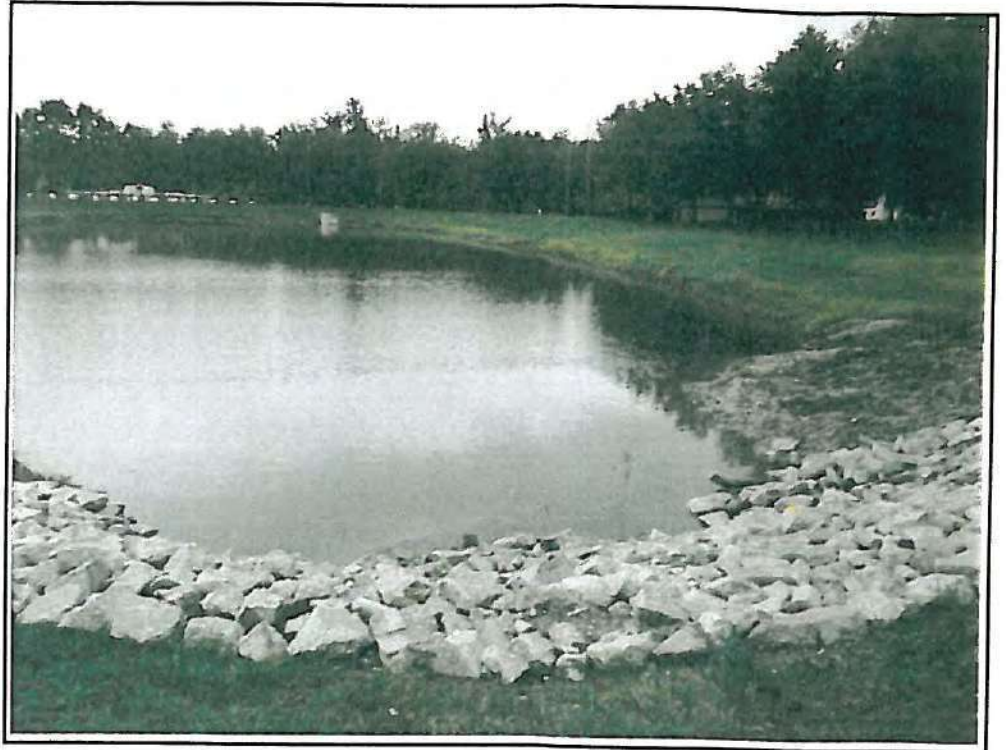
Comments: Northerly view of Pond 10 (CDD # 1)

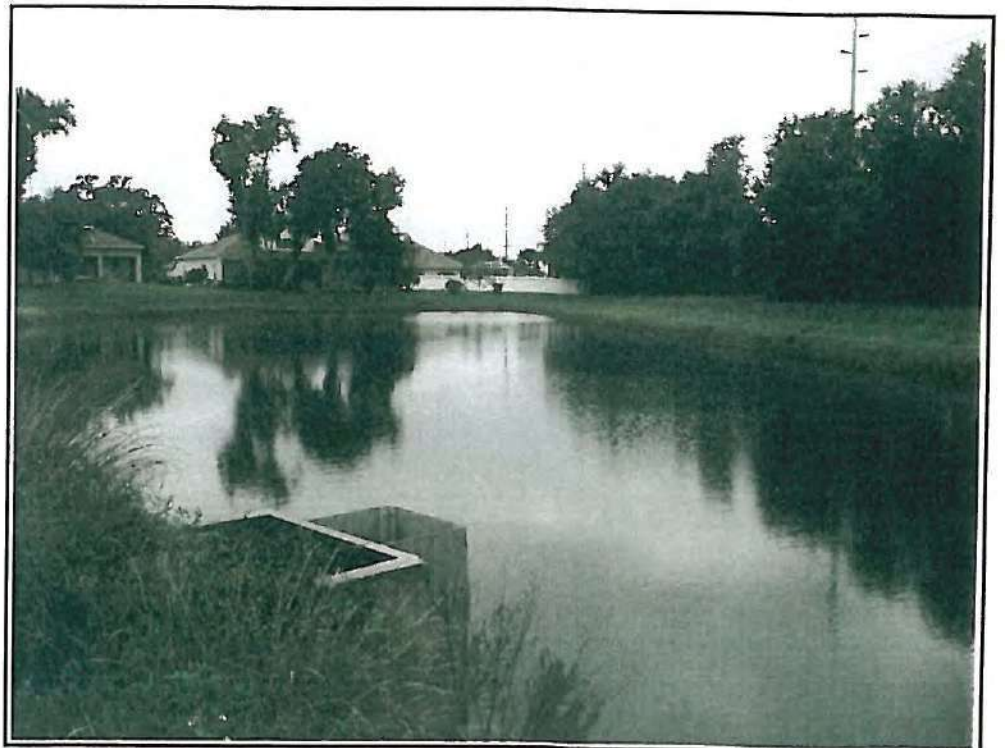
Comments: Southerly view of Pond 20 (CDD # 2)
