**DIAMOND HILL
COMMUNITY DEVELOPMENT DISTRICT**

**FEBRUARY 12, 2024
AGENDA PACKAGE**

- 1.0 ERP PERMIT INFORMATION
- 2.0 PERMIT INSPECTION HISTORY
- 3.0 RECONCILIATION OF CURRENT DEFECT OBSERVATIONS
- 4.0 POND ELEVATION SUMMARY
- 5.0 INSPECTION REPORTS & PICTURES

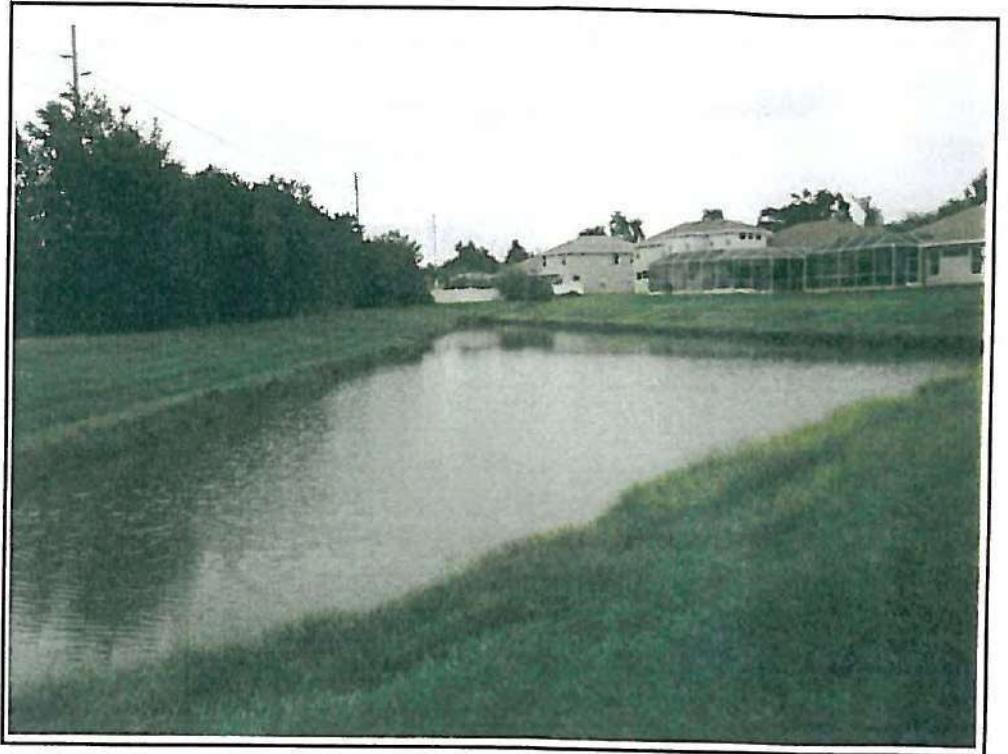
Comments: Northerly view of Pond 30(CDD # 3) North side

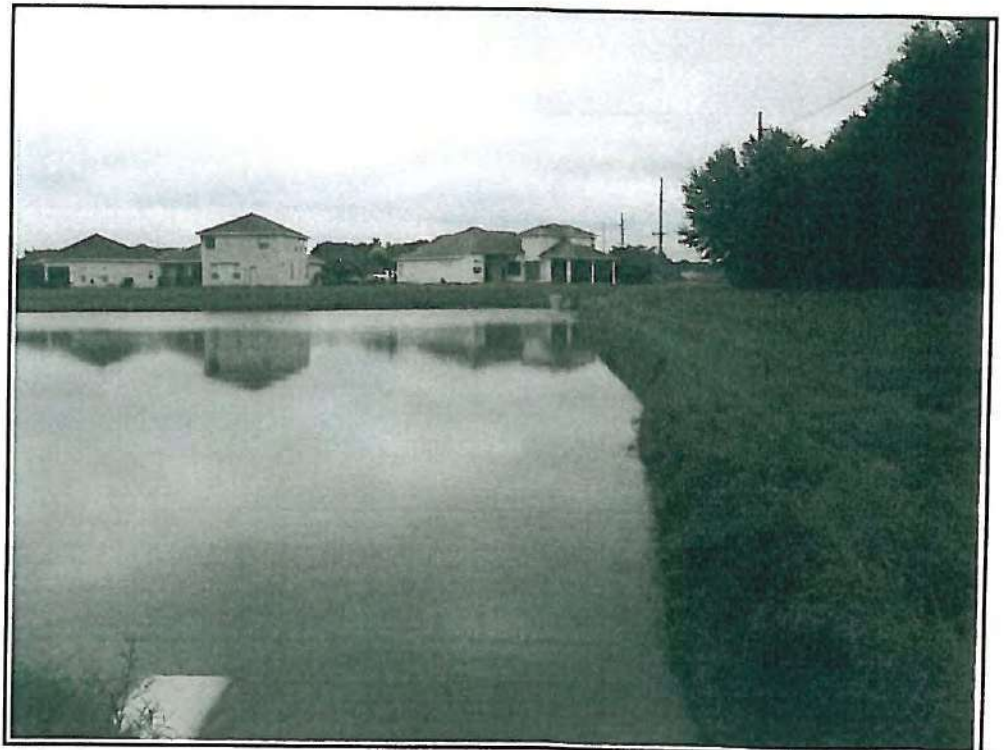
Comments: Southerly view of Pond 30 (CDD # 4) southwest end

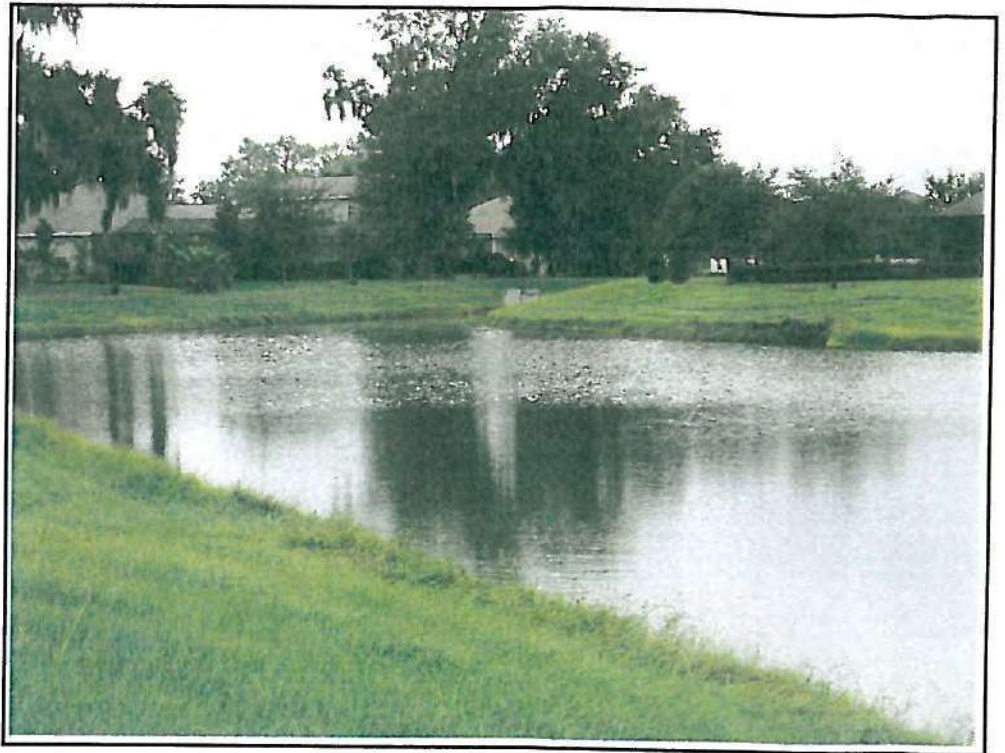
Comments: Southeasterly view of Pond 30(CDD # 4) Southside side

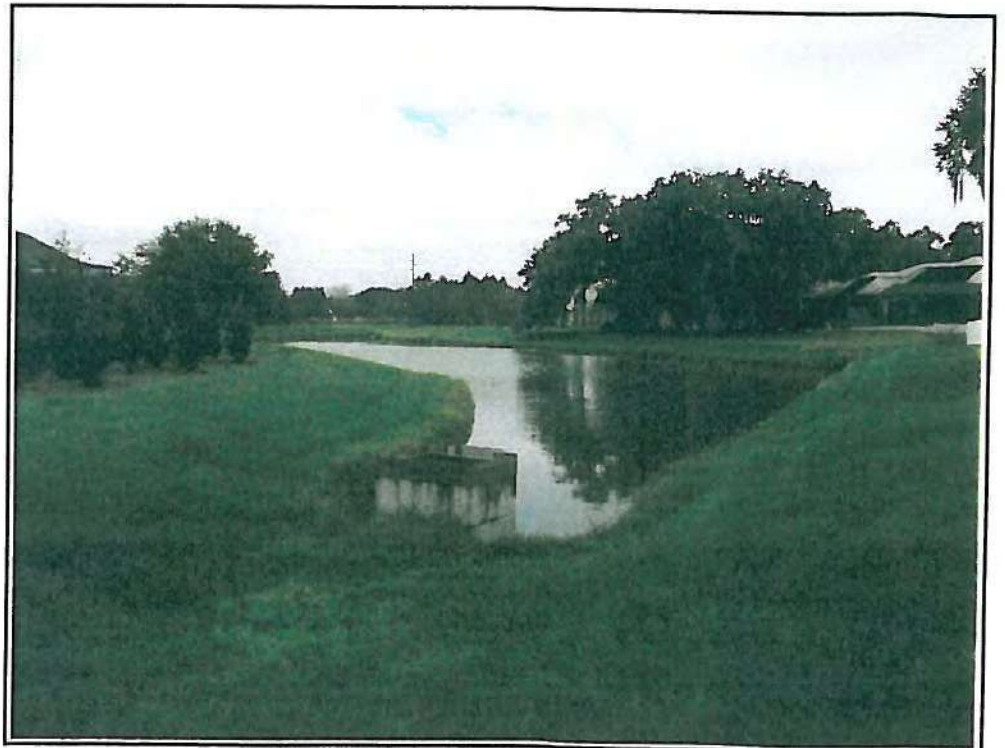
Comments: Northerly view of Pond 30 (CDD # 4) southeast end

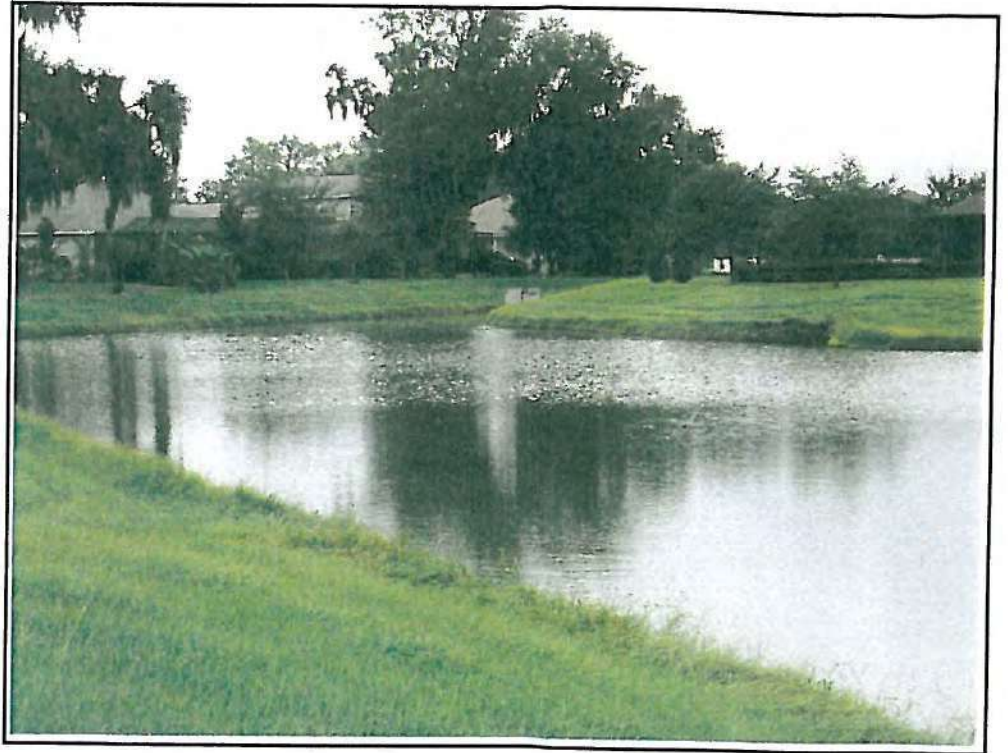
Comments: Southeasterly view of Pond 30(CDD # 4) Southside

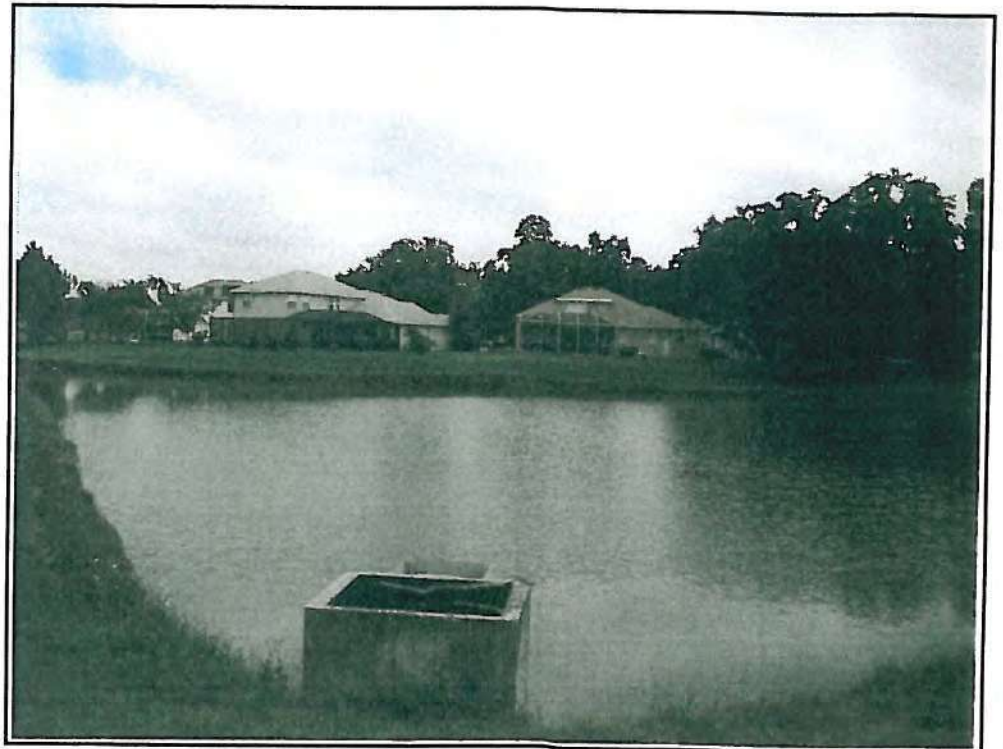
Comments: Northerly view of Pond 30 (CDD # 4) southwest end

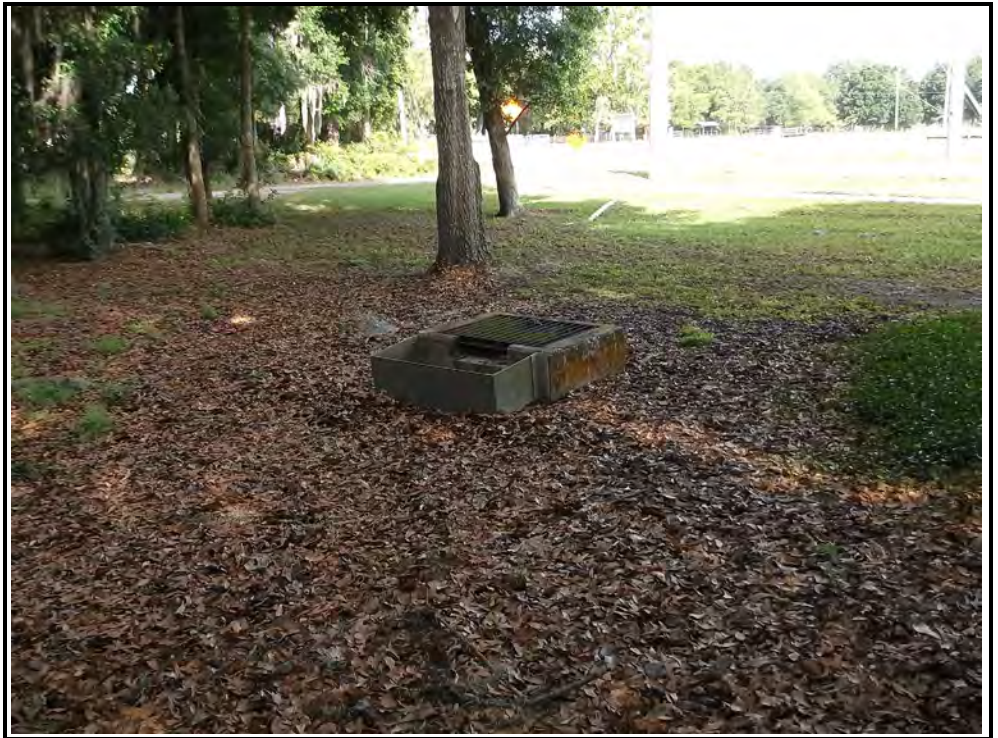
Comments: View of the NW entrance pond

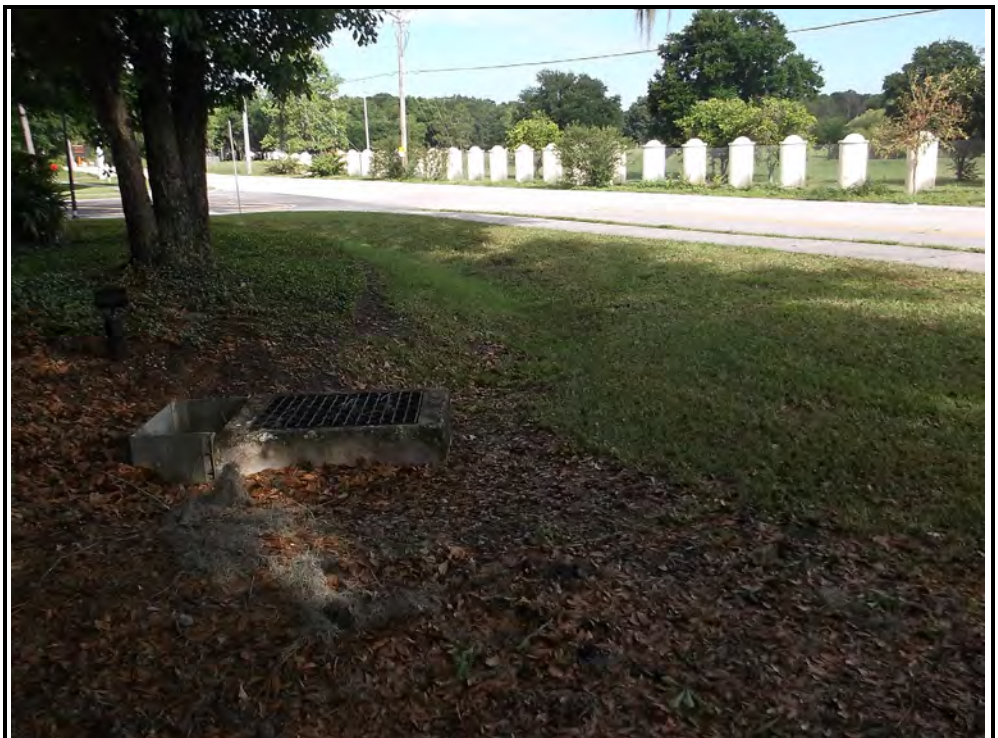
Comments: Northwesterly view of NE entrance pond

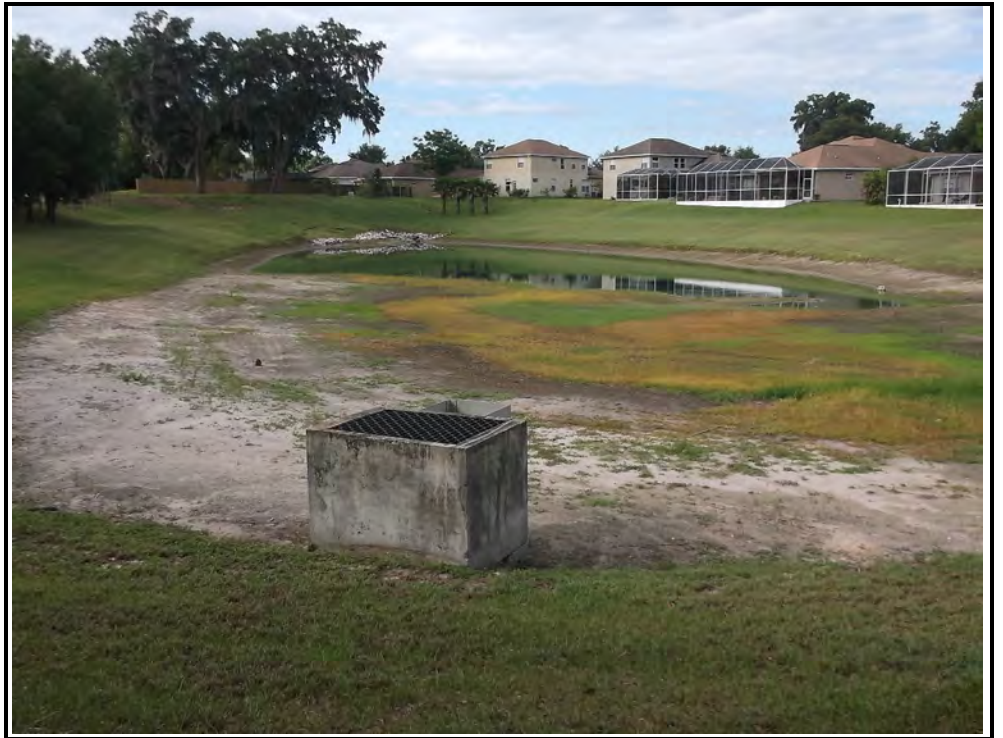
Comments: Southerly view of Pond 10 (CDD # 1)

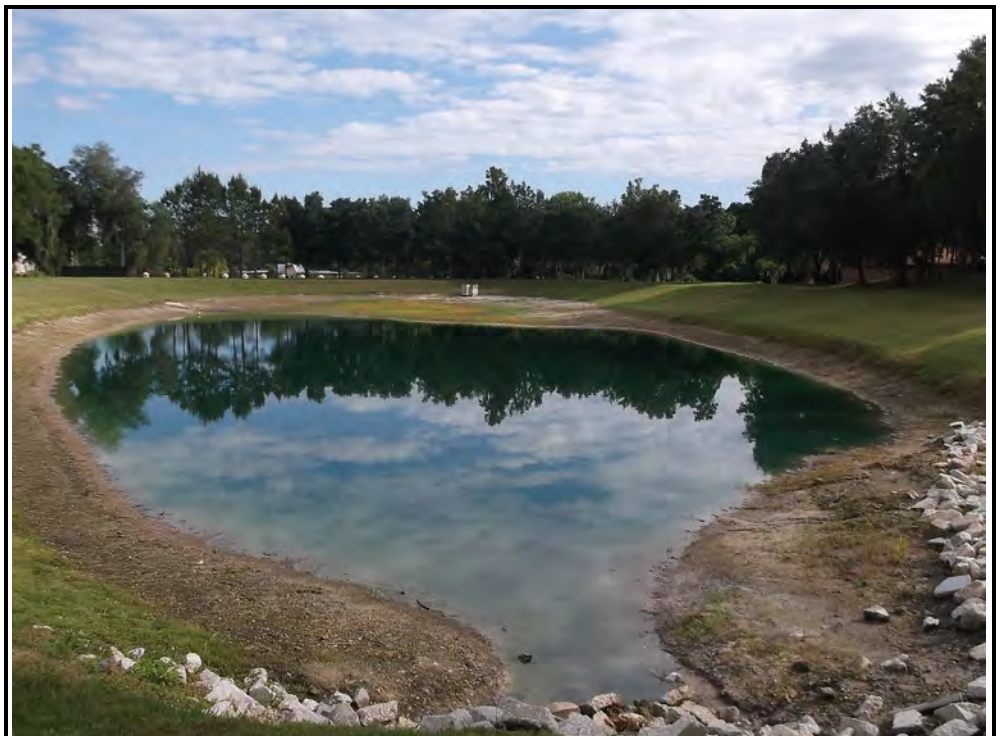
Comments: Northerly view of the south end of Pond 10 (CDD # 1)

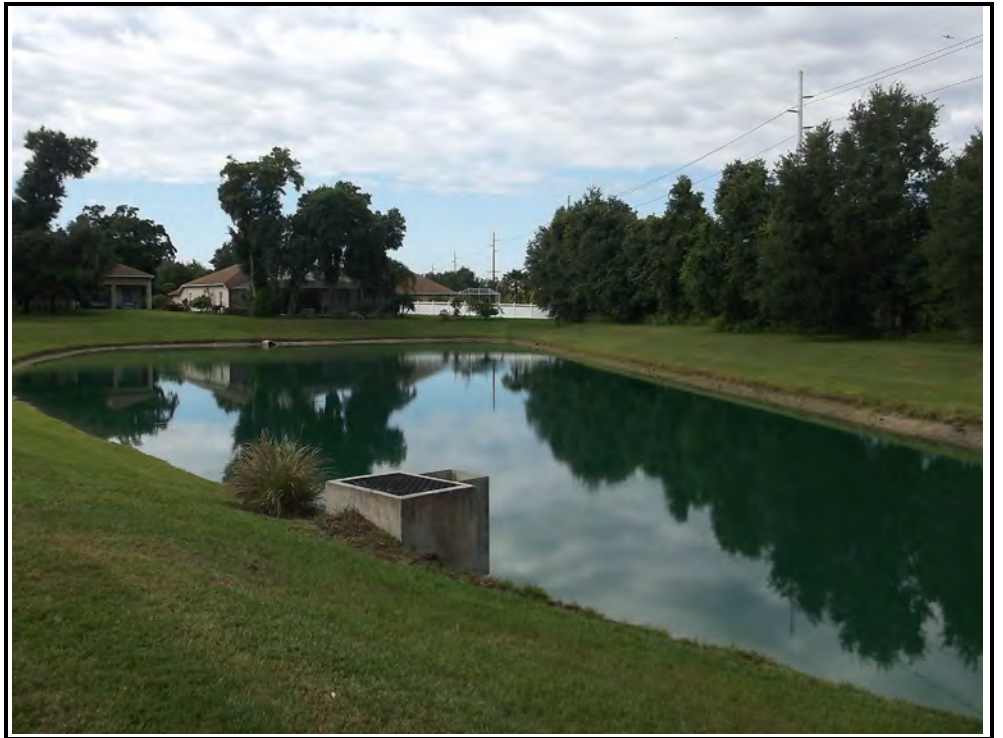
Comments: Southerly view of Pond 20 (CDD # 2)

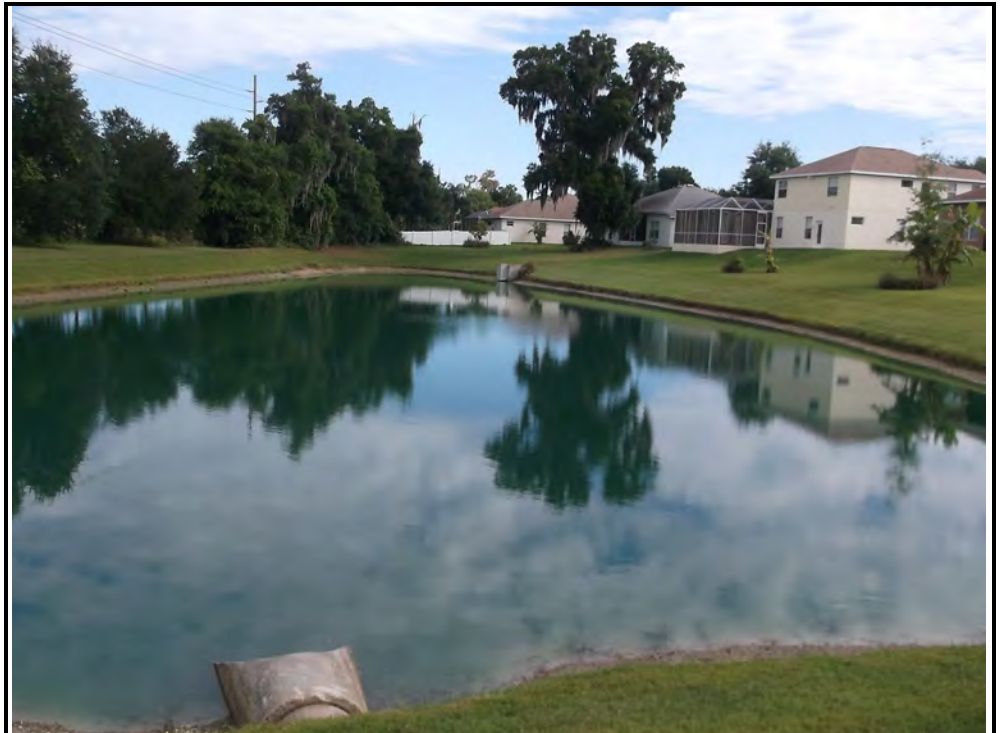
Comments: Northerly view of Pond 20 (CDD # 2)

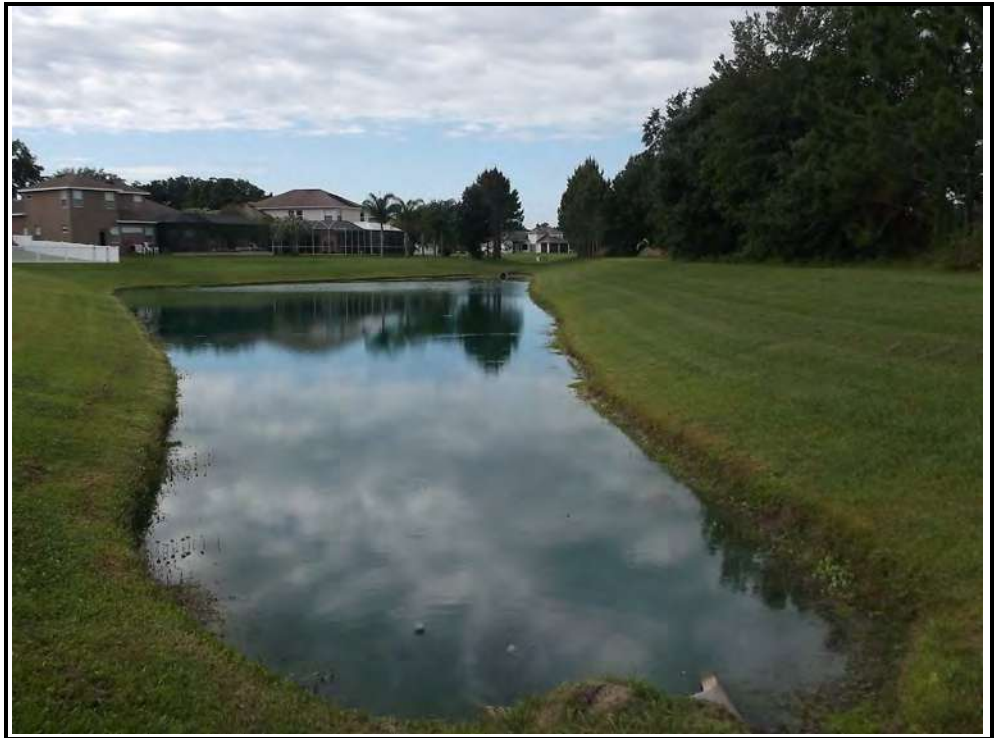
Comments: Southerly view of Pond 30(CDD # 3) North side

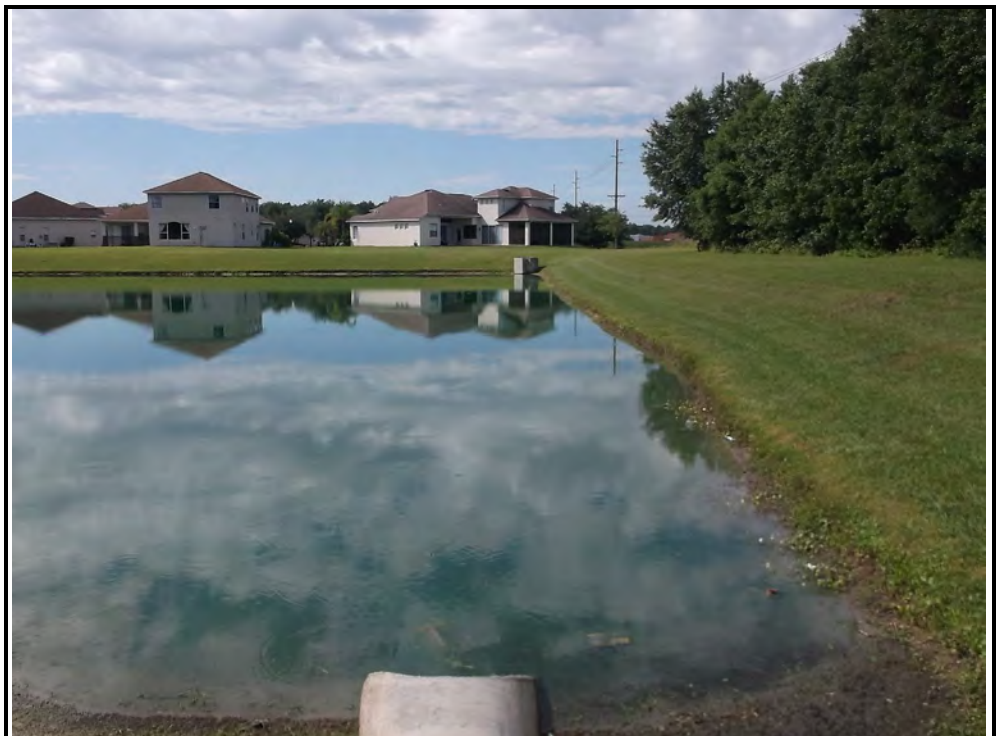
Comments: Southerly view of Pond 30 (CDD # 4) Northwest end

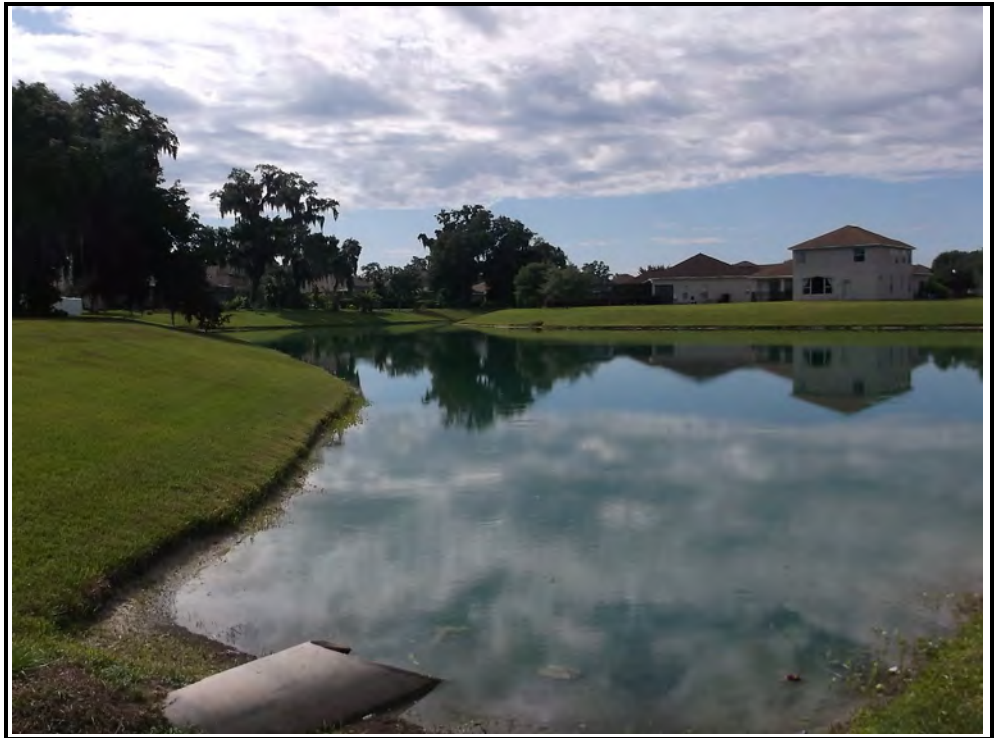
Comments: Southeasterly view of Pond 30(CDD # 4) Northwest side

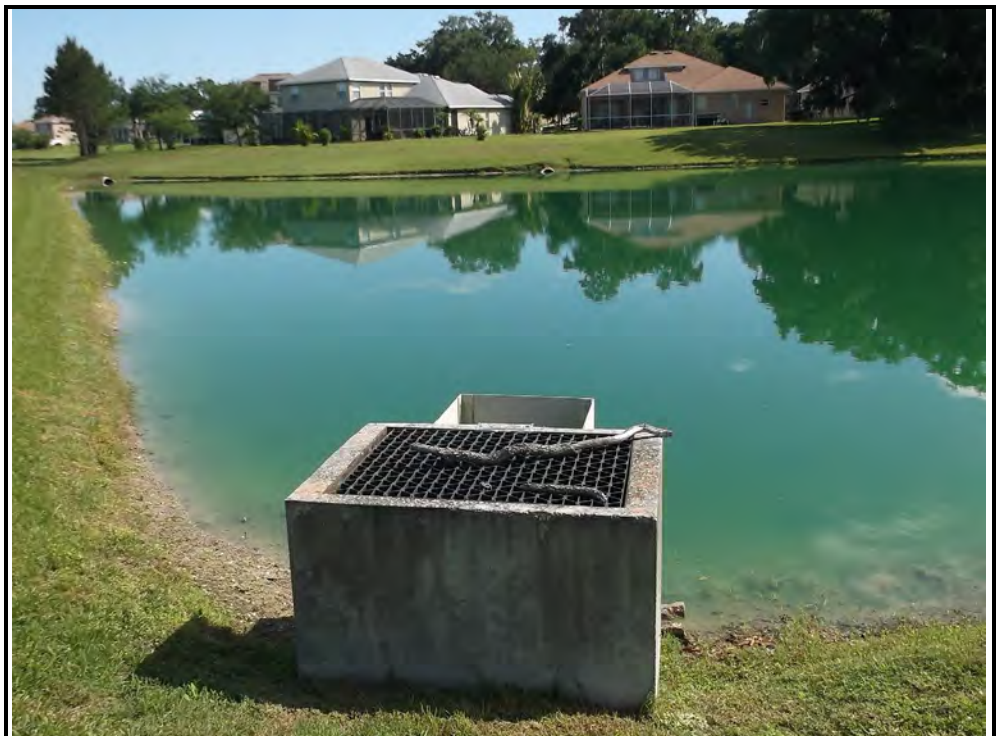
Comments: Northerly view of Pond 30 (CDD # 4) southwest end

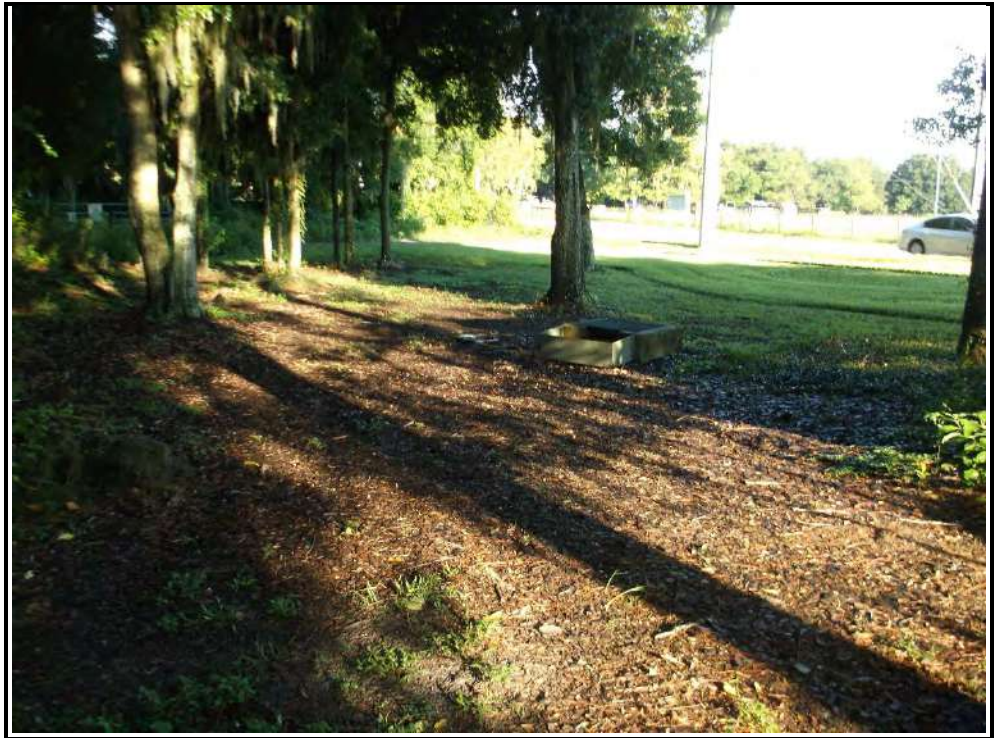
Comments: Northwesterly view of the NW entrance pond

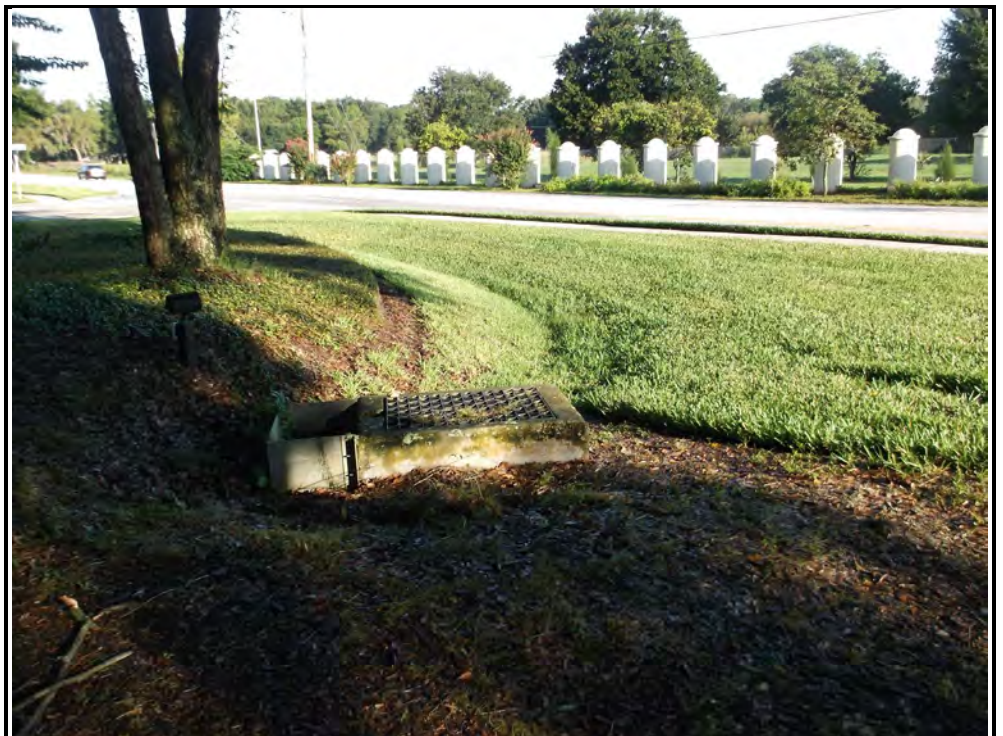
Comments: Northwesterly view of the NE entrance pond

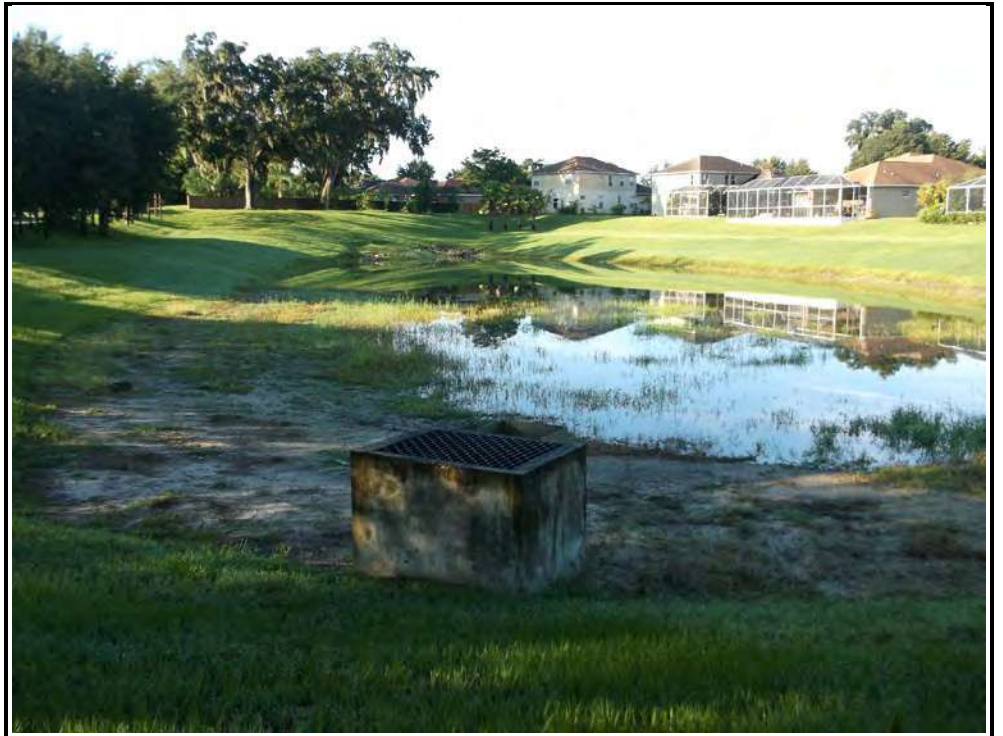
Comments: Southerly view of Pond 10 (CDD # 1)

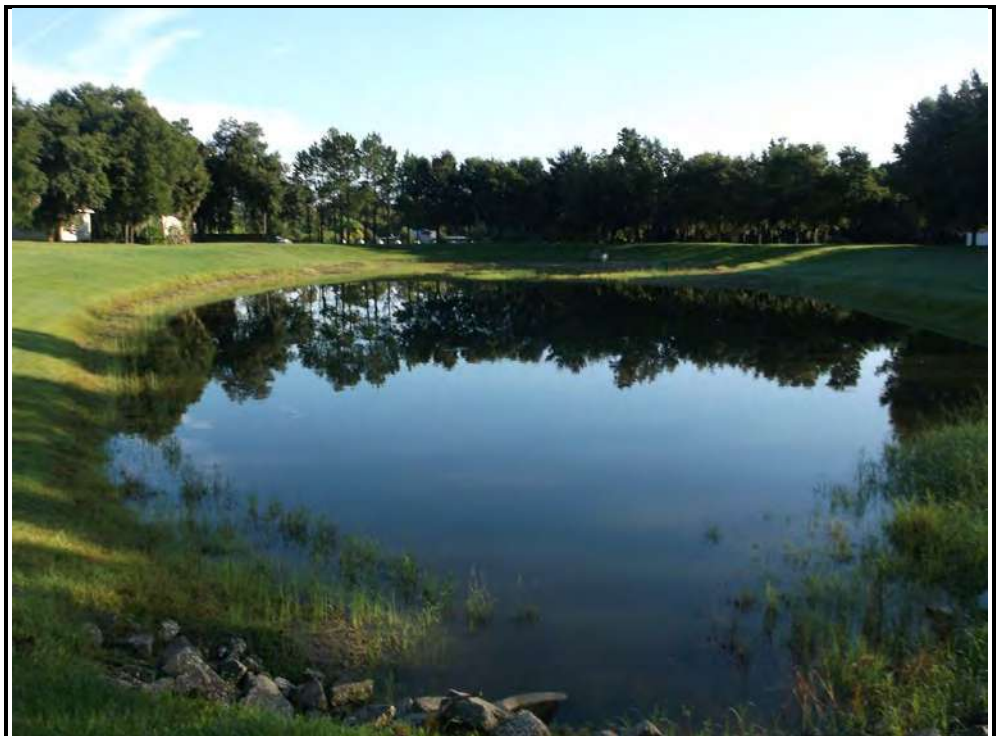
Comments: Northerly view of the south end of Pond 10 (CDD # 1)

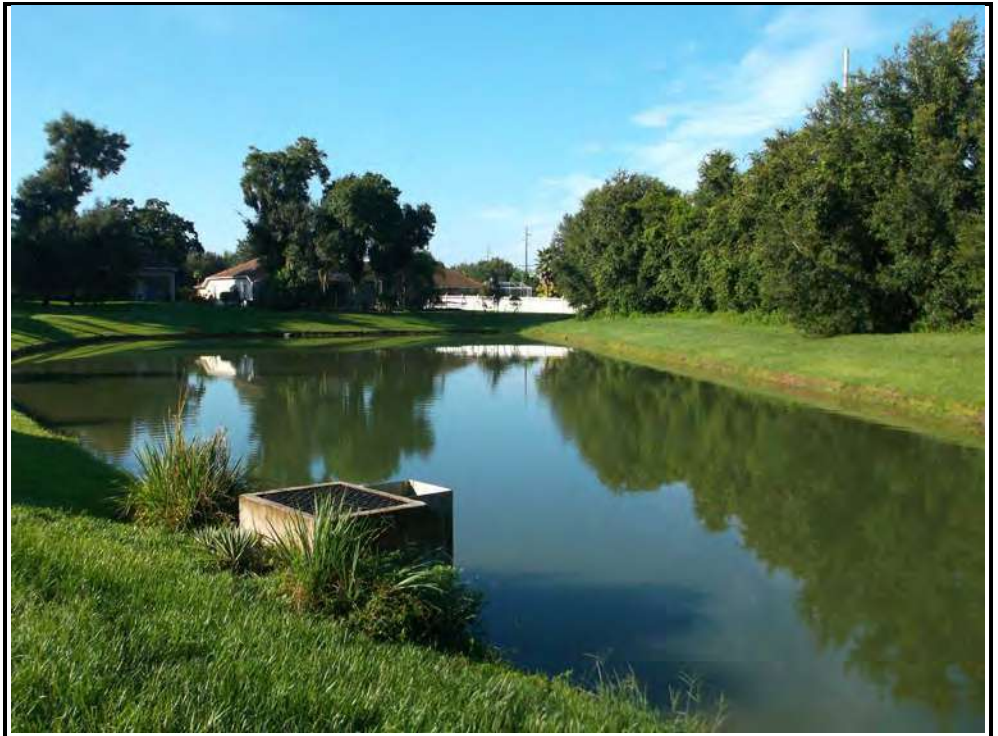
Comments: Southerly view of Pond 20 (CDD # 2)

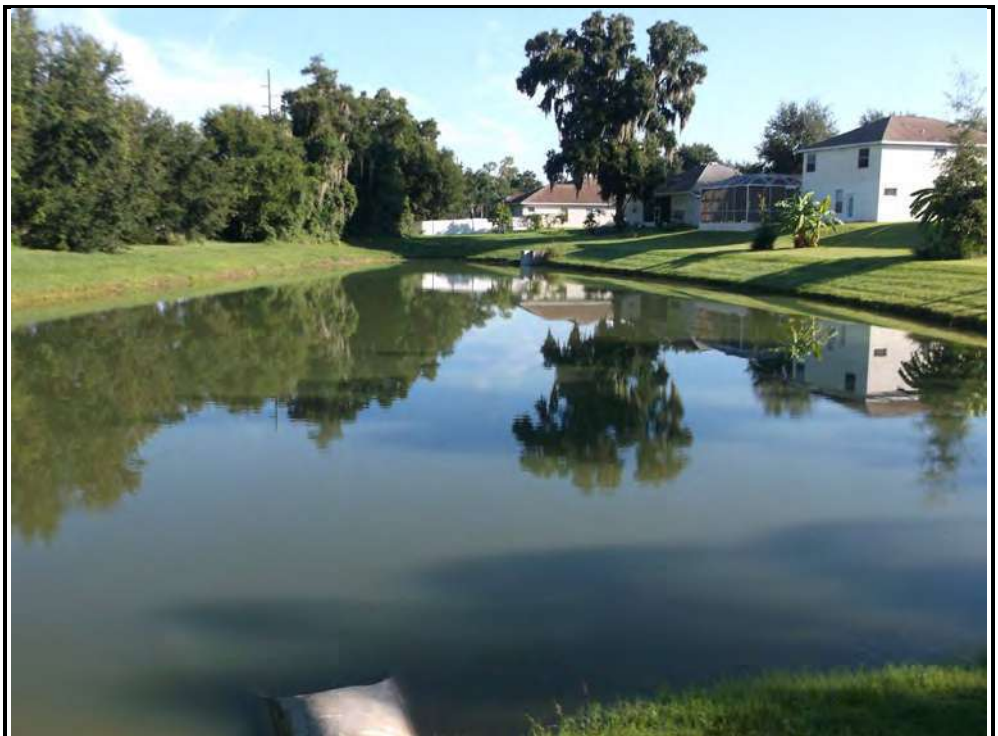
Comments: Northerly view of Pond 20 (CDD # 2)

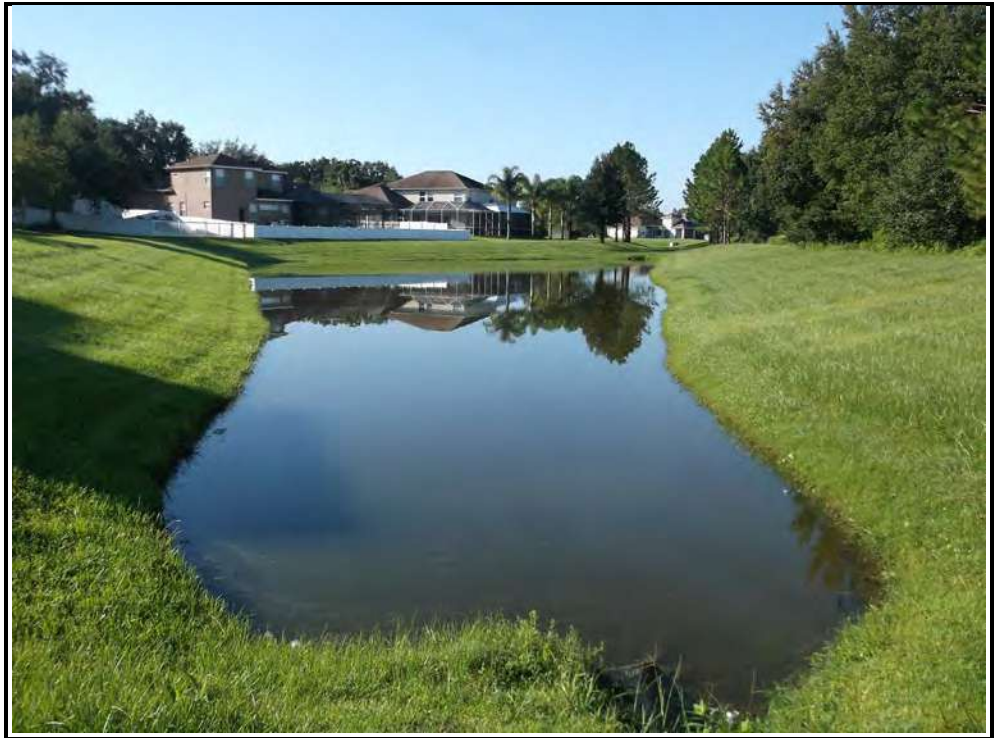
Comments: Southerly view of Pond 30(CDD # 3) North side

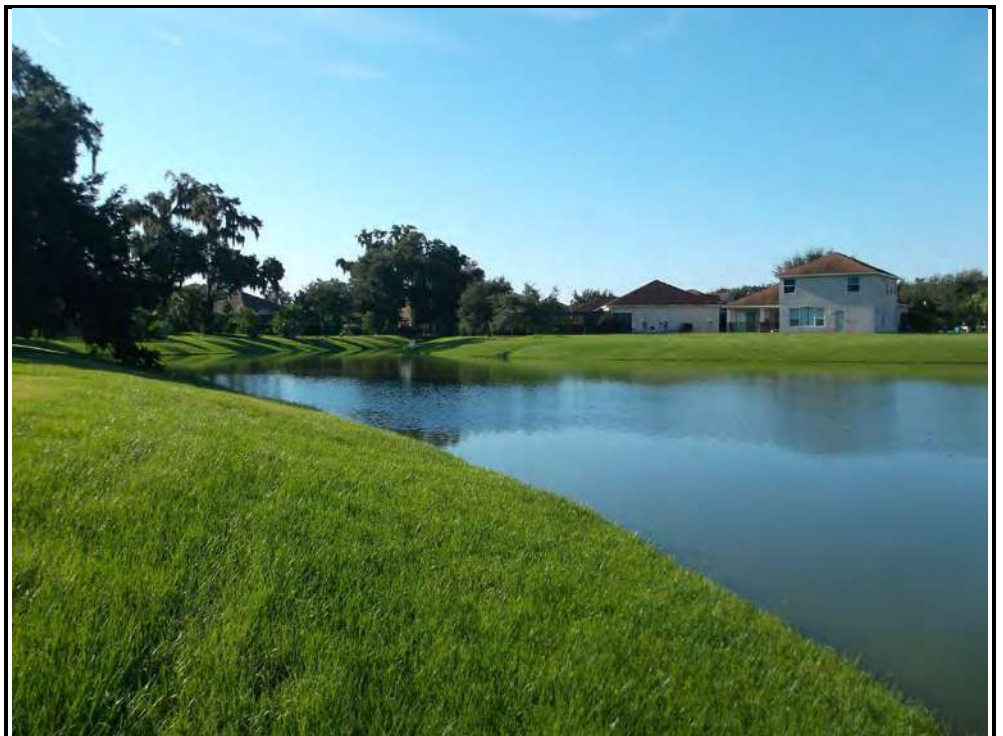
Comments: Southeasterly view of Pond 30 (CDD # 4) Northwest end

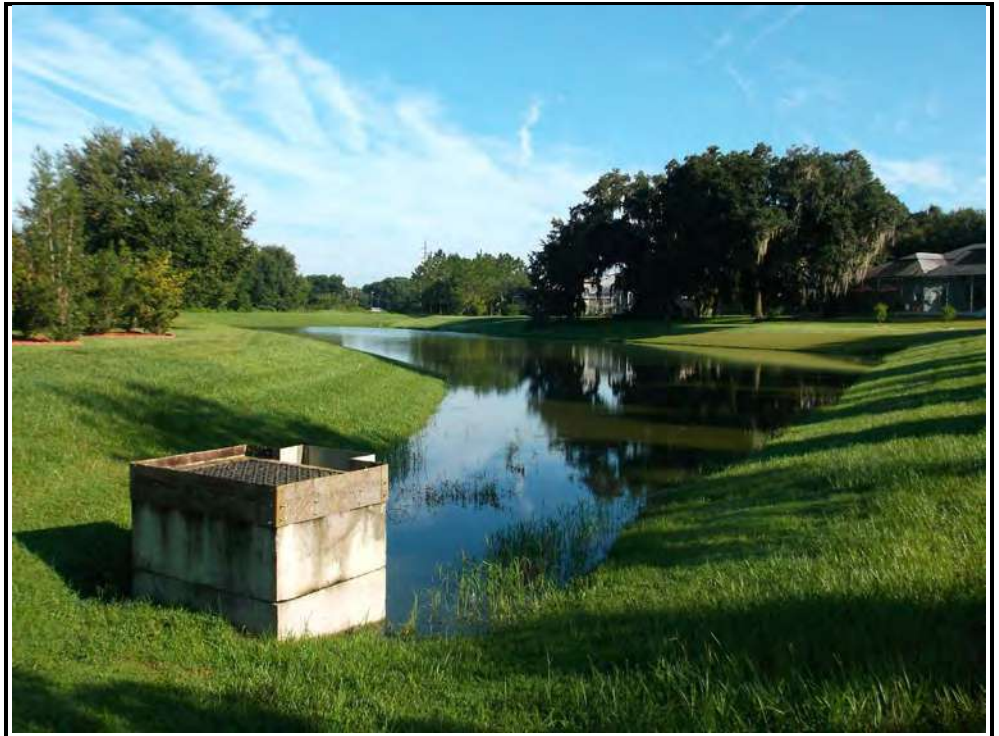
Comments: Northwesterly view of Pond 30(CDD # 4) southeast end

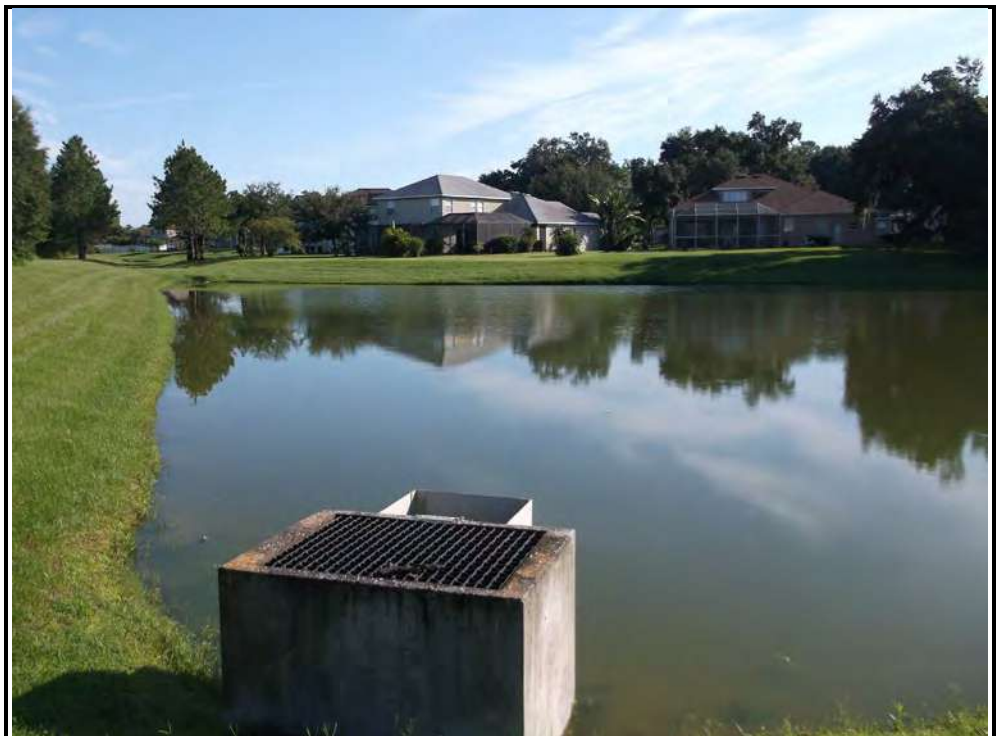
Comments: Northerly view of Pond 30 (CDD # 4) southwest end

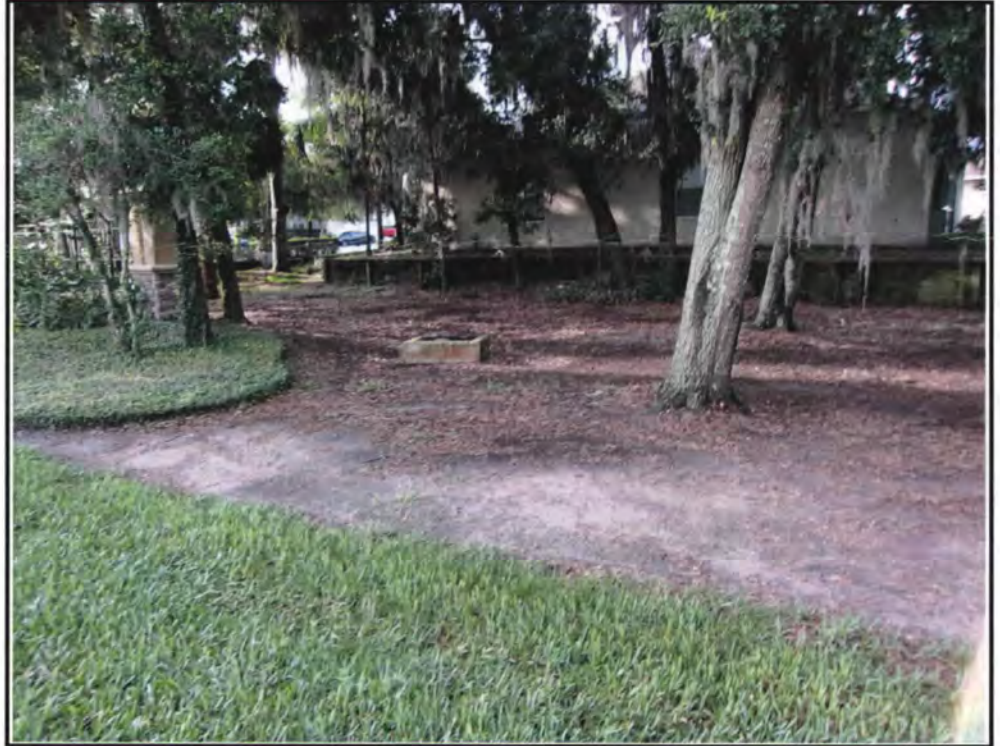
Comments: Southeasterly view of the NW entrance pond

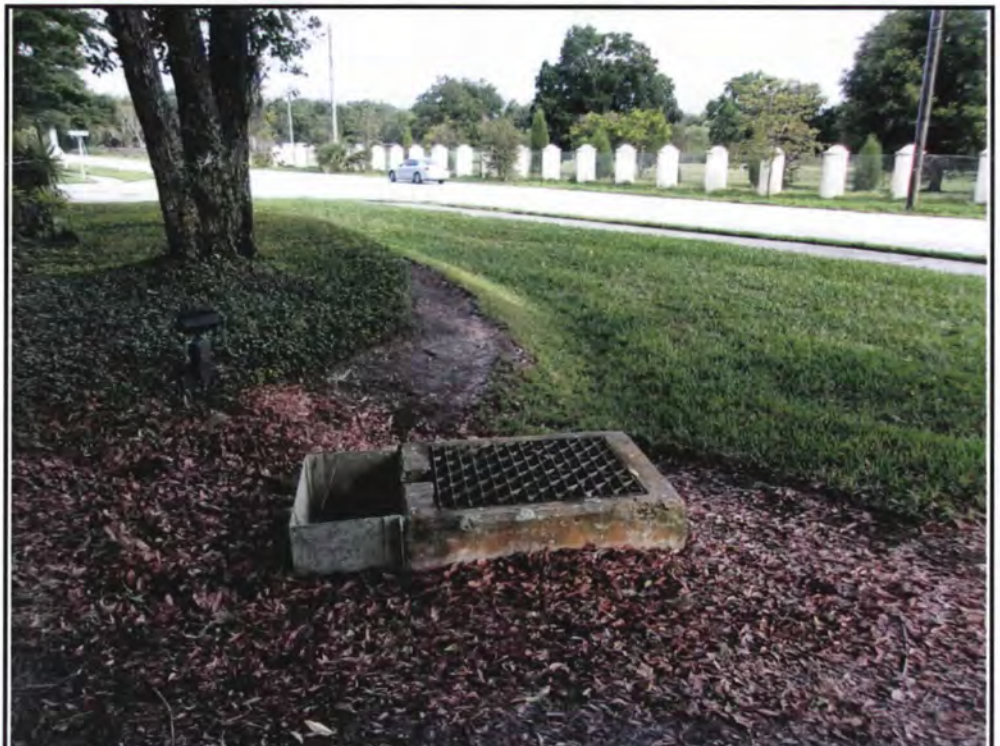
Comments: Northwesterly view of the NE entrance pond

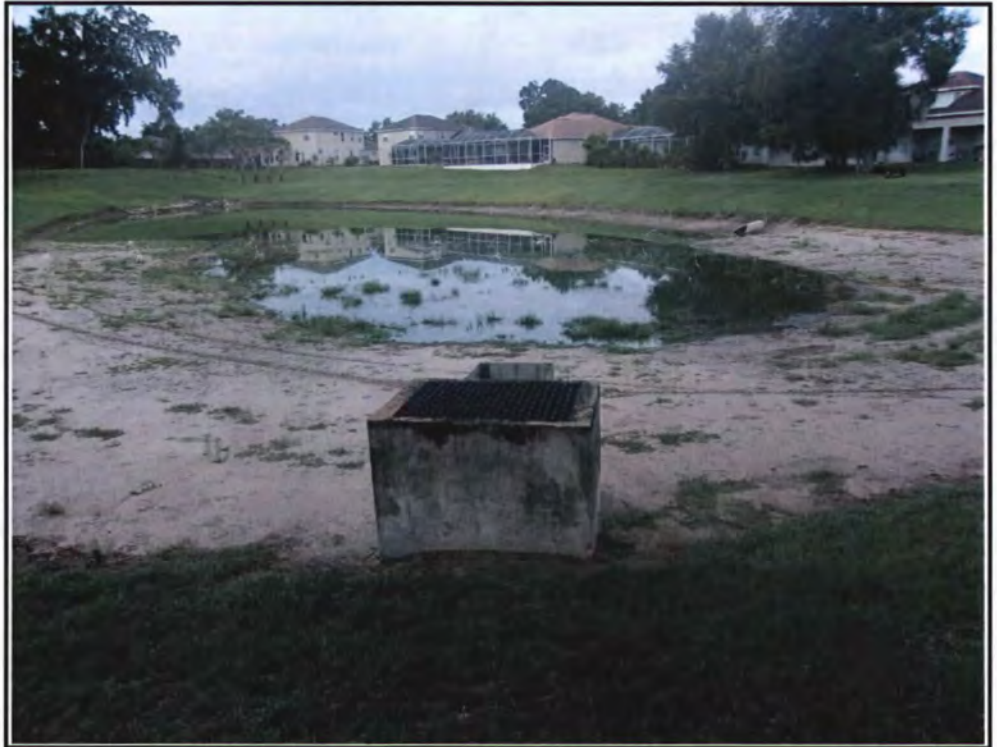
Comments: Southerly view of Pond 10 (CDD # 1)

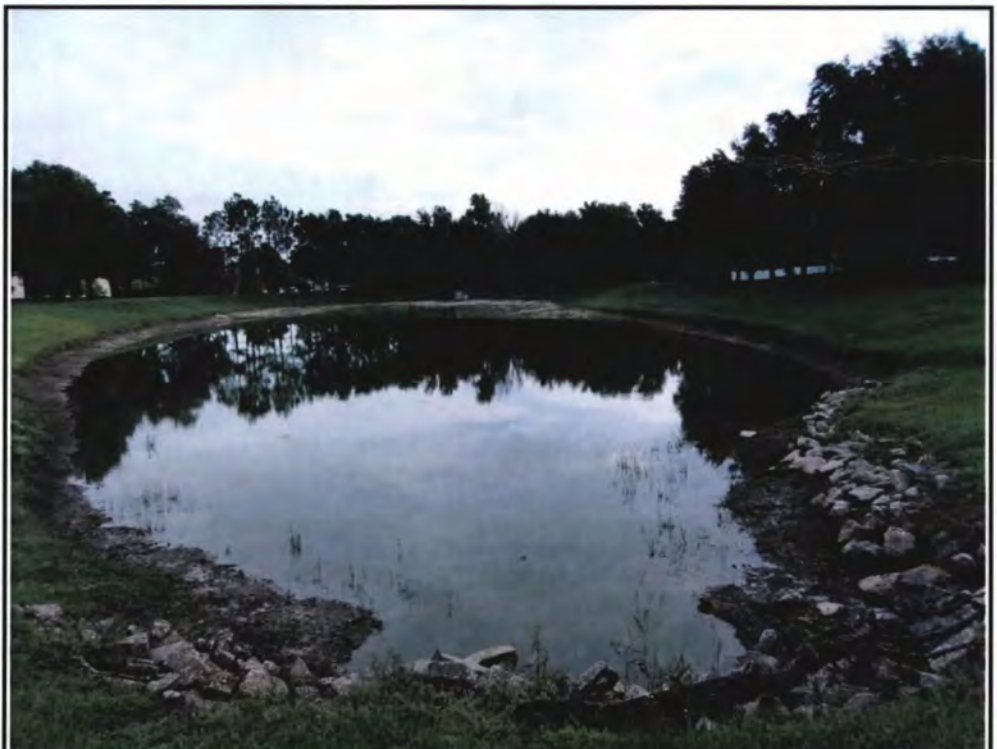
Comments: Northerly view of the south end of Pond 10 (CDD # 1)
