**DIAMOND HILL
COMMUNITY DEVELOPMENT DISTRICT**

**FEBRUARY 12, 2024
AGENDA PACKAGE**

- 1.0 ERP PERMIT INFORMATION
- 2.0 PERMIT INSPECTION HISTORY
- 3.0 RECONCILIATION OF CURRENT DEFECT OBSERVATIONS
- 4.0 POND ELEVATION SUMMARY
- 5.0 INSPECTION REPORTS & PICTURES

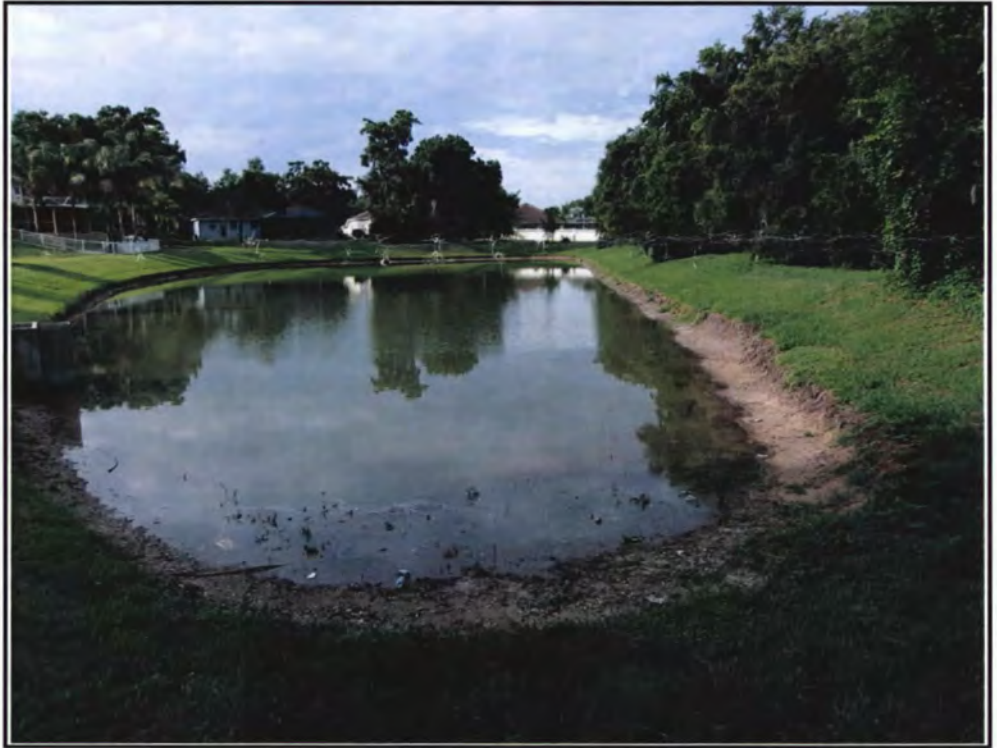
Comments: Southerly view of Pond 20 (CDD # 2)

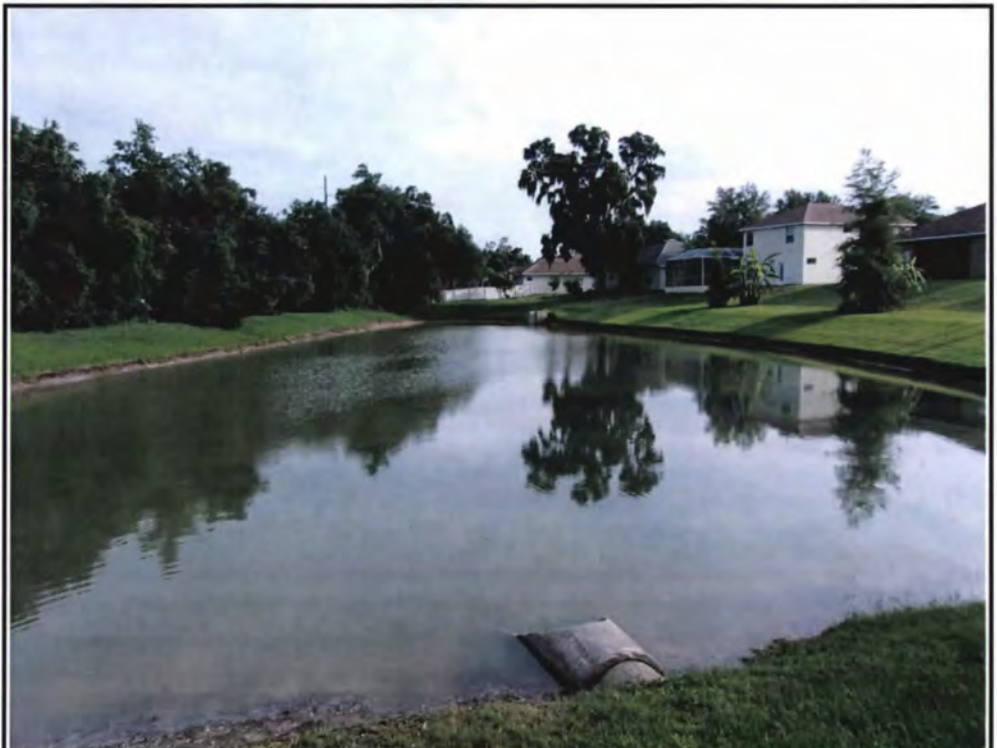
Comments: Northerly view of Pond 20 (CDD # 2)

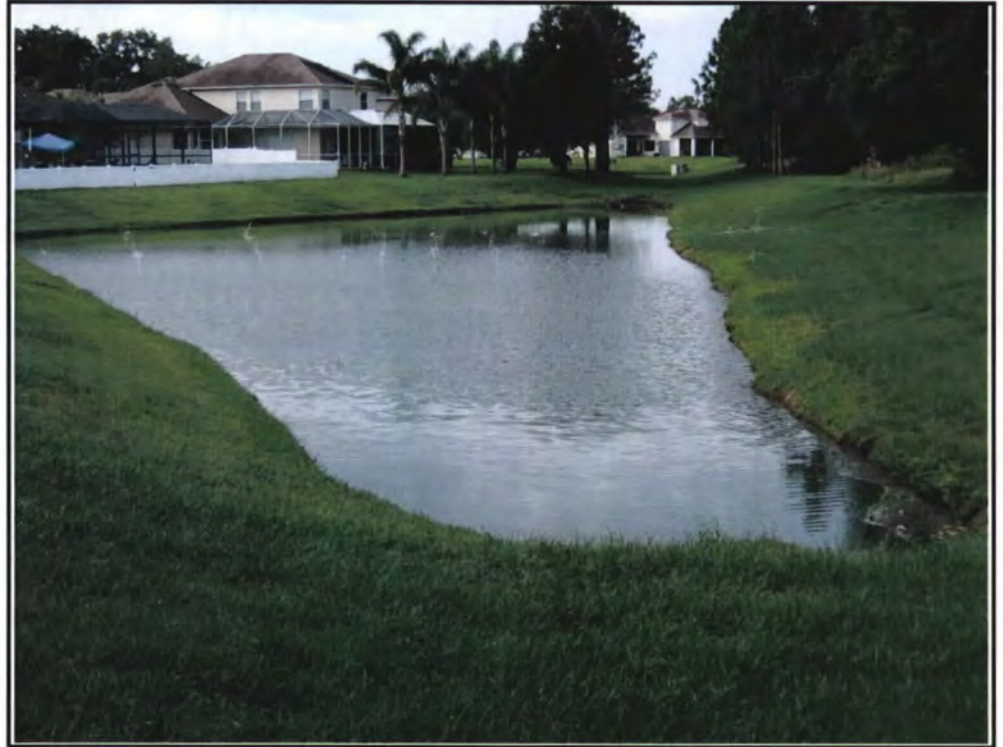
Comments: Southerly view of Pond 30 (CDD # 3) North side

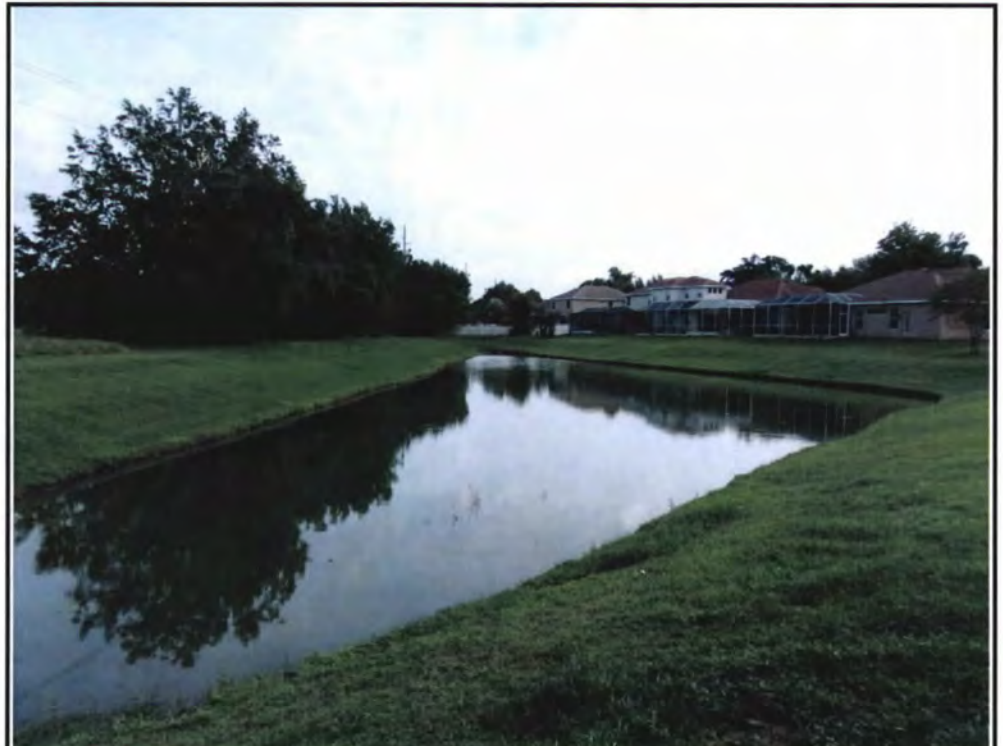
Comments: Northerly view of Pond 30 (CDD # 4) Northwest end

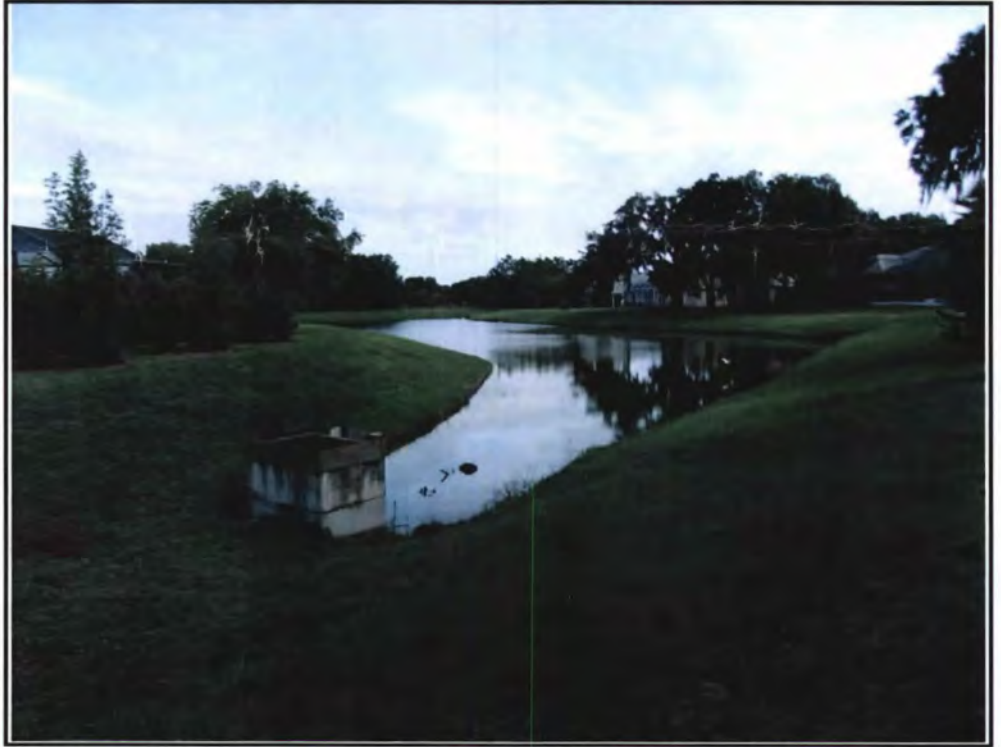
Comments: Northwesterly view of Pond 30 (CDD # 4) southeast end

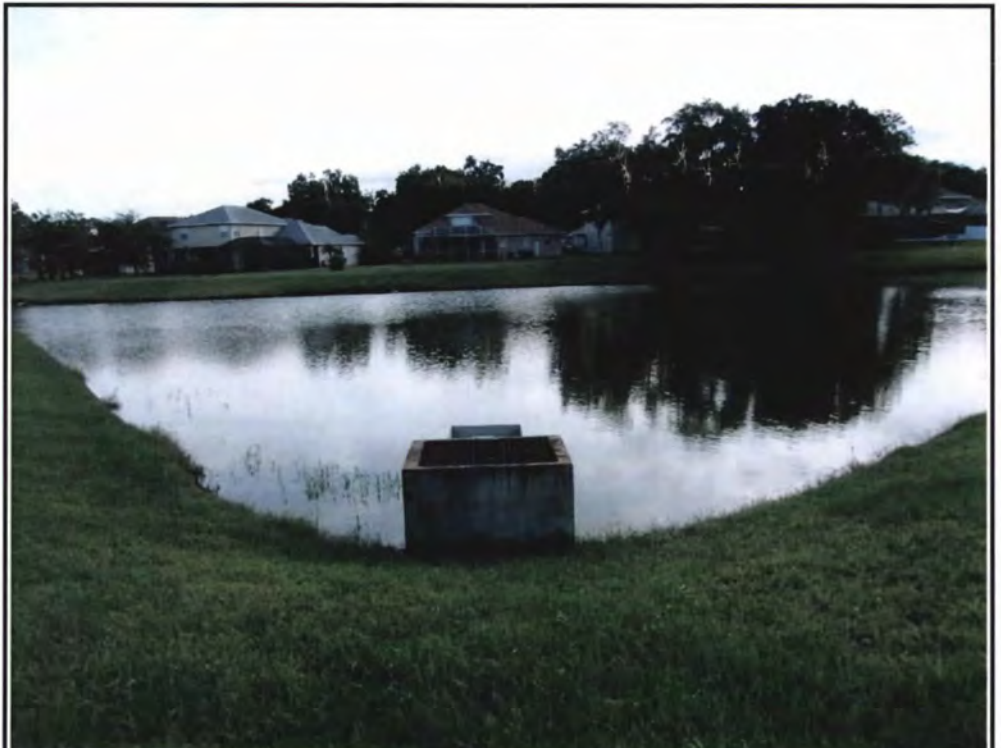
Comments: Northerly view of Pond 30 (CDD # 4) southwest end

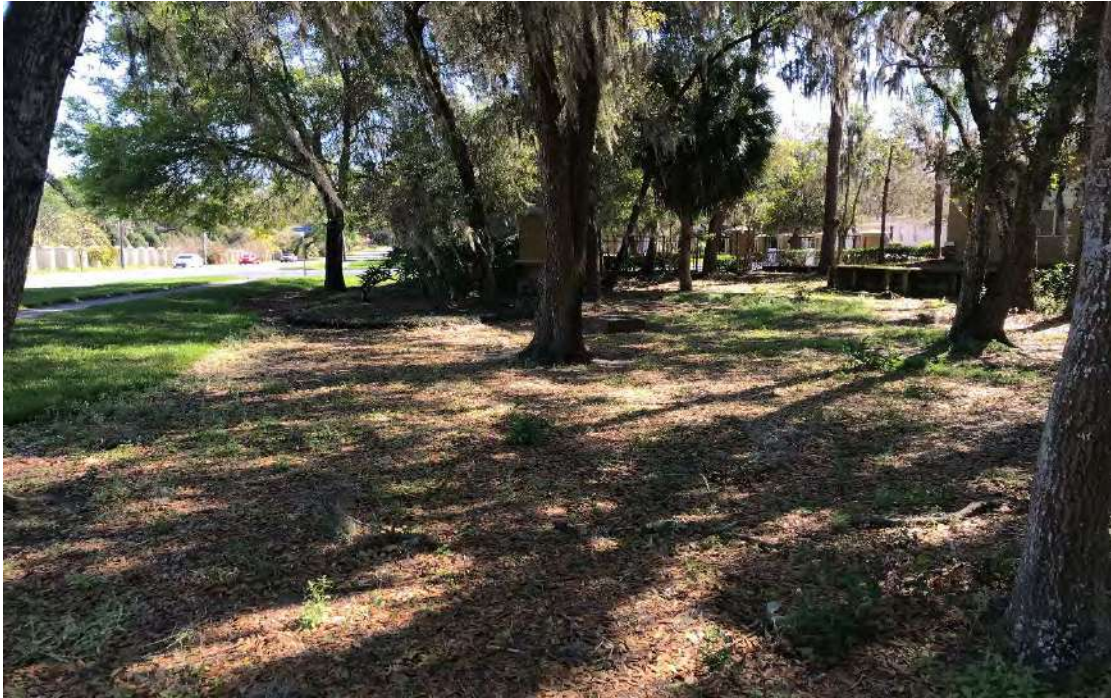
Structural Condition Notes: Skimmer detached from OCS NW Entrance Pond. Sediment build-up around OCS 100 and 300 orifice.
Rating List
Select 3

Photo 1
Easterly View of Pond NW Entrance

Qty	Ordered On	Performed
Maintenance Activity	Miscellaneous Tasks 498	1	02/28/20	
Comments	Attached skimmer to OCS NW within the NW Entrance Pond

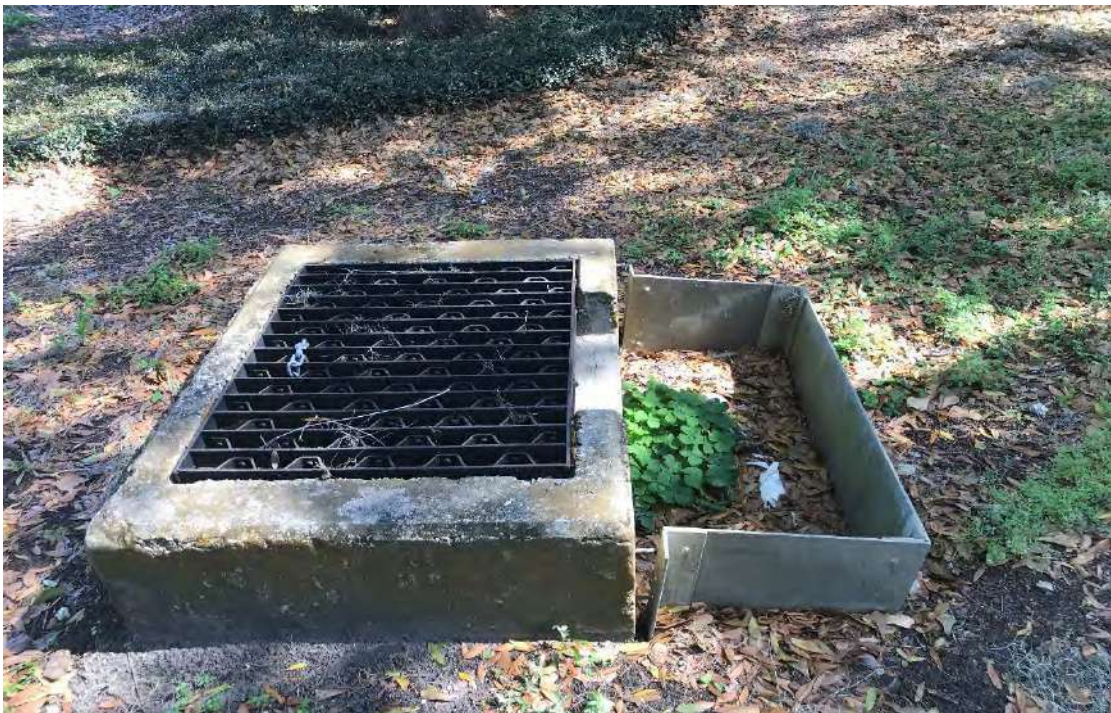
Photo 2
View of OCS NW (detached skimmer)

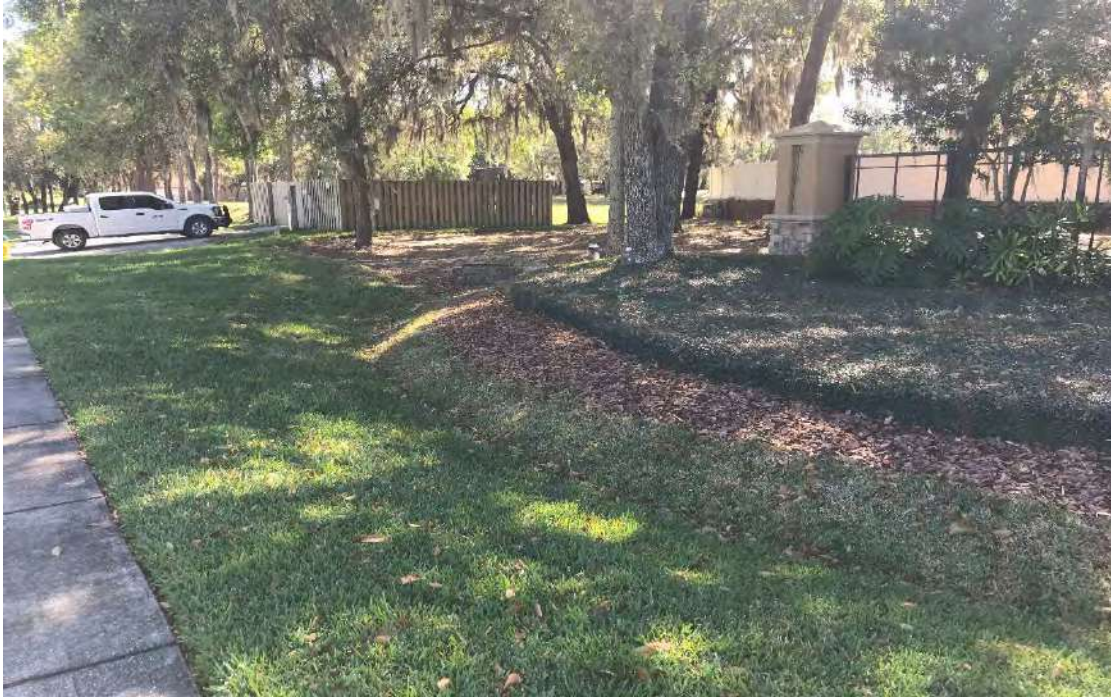
Photo 3
Southeasterly View of NE Entrance Pond

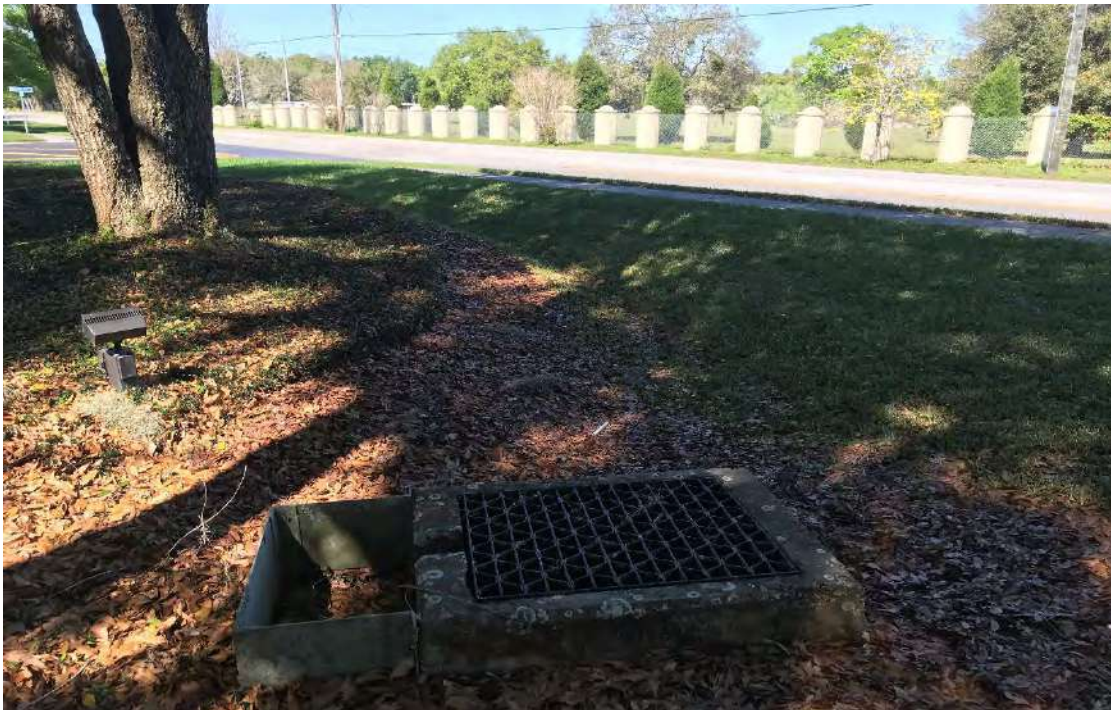
Photo 4
View of OCS NE

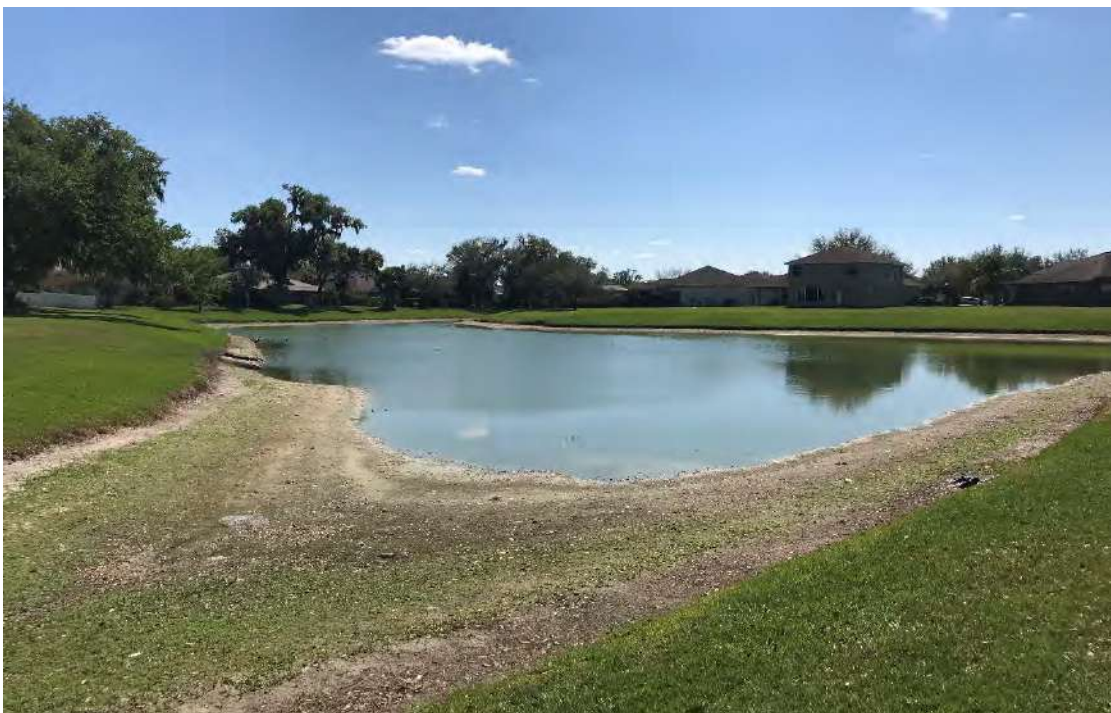
Photo 10
Southeasterly View of the South Half of Pond 30

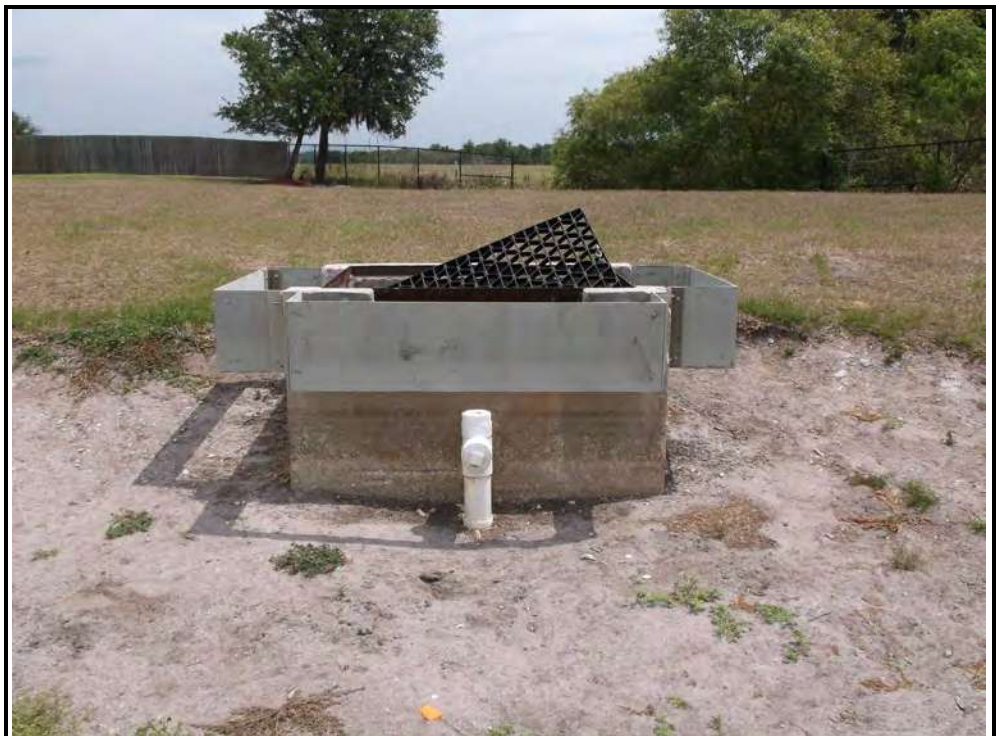
Comments: View of the control structure within Pond 1100

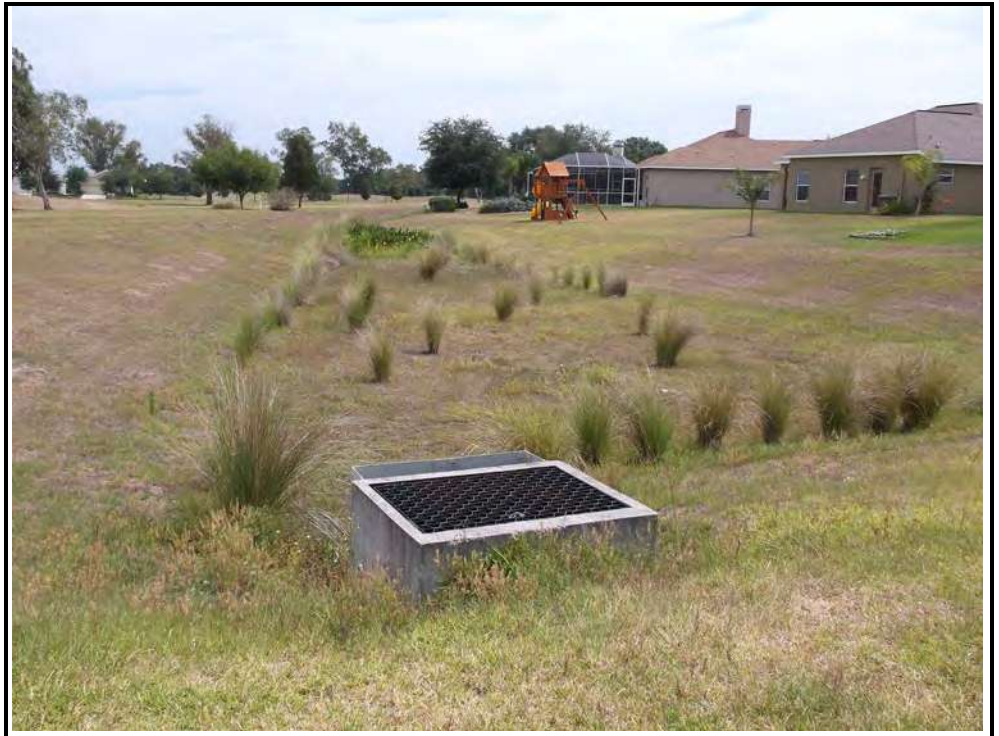
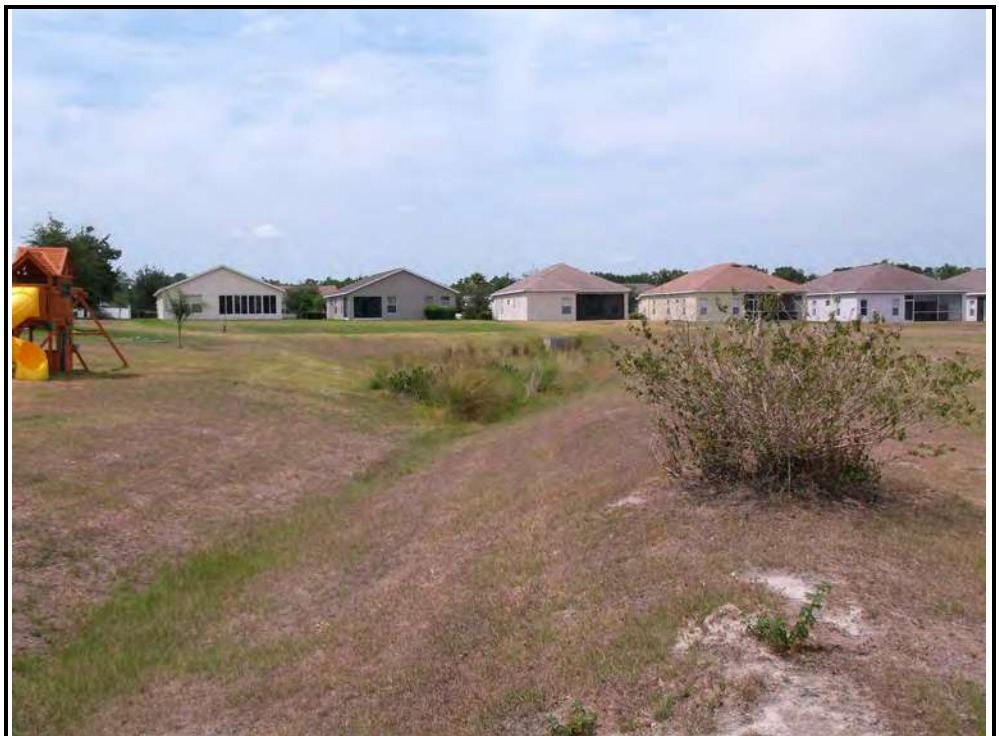
CDD POND EVALUATION			
INSPECTION DATE:	1/11/2024	PERMIT NUMBER:	24679.003
INSPECTED BY:	Jerry Whited	POND PERIMETER:	398 ft
POND NUMBER:	1450	POND AREA:	6,744 sq ft
Full Pond Access:	Yes	Trash Observed:	No
Beneficial Vegetaion Present:	NA	Water Quality:	NA
Tailwater Issue Observed:	No	Water Quality Notes:	Dry Pond
Observed Depth:	NA	Observed Temperature:	NA
POND ELEVATION ANALYSIS			
Treatment Type:	Dry (NA)	Design Bottom Elevation:	110
Weir/Orifice Elevation:	110	Observed Elevation:	110
Skimmer Bottom Elevation:	109.5	Elevation Difference:	0
Pond Elevation Notes: This is a dry pond.			
BANK EROSION AND SCOUR			
Severity Ranking:	NA		
Type of Erosion:	None		
Bank Erosion Notes: Dry Pond - no erosion or shoreline defects observed.			
CONDITION OF POND STRUCTURES (CONTROL STRUCTURES, MITERED END SECTIONS, INLETS)			
Severity Ranking:	Minor		
Type of Damage:	Skimmer Repair		
Structures Notes: One control structure observed with a skimmer that has connection hardware that has failed. Hardware should be replaced on skimmer. One FES observed in operational condition with no defects.

Comments: Northeasterly view of Pond 1450

Comments: Southwesterly view of Pond 1450

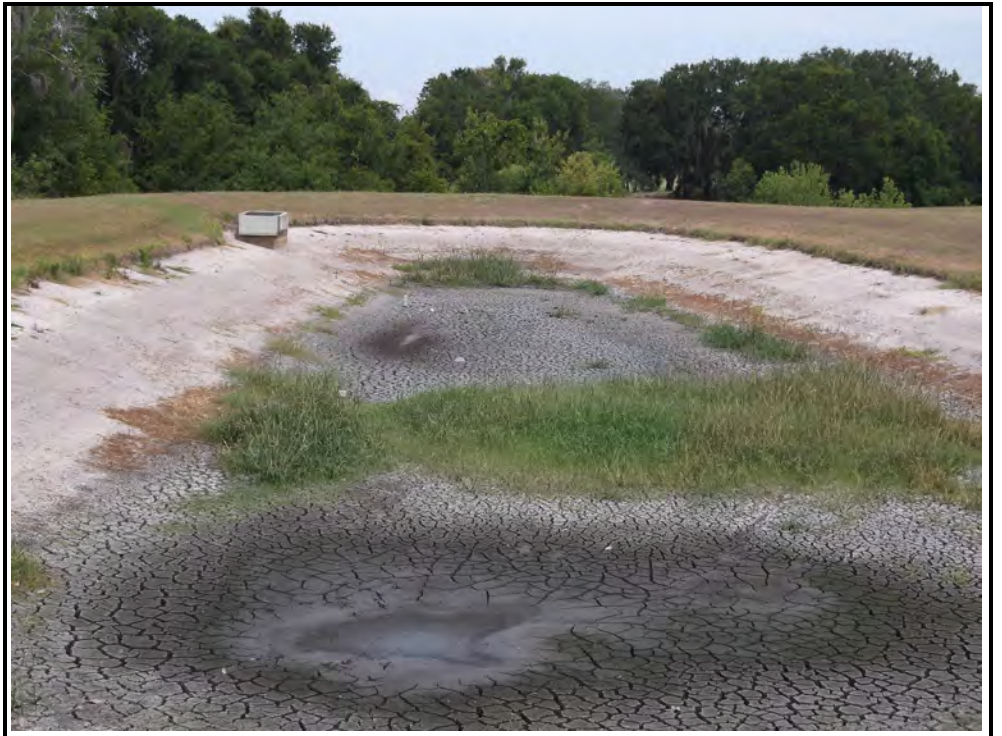
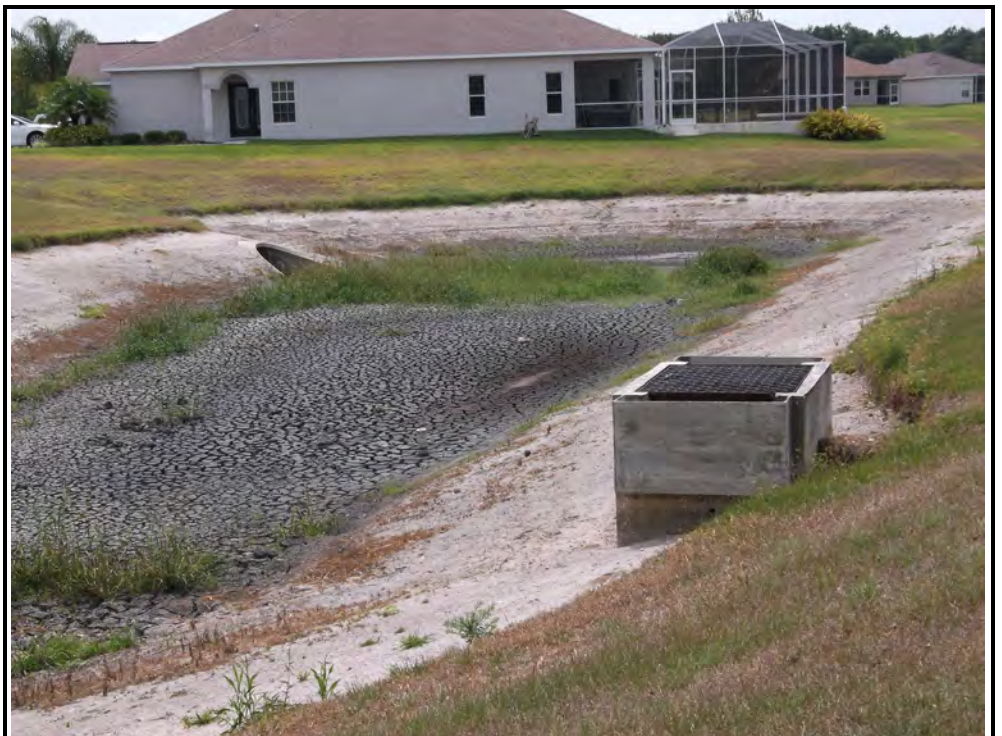
Severity Ranking:	N/A		
Type of Damage:	None		
Structures Notes: One control structure with two skimmers observed to be in operational condition with no defects. One FES completely submerged from view.

Comments: Westerly view of Pond 1475

Comments: Easterly view of Pond 1475

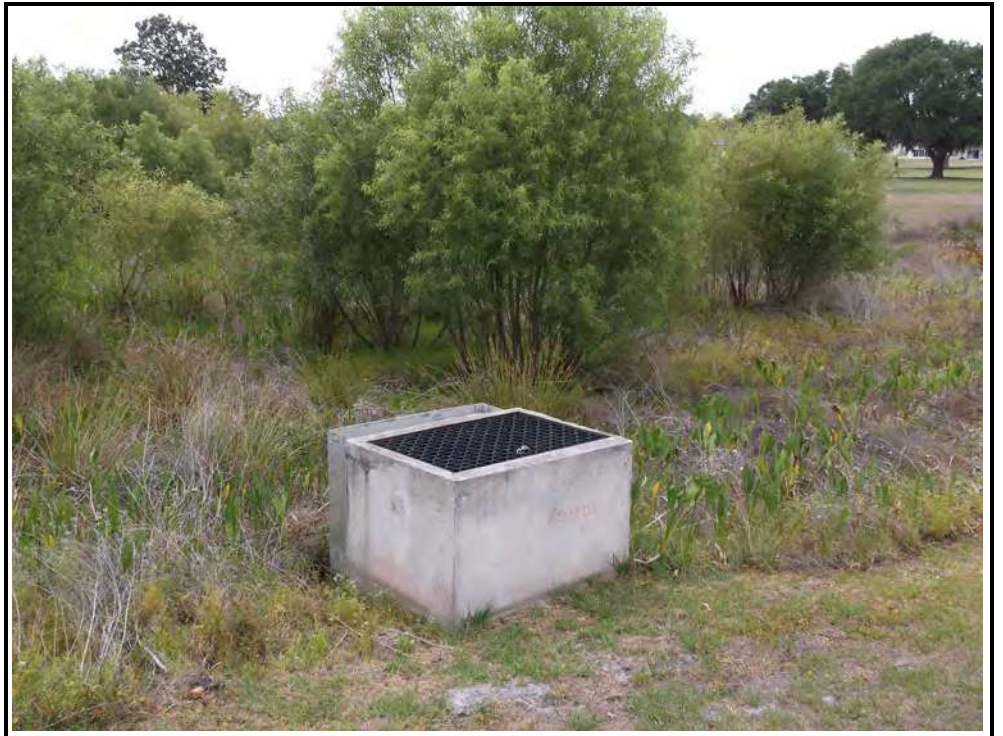
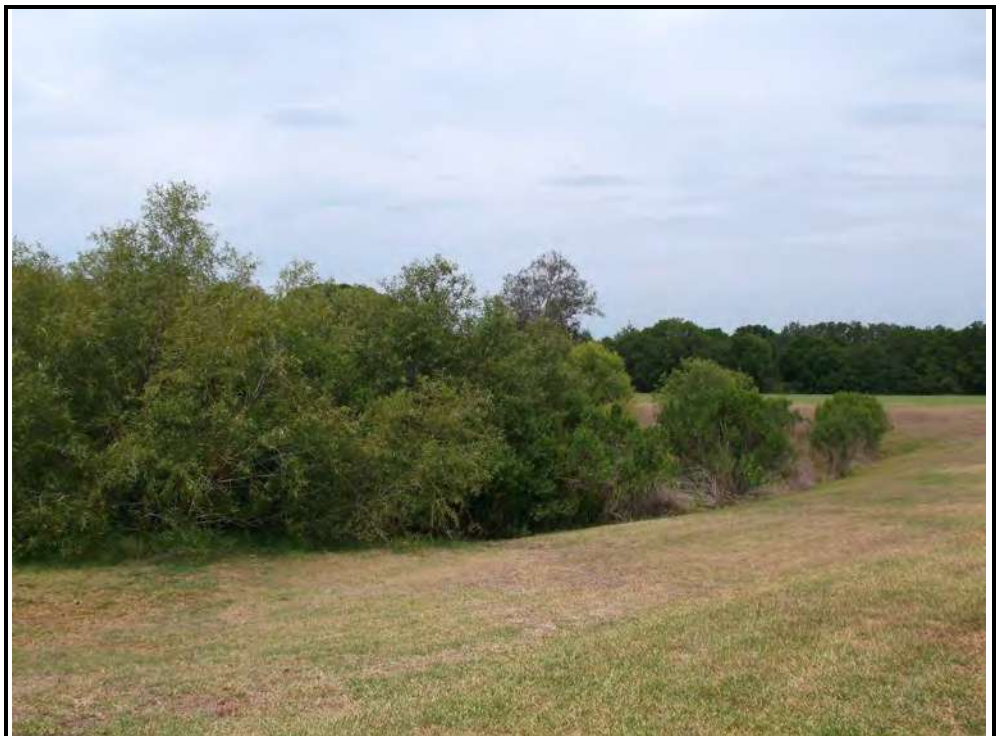
CDD POND EVALUATION			
INSPECTION DATE:	1/11/2024	PERMIT NUMBER:	24679.003
INSPECTED BY:	Jerry Whited	POND PERIMETER:	620 ft
POND NUMBER:	1500	POND AREA:	21,733 sq ft
Full Pond Access:	Yes	Trash Observed:	Yes
Benifitial Vegetaion Present:	Np	Water Quality:	NA
Tailwater Issue Observed:	No	Water Quality Notes:	NA
Observed Depth:	0	Observed Temperature:	NA
POND ELEVATION ANALYSIS			
Treatment Type:	Dry Filter	Design Bottom Elevation:	100
Weir/Orifice Elevation:	102.1	Observed Bottom Elevation:	100
Skimmer Bottom Elevation:	101.6	Elevation Difference:	0
Pond Depth Notes: This is a dry pond.			
BANK EROSION AND SCOUR			
Severity Ranking:	NA		
Type of Erosion:	None		
Bank Erosion Notes: Dry pond. No erosion or shoreline defects observed.			
CONDITION OF POND STRUCTURES (CONTROL STRUCTURES, MITERED END SECTIONS, INLETS)			
Severity Ranking:	Moderate		
Type of Damage:	FES covered and concrete failing.		
Structures Notes: FES on NE side of pond appears to have been covered up or buried by debris. There is a need to uncover the FES to avoid issues with the curb inlets flooding the adjacent streets. Historical records show this pond was not overgrown like this until after 2016. One control structure observed to have cracks in the concrete and skimmer hardware is completely exposed on one side. Vegetation must be cleared to provide access to MES & Control Structure. Recommend full pond quarterly maintenance.

Comments: Southeasterly view of Pond 1500

Comments: Southwesterly view of Pond 1500

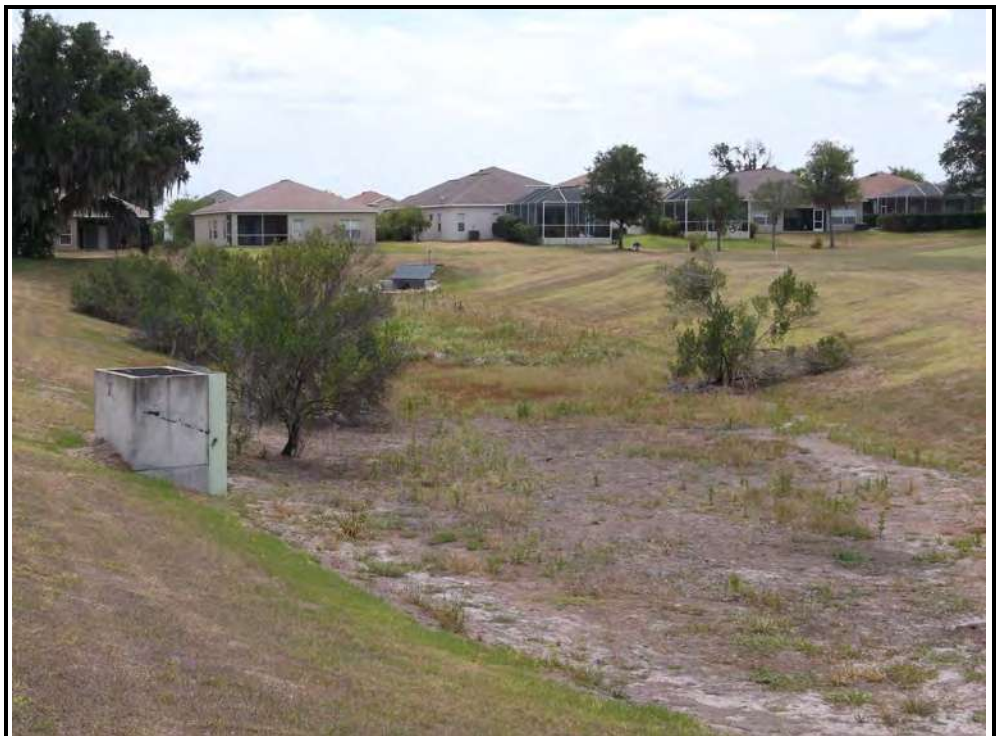
Comments: Easterly view of Pond 1350

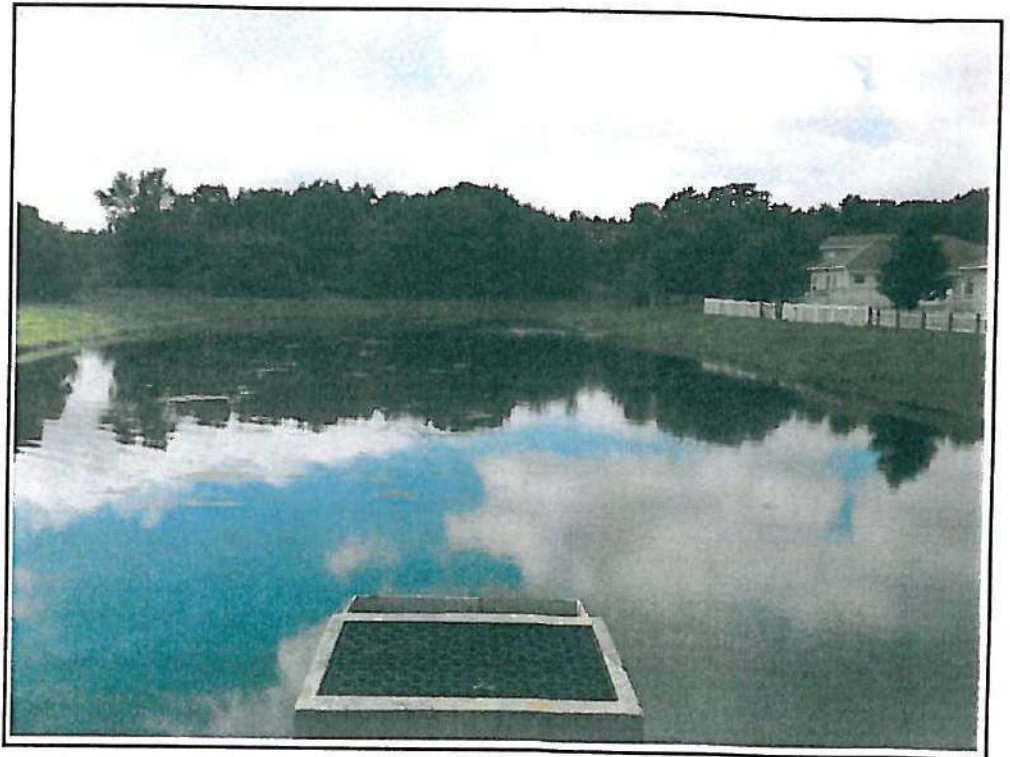
Comments: Southerly view of Pond 1000 (CDD # 8)

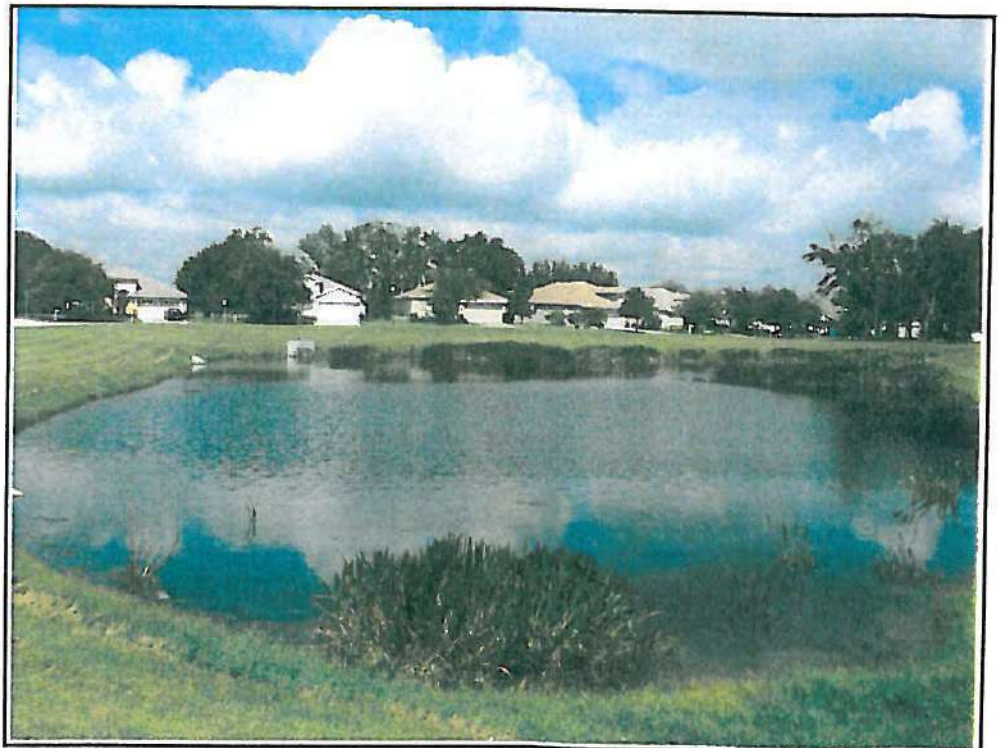
Comments: Northwesterly view of Pond 1200 (CDD # 12)

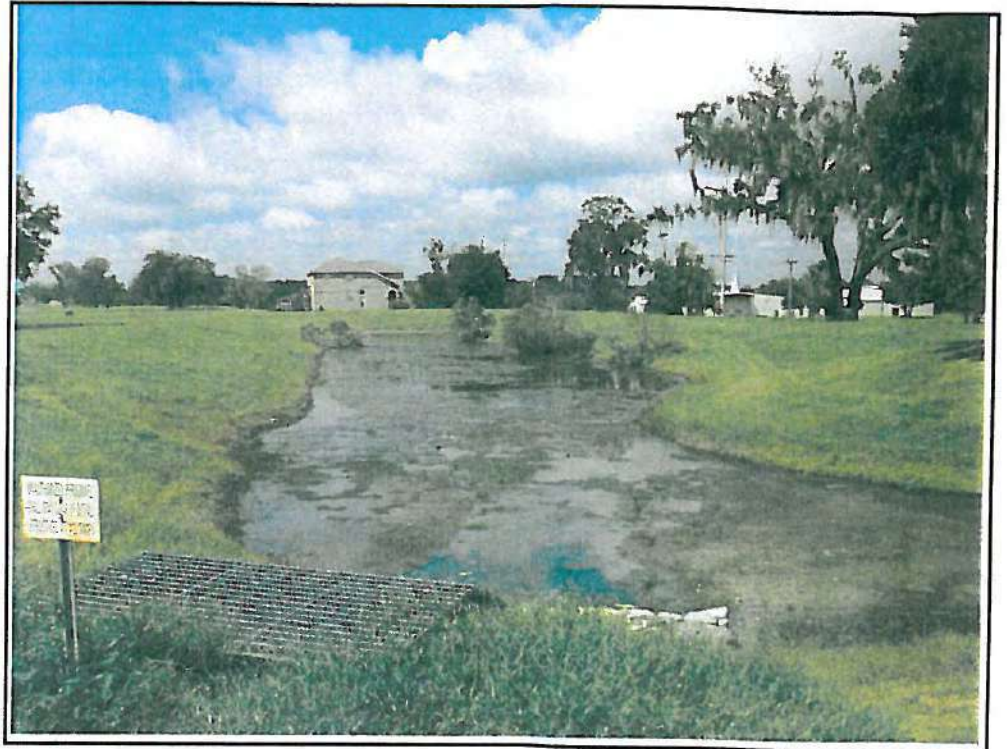
Comments: Westerly view of Pond 1350 (CDD # 13)

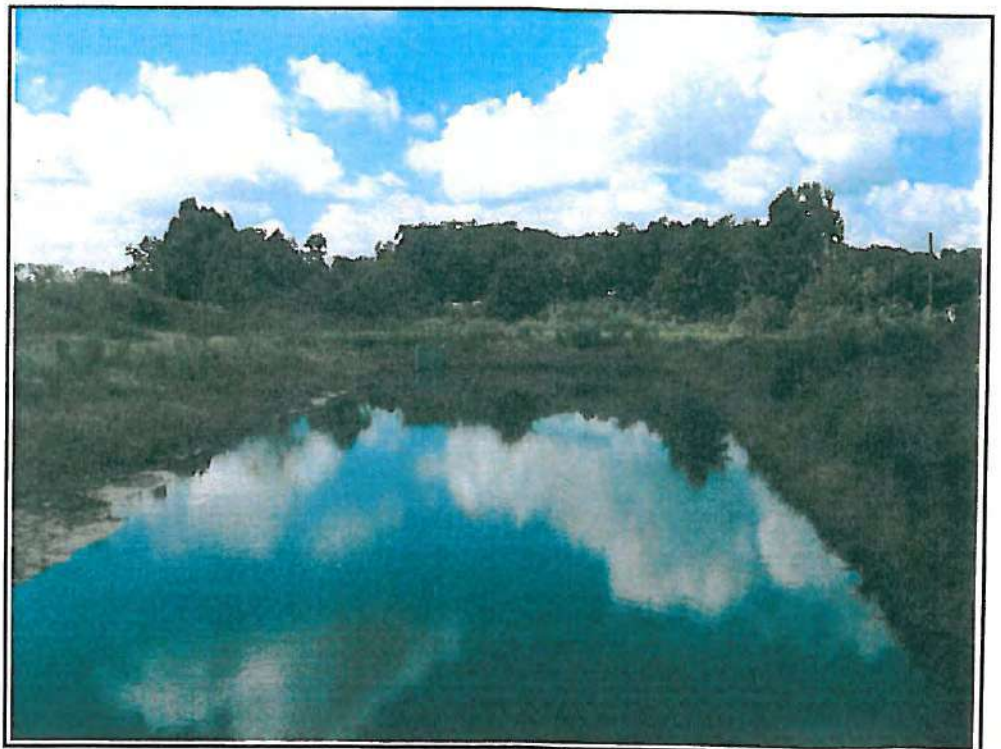
Comments: Easterly view of Pond 1300 (CDD # 14)

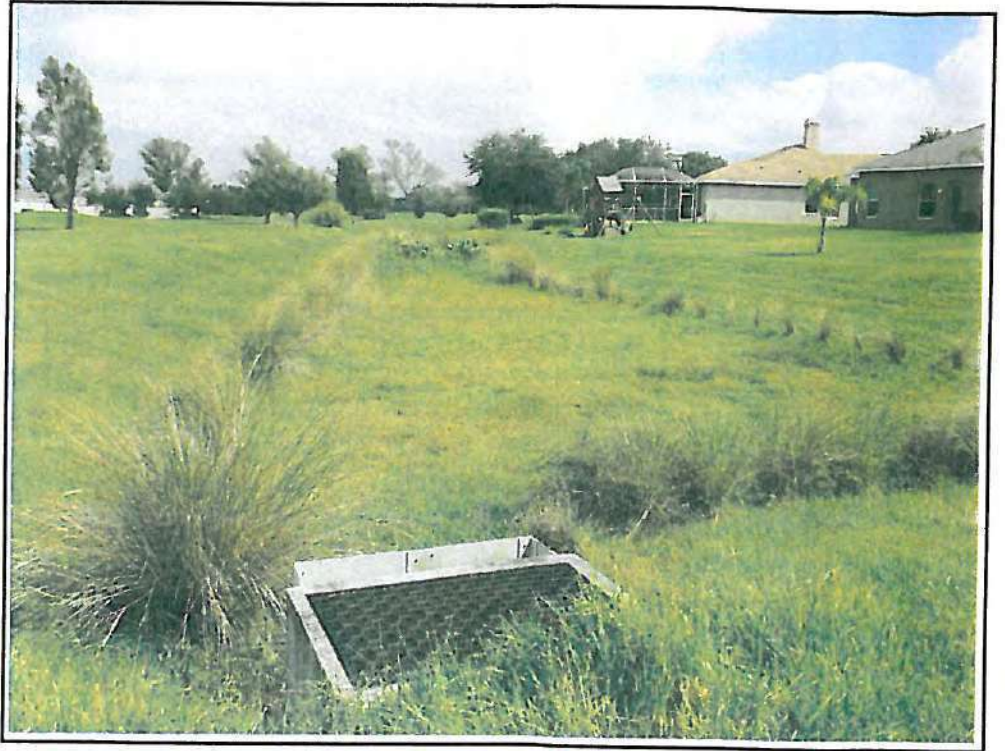
Comments: Northerly view of
Pond 1450 (CDD # 15)

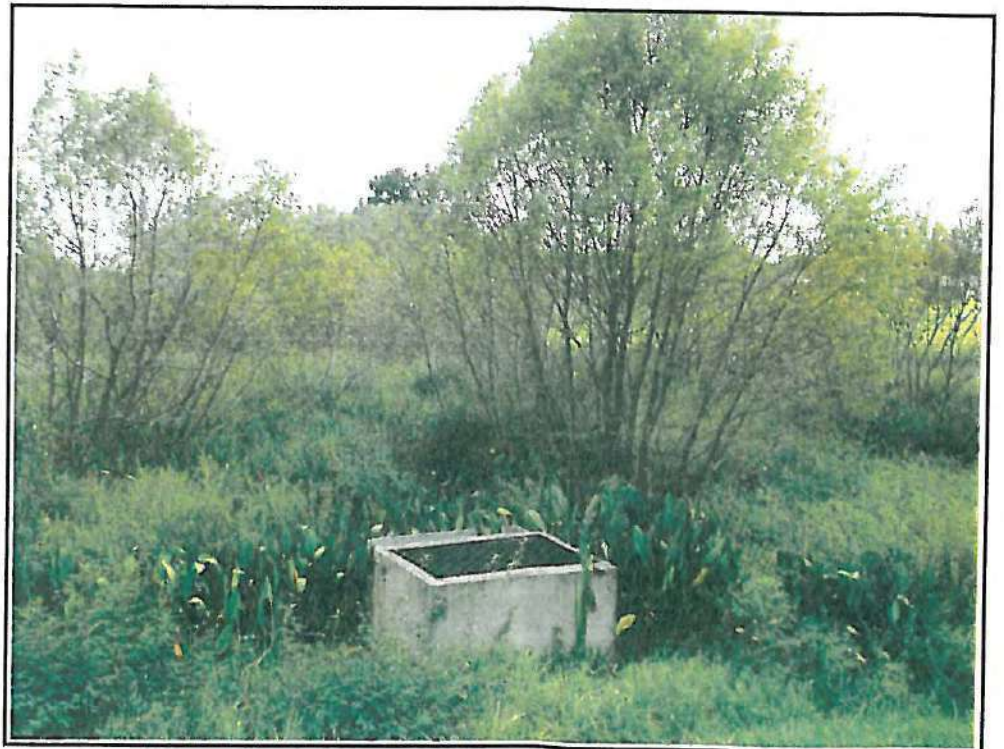
Comments: Easterly view of
Pond 1500 (CDD # ?)

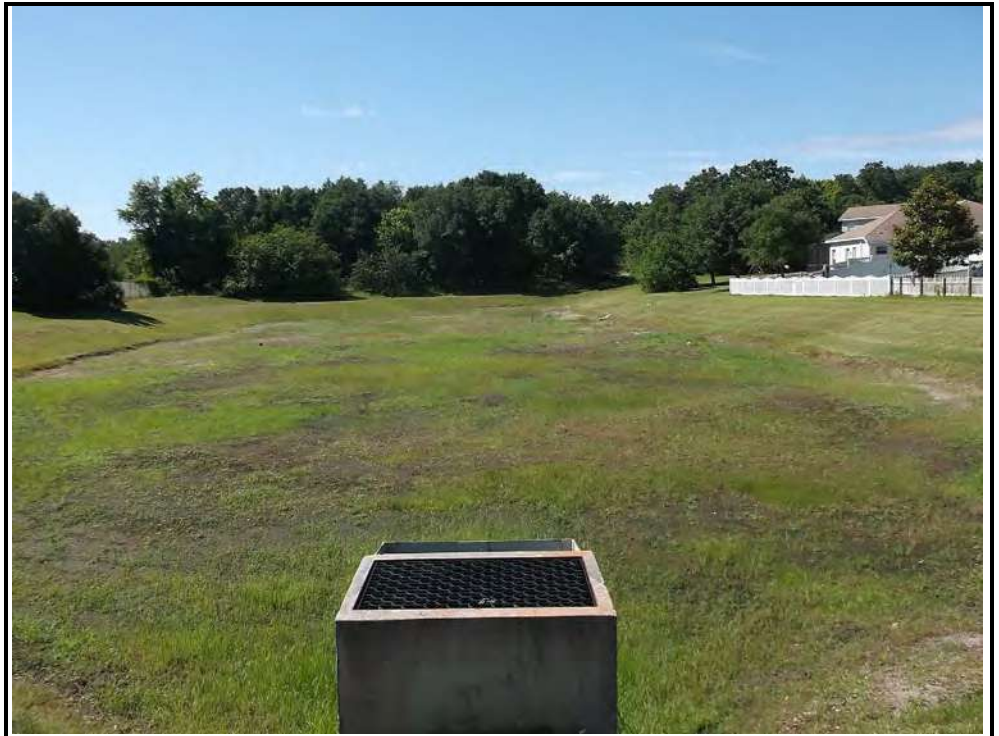
Comments: Southerly view of Pond 1000 (CDD # 8)

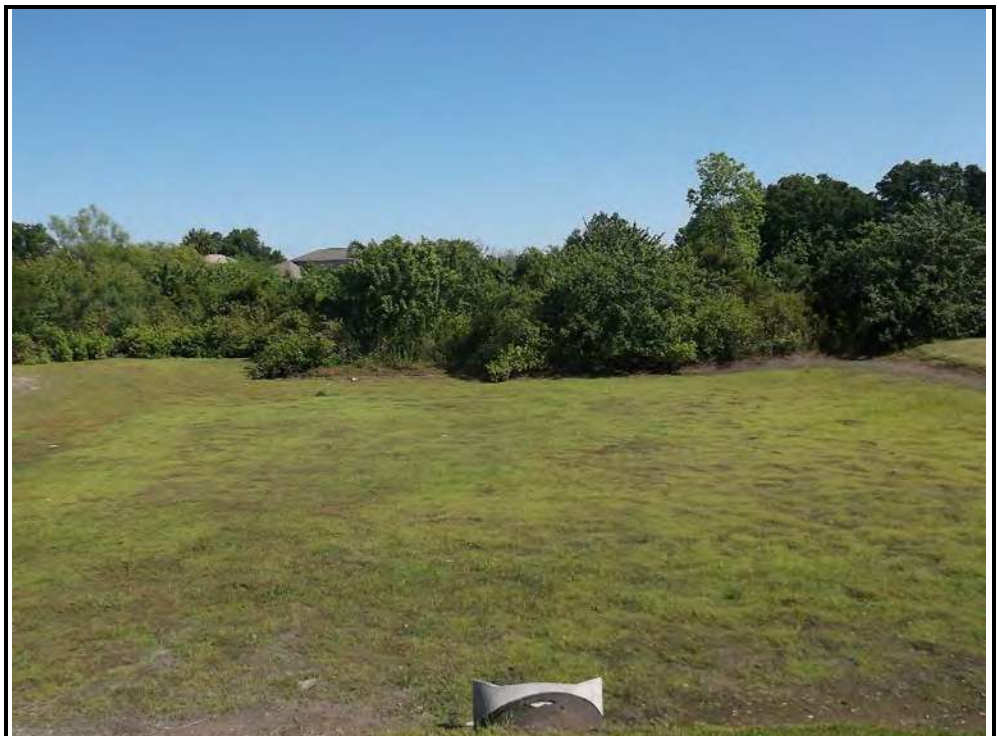
Comments: Northerly view of Pond 1000 (CDD # 10)

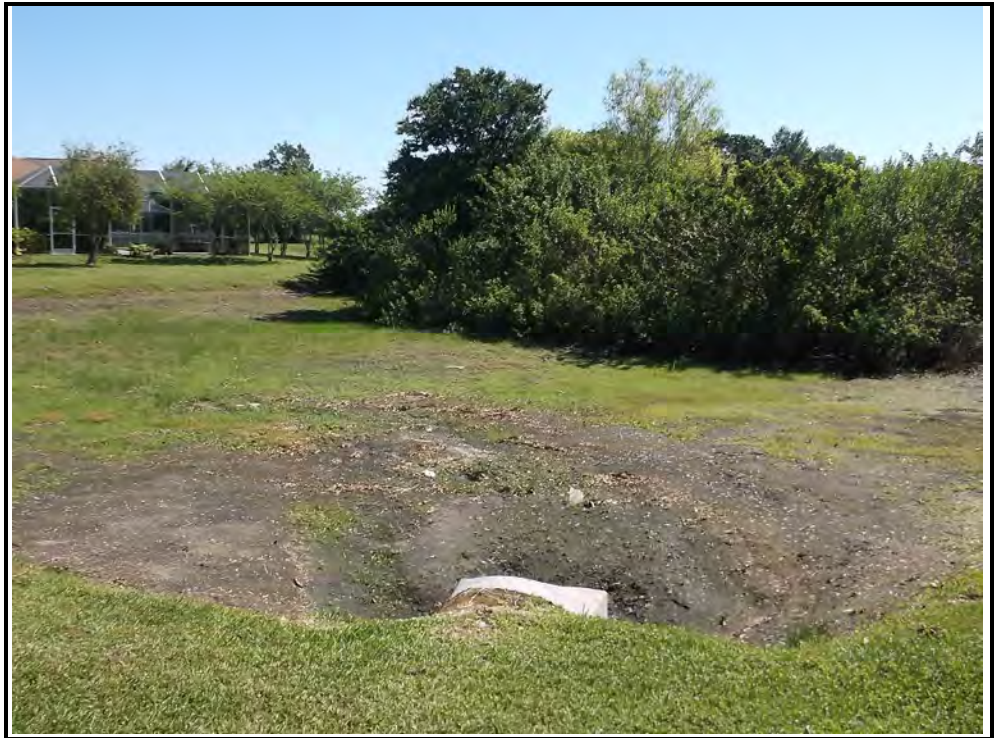
Comments: Northerly view of the south end of Pond 1100 (CDD # 9)

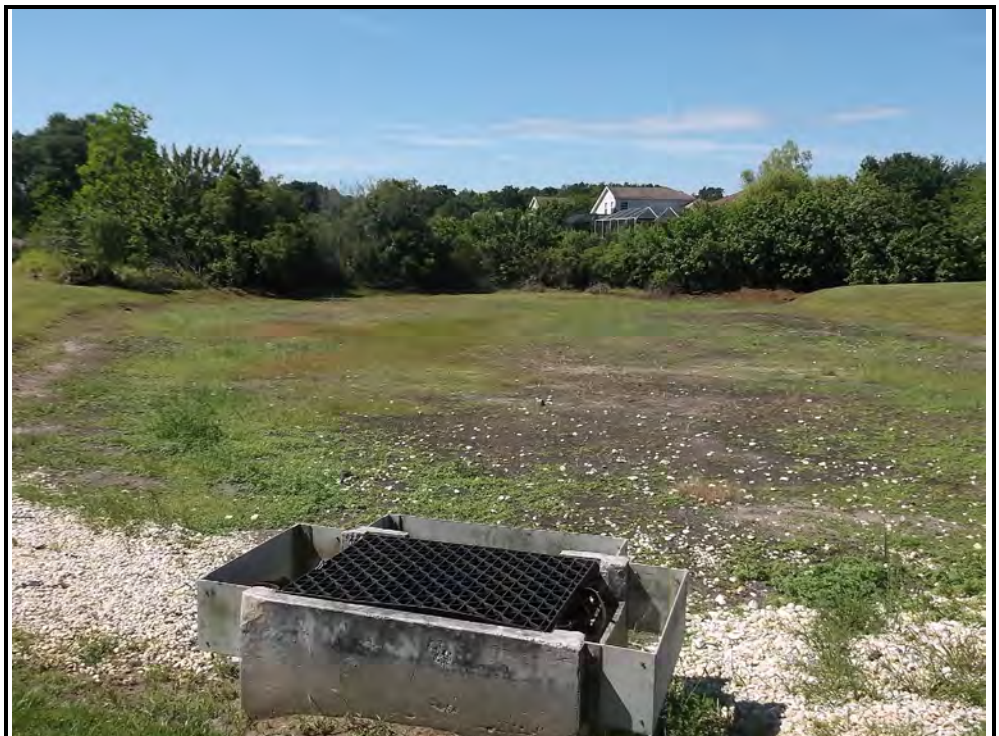
Comments: Southerly view of Pond 1100 (CDD #11)
