**DIAMOND HILL
COMMUNITY DEVELOPMENT DISTRICT**

**FEBRUARY 12, 2024
AGENDA PACKAGE**

- 1.0 ERP PERMIT INFORMATION
- 2.0 PERMIT INSPECTION HISTORY
- 3.0 RECONCILIATION OF CURRENT DEFECT OBSERVATIONS
- 4.0 POND ELEVATION SUMMARY
- 5.0 INSPECTION REPORTS & PICTURES

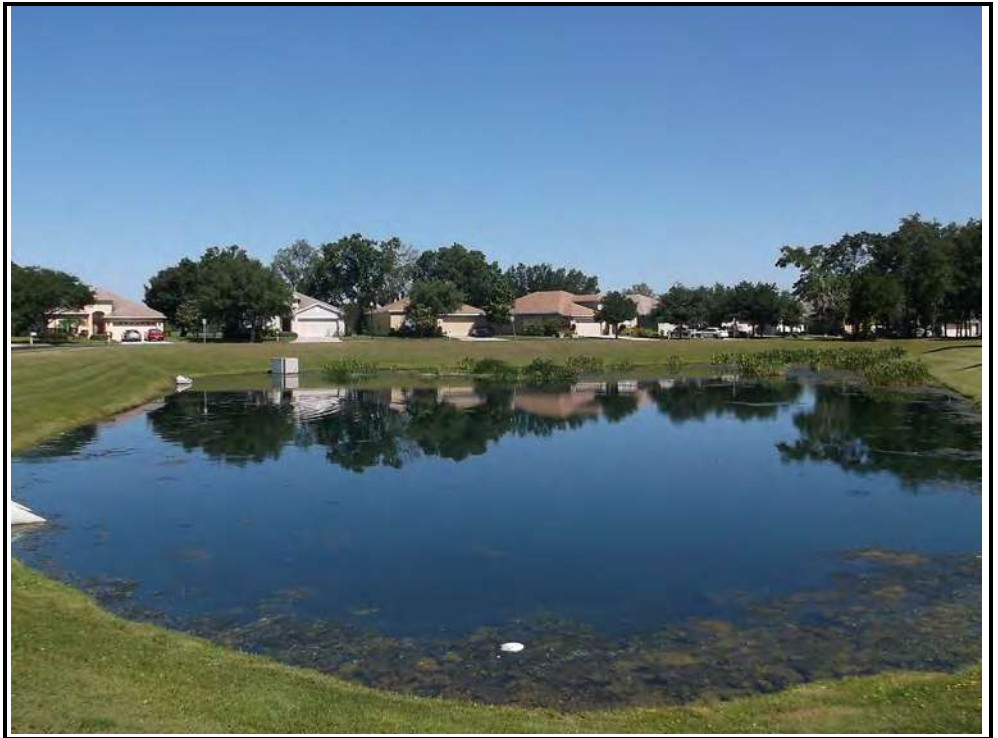
Comments: Northwesterly view of Pond 1200 (CDD # 12)

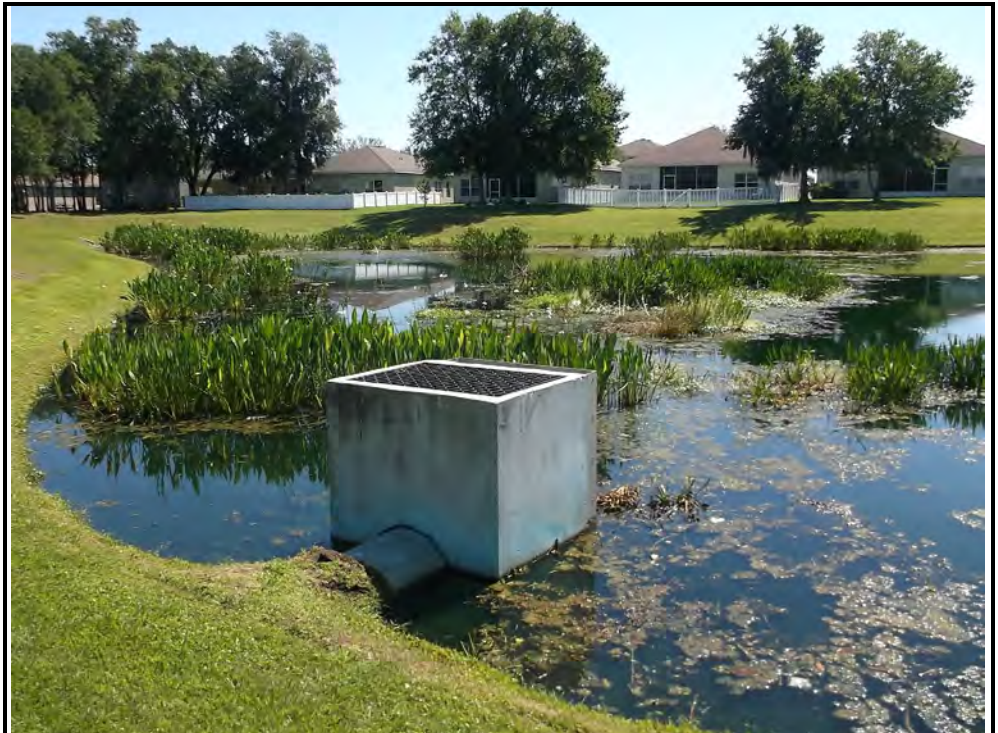
Comments: Northeasterly view of Pond 1200

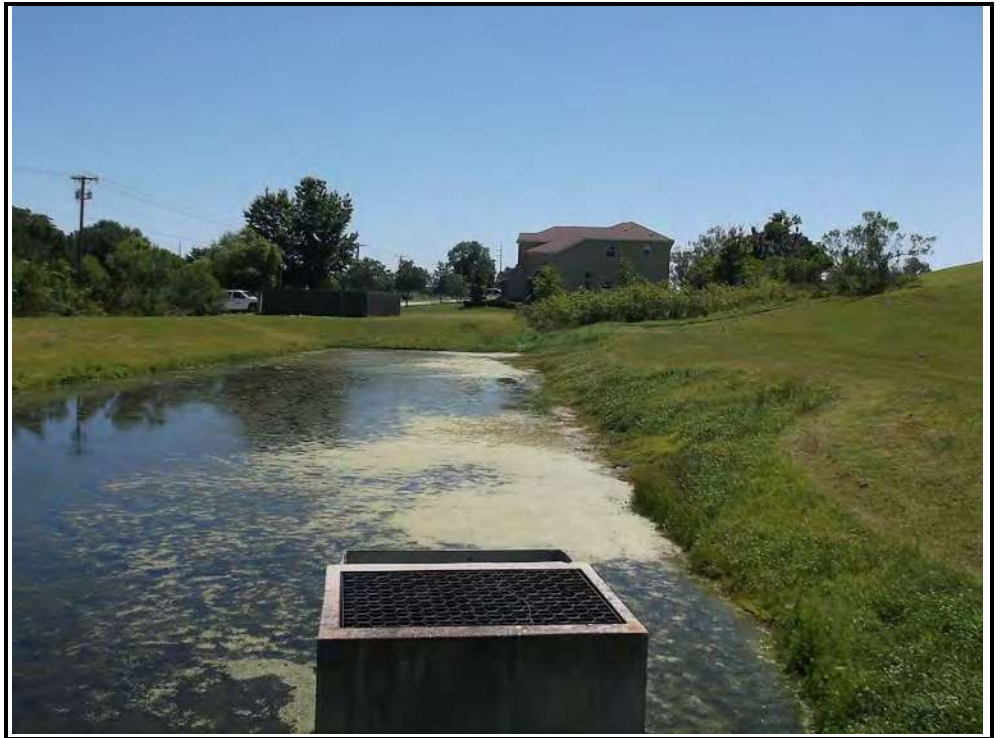
Comments: Easterly view of Pond 1300 (CDD #14)

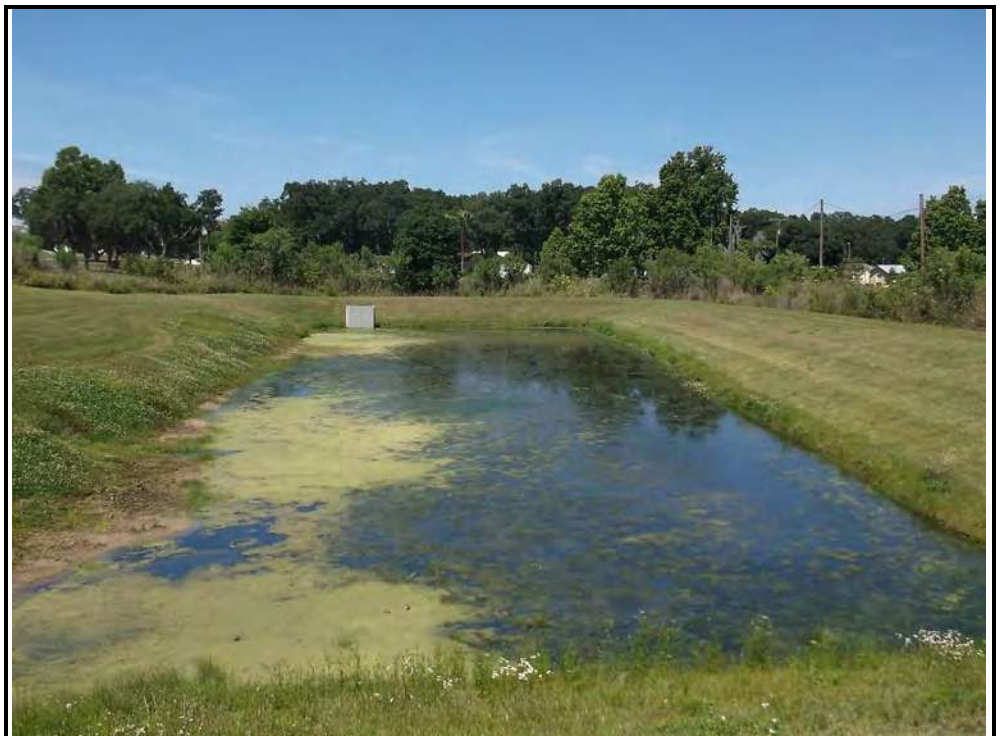
Comments: Westerly view of Pond 1300 (CDD #14)

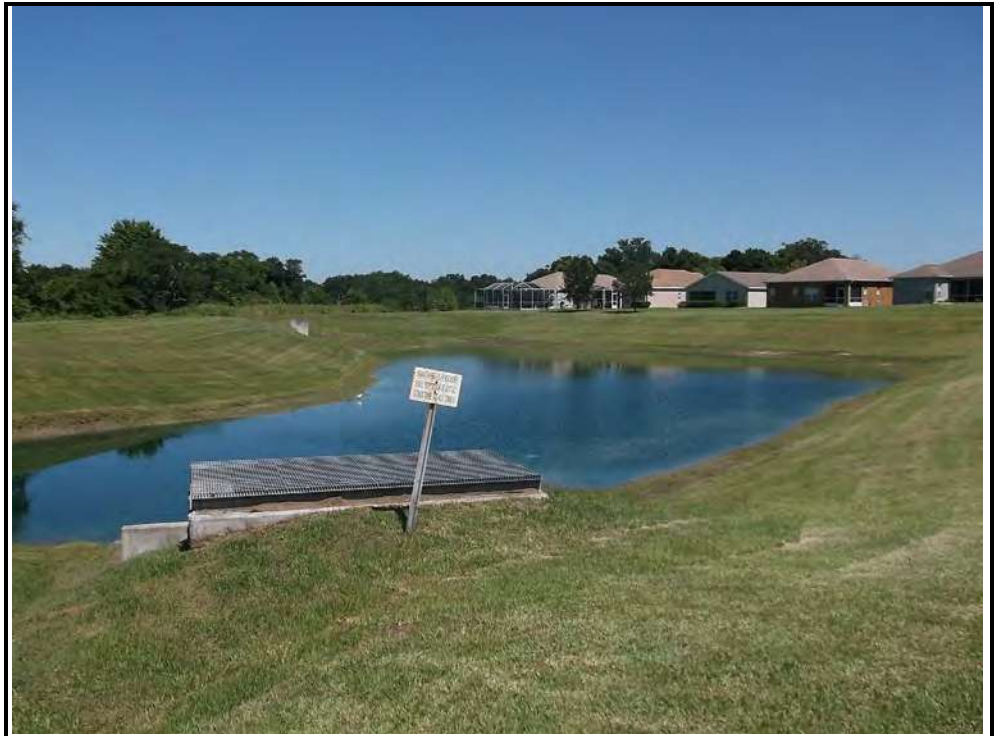
Comments: Northwesterly view of Pond 1400 (CDD #6)

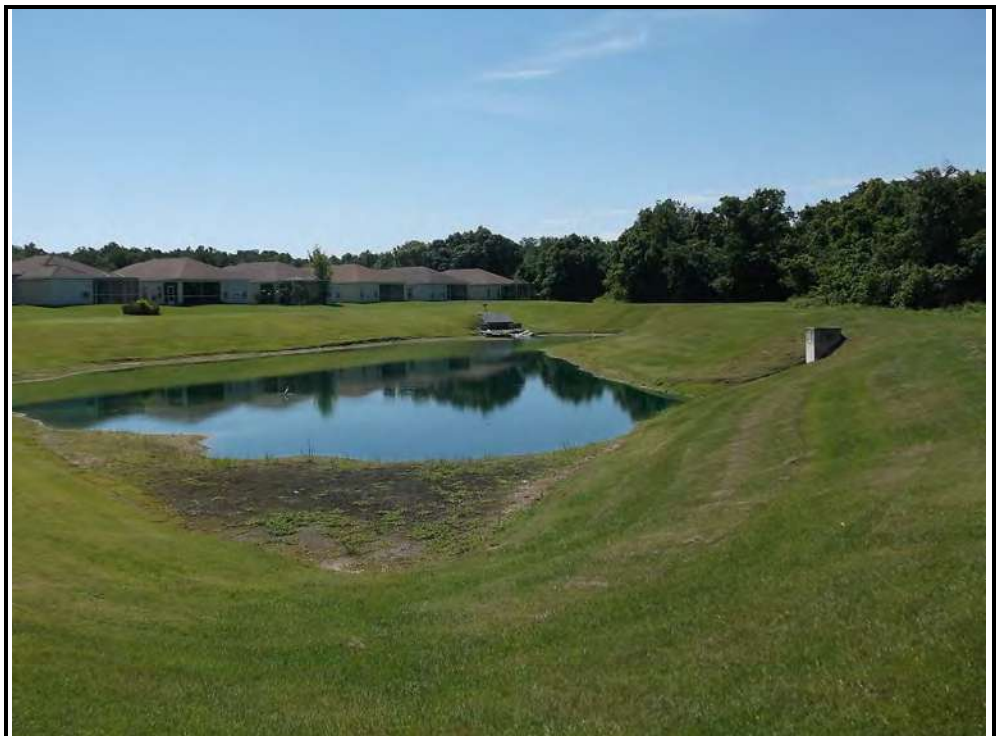
Comments: Southeasterly view of Pond 1400

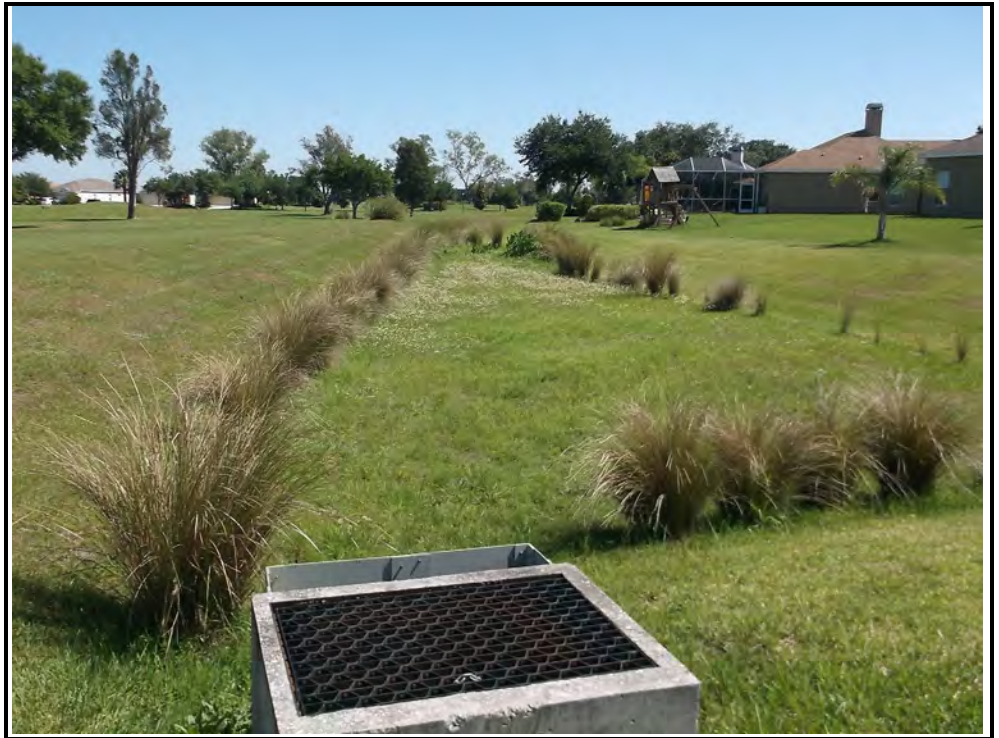
Comments: Northeasterly view of Pond 1450 (CDD #15)

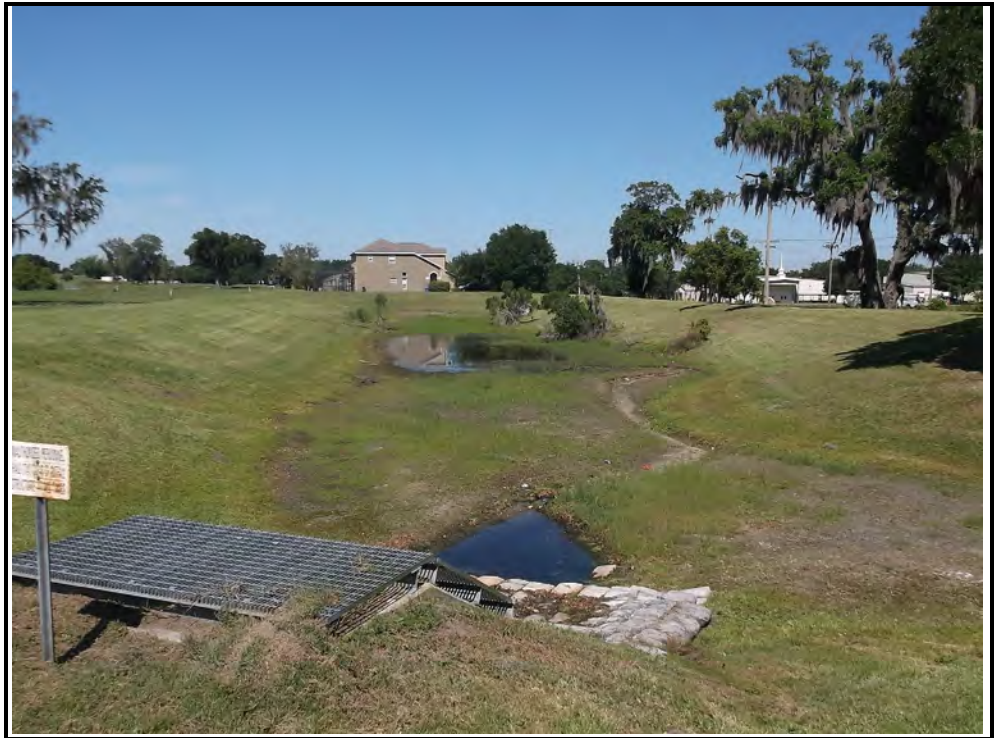
Comments: Westerly view of Pond 1350 (CDD # 13)

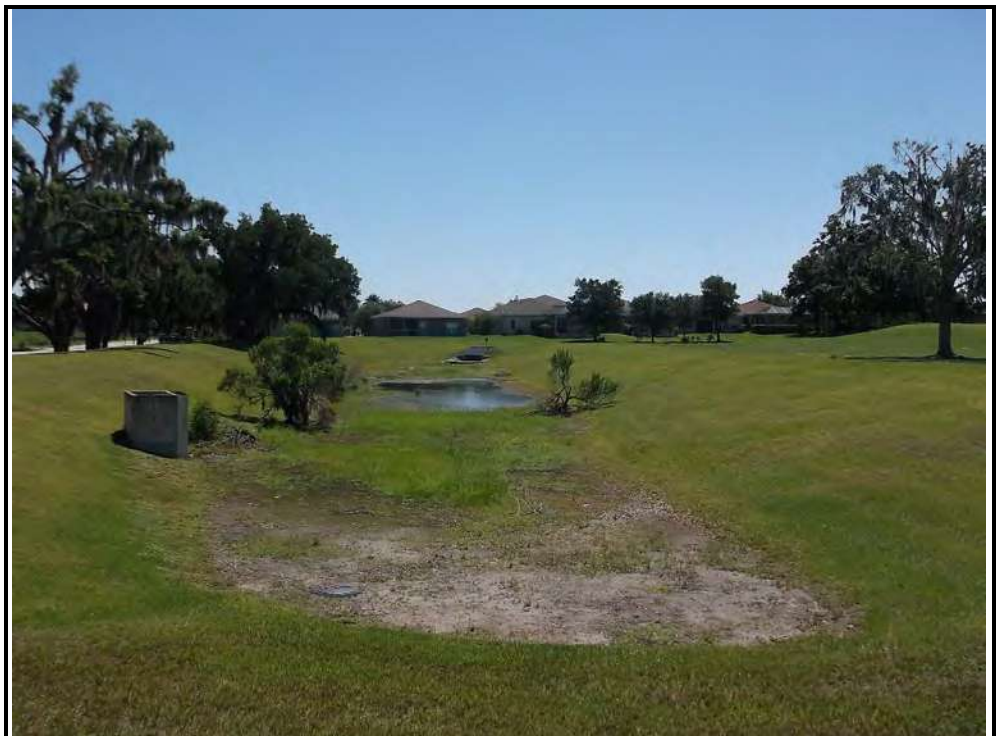
Comments: Easterly view of Pond 1350 (CDD # 13)

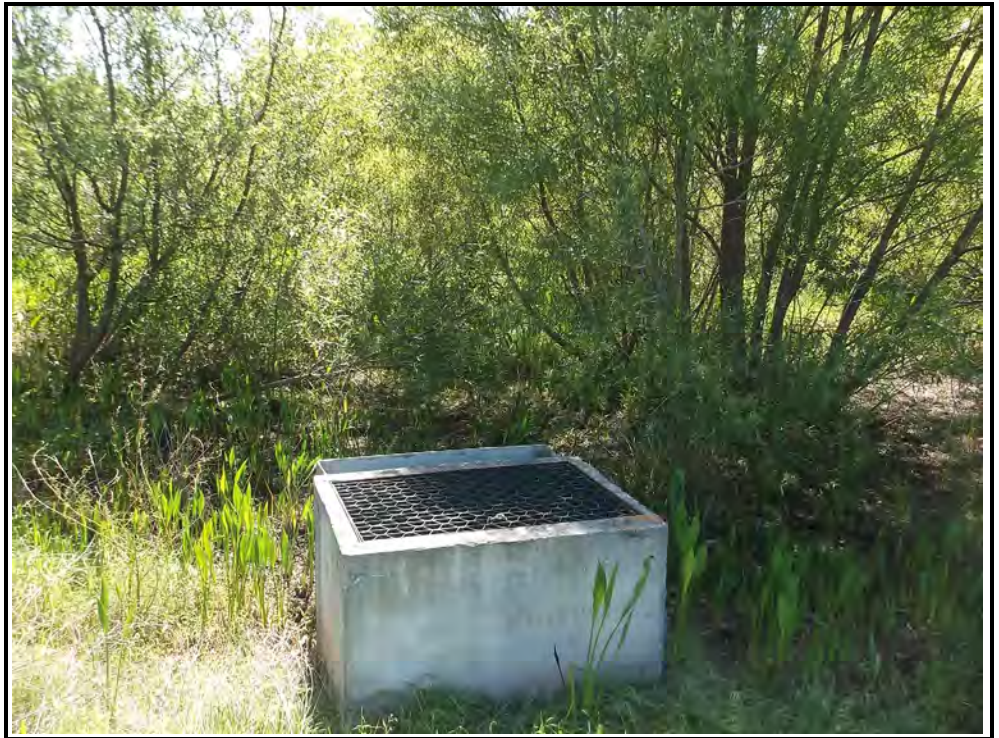
Comments: Southeasterly view of Pond 1500

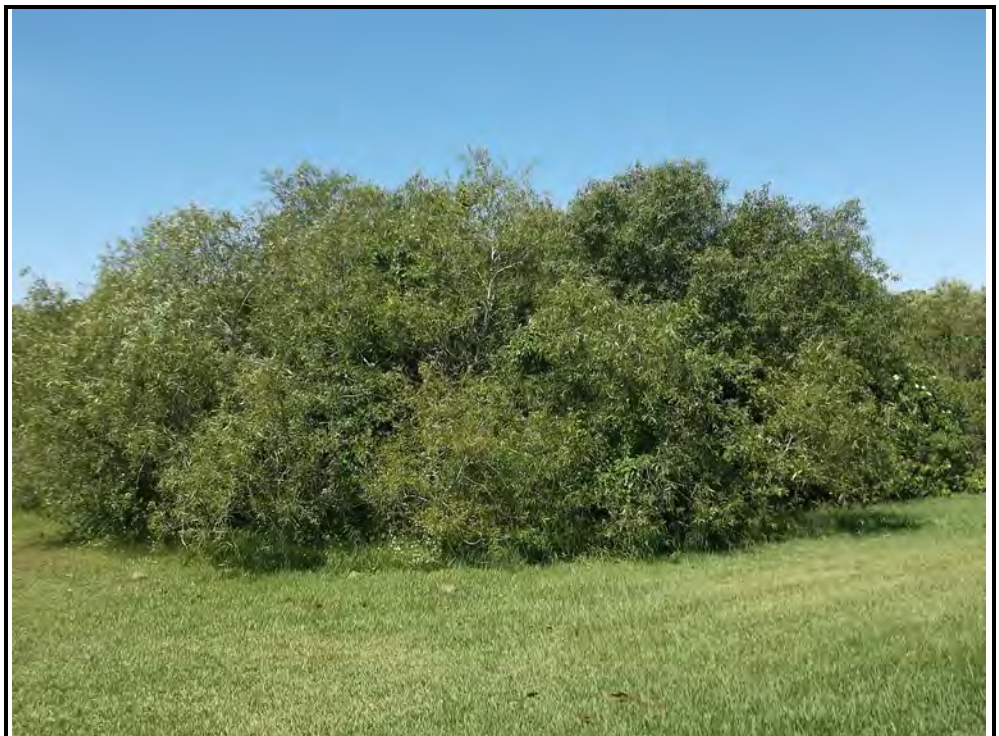
Comments: Southwesterly view of Pond 1500

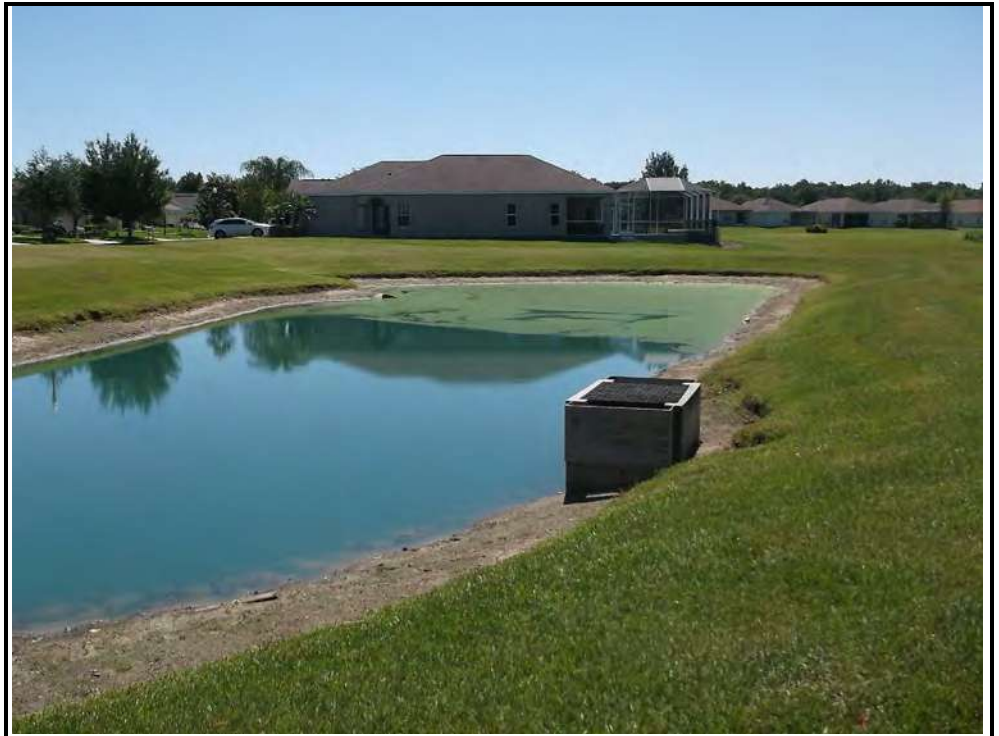
Comments: Easterly view of Pond 1475 (CDD #7)

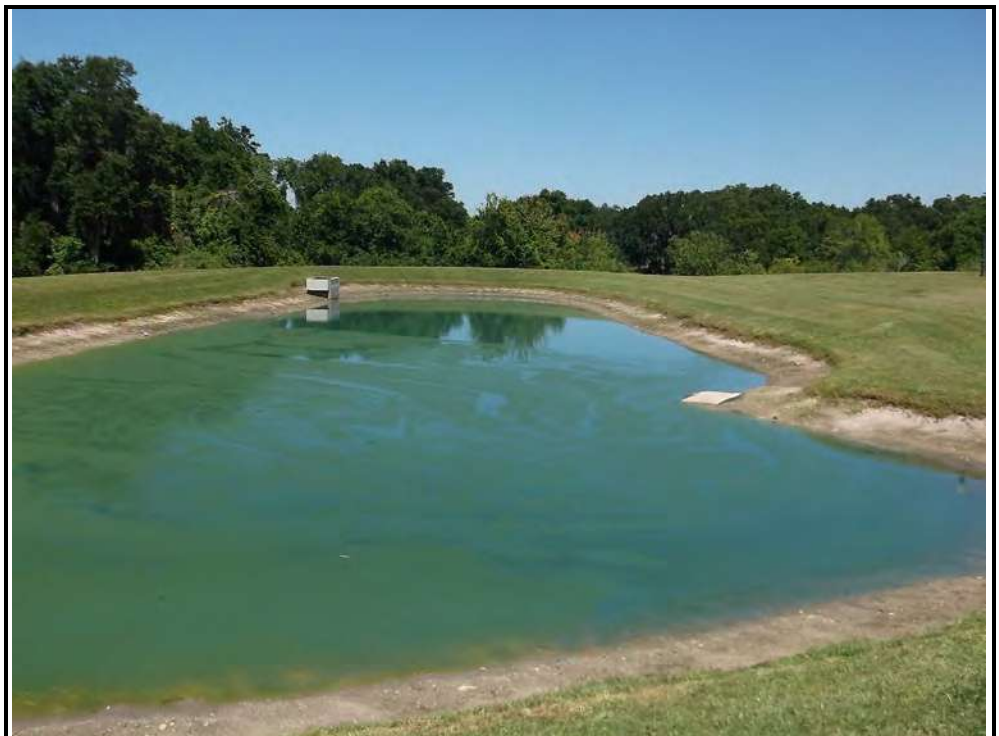
Comments: Westerly view of Pond 1475

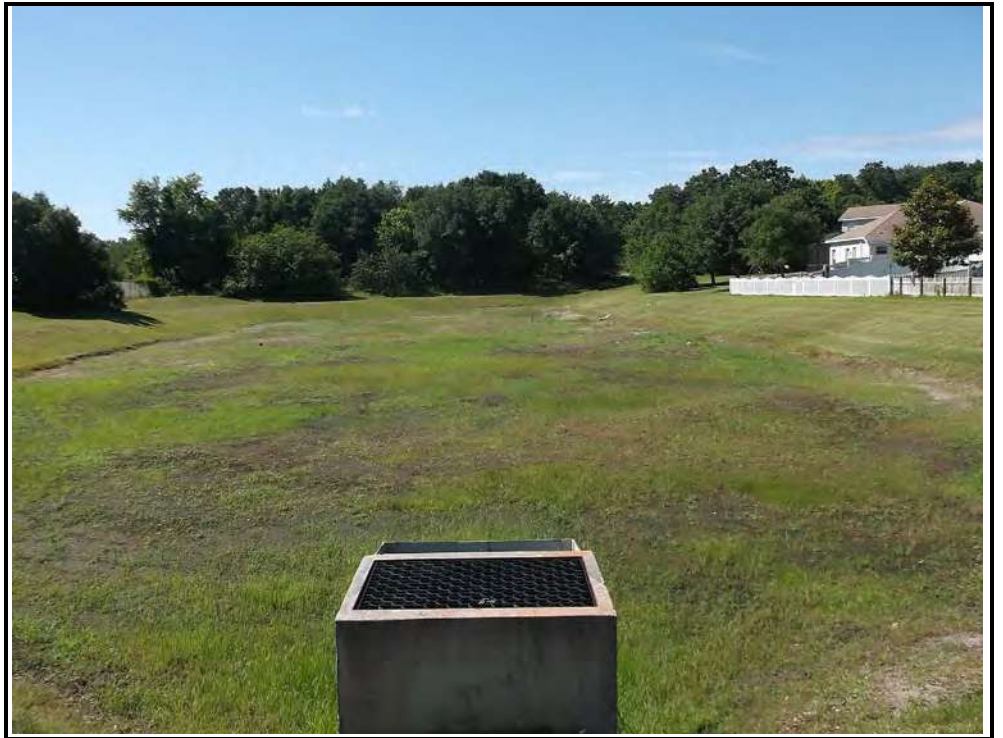
Comments: Southerly view of Pond 1000 (CDD # 8)

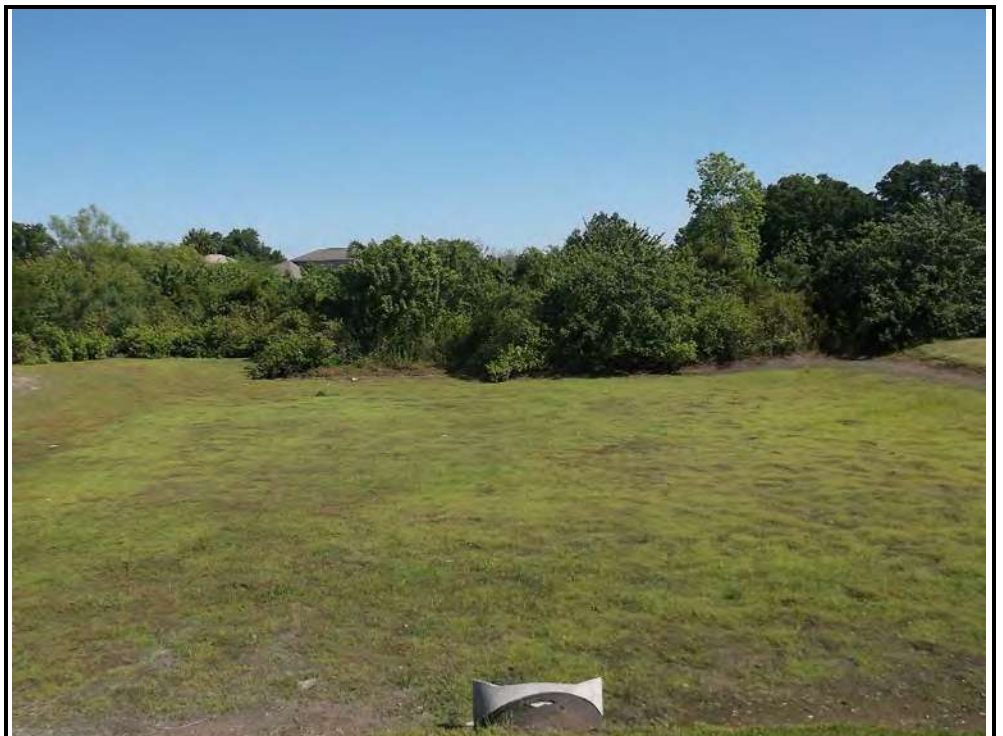
Comments: Northerly view of Pond 1000 (CDD # 10)

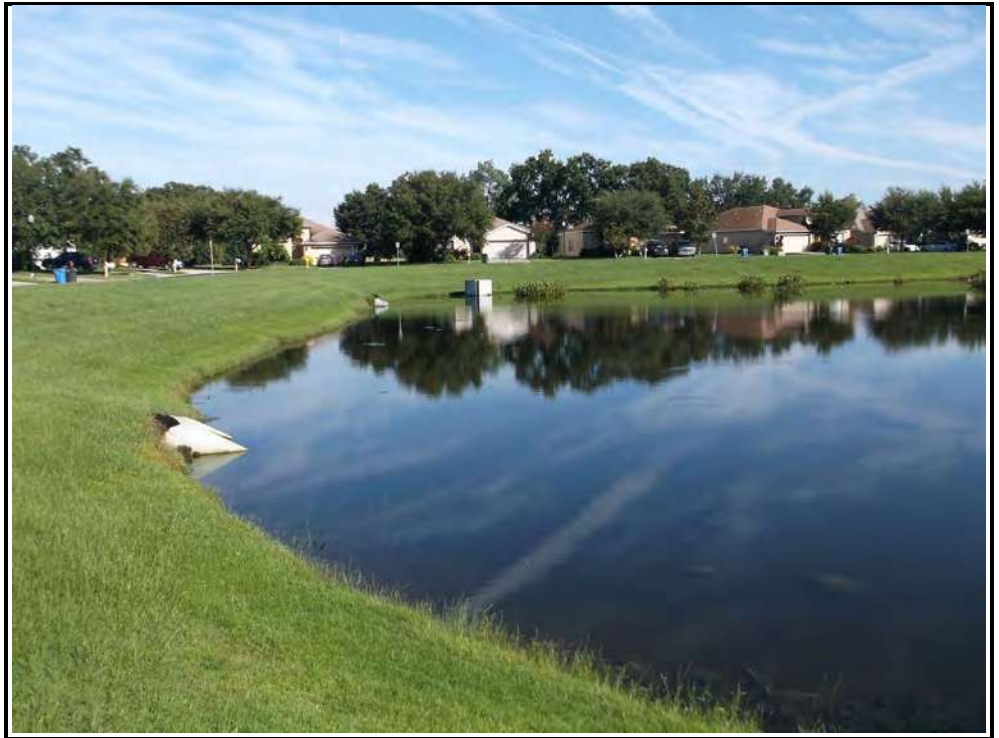
Comments: Northwesterly view of Pond 1200 (CDD # 12)

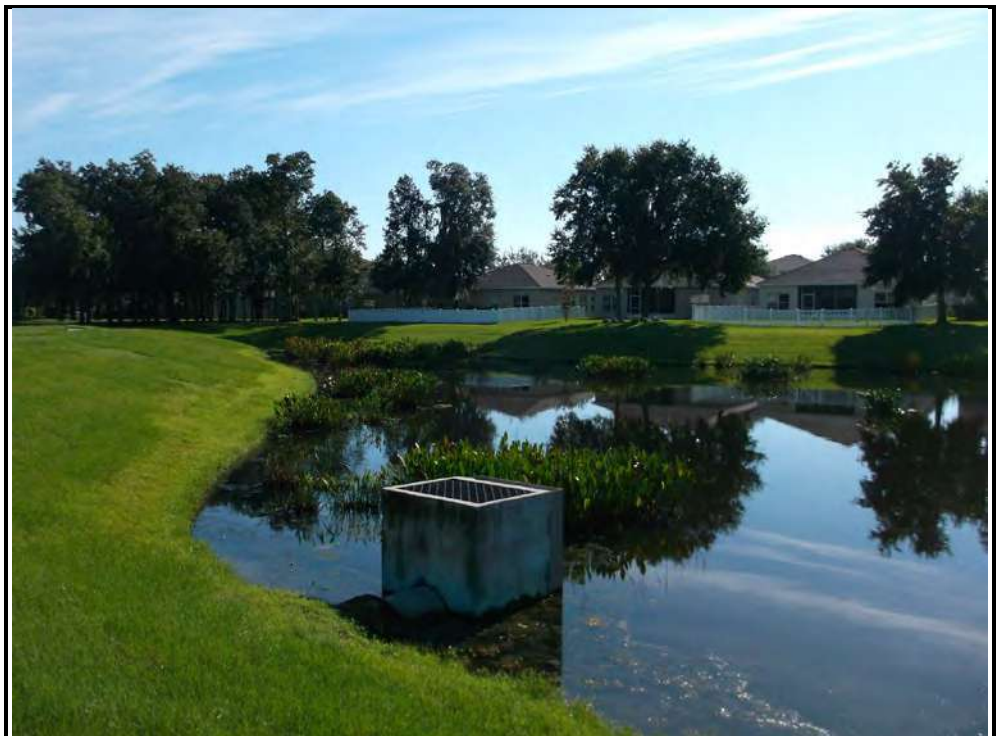
Comments: Northeasterly view of Pond 1200

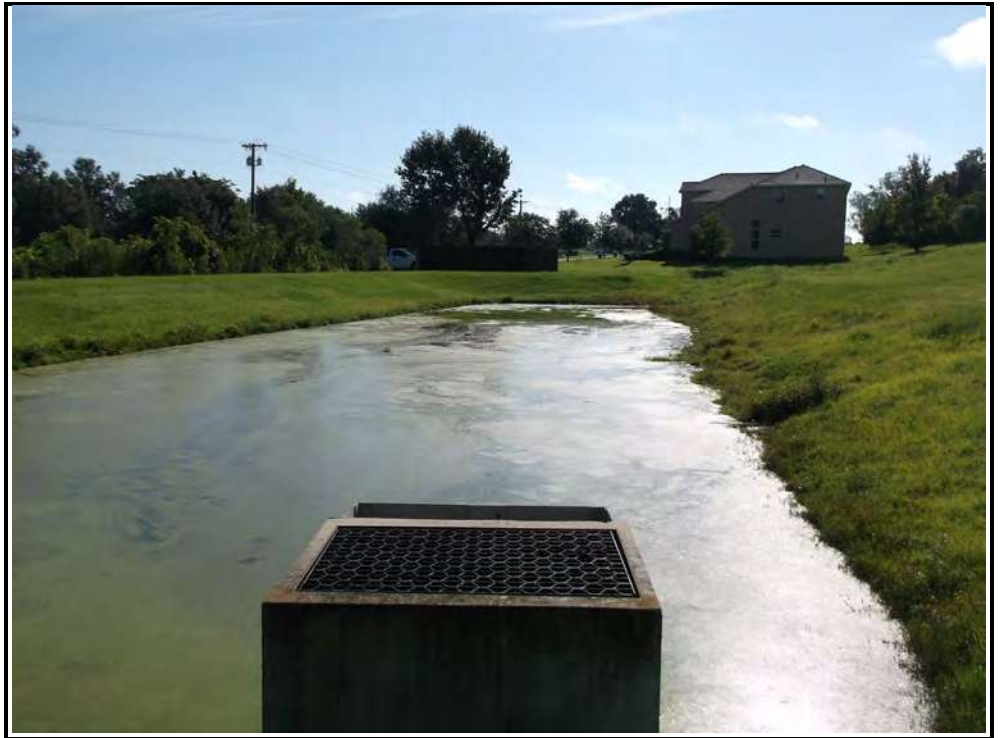
Comments: Easterly view of Pond 1300 (CDD #14)

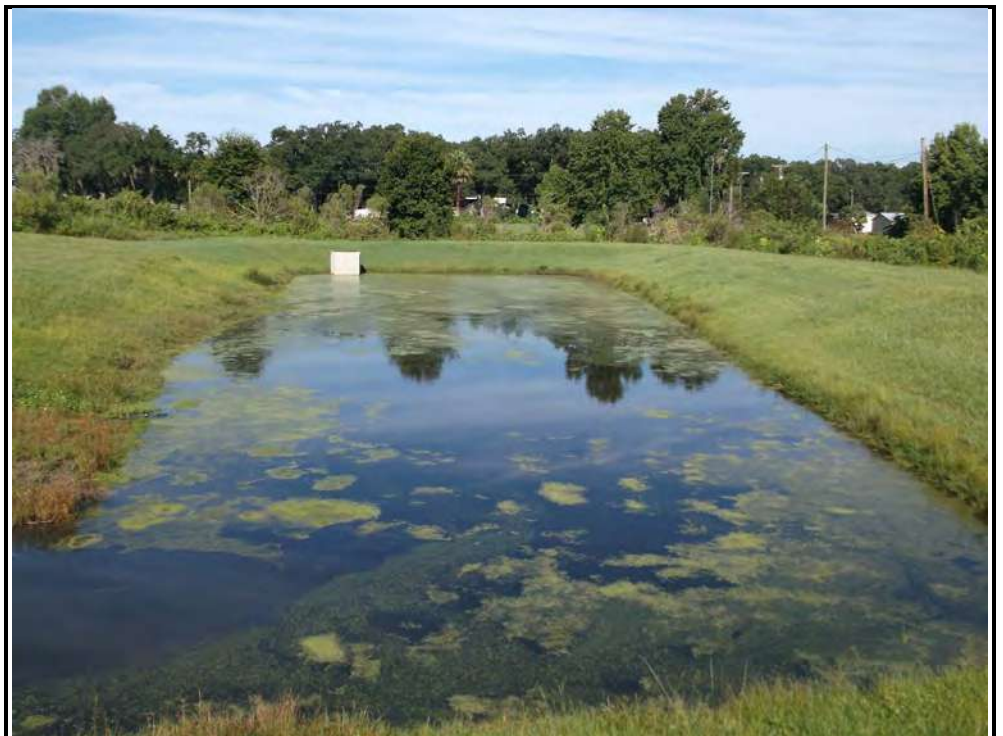
Comments: Westerly view of Pond 1300 (CDD #14)

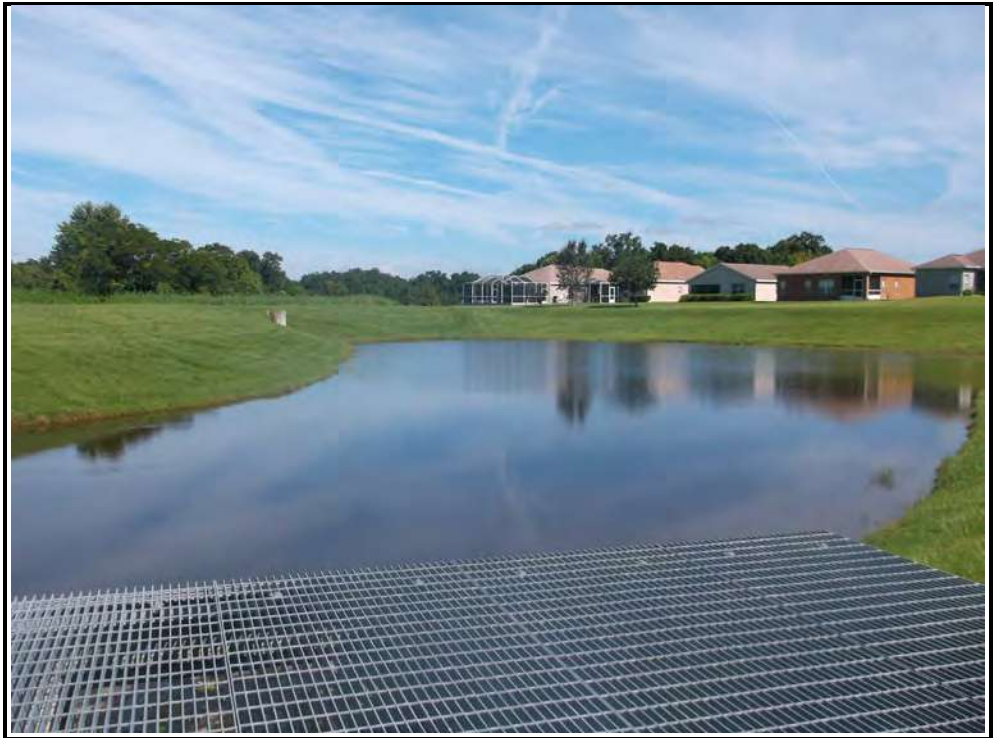
Comments: Northwesterly view of Pond 1400 (CDD #6)

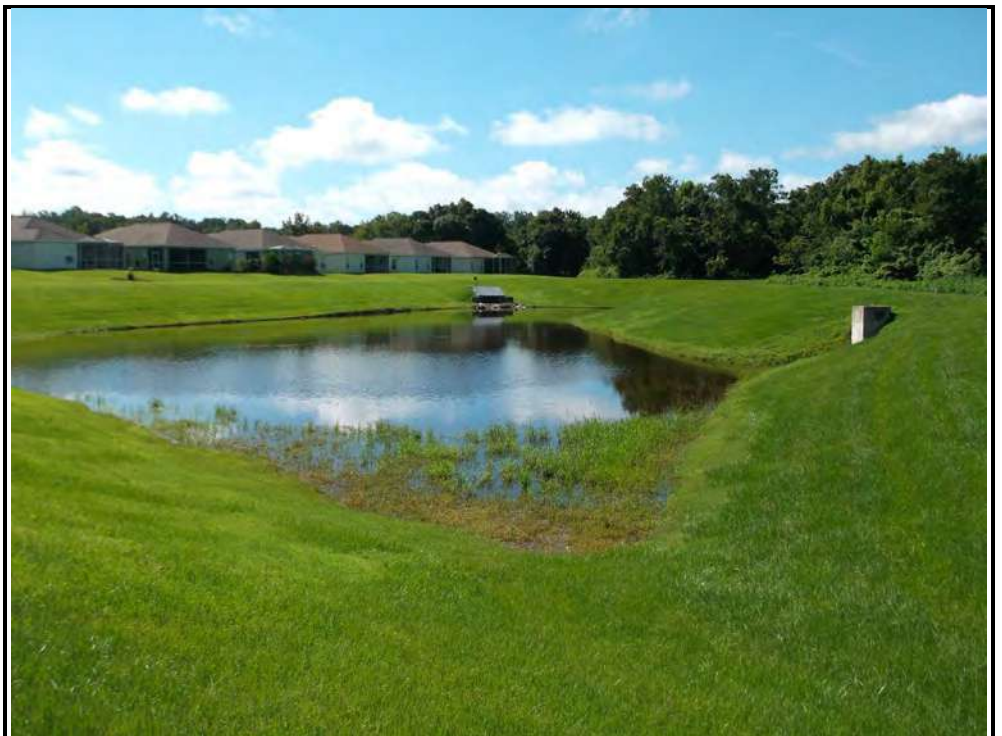
Comments: Southeasterly view of Pond 1400

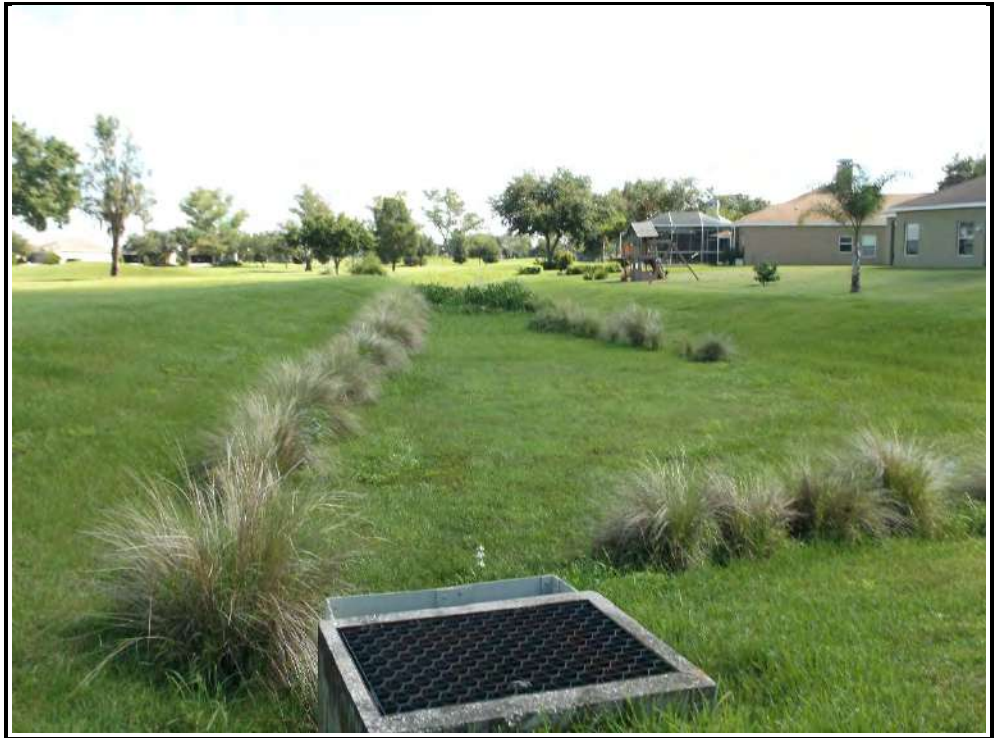
Comments: Northeasterly view of Pond 1450 (CDD #15)

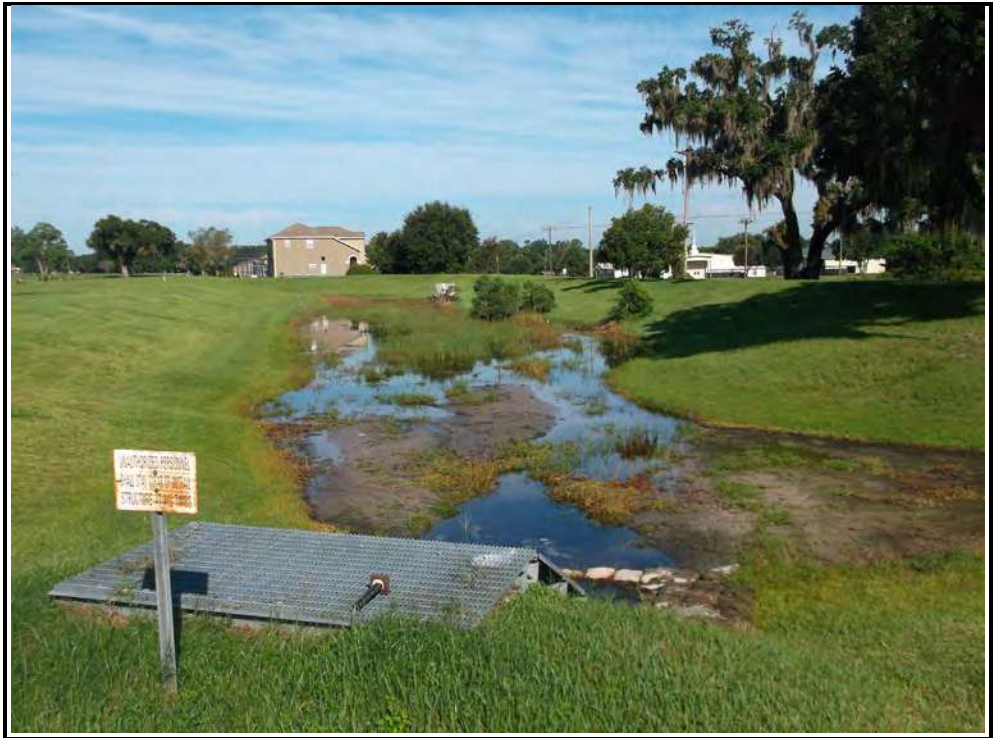
Comments: Westerly view of Pond 1350 (CDD # 13)

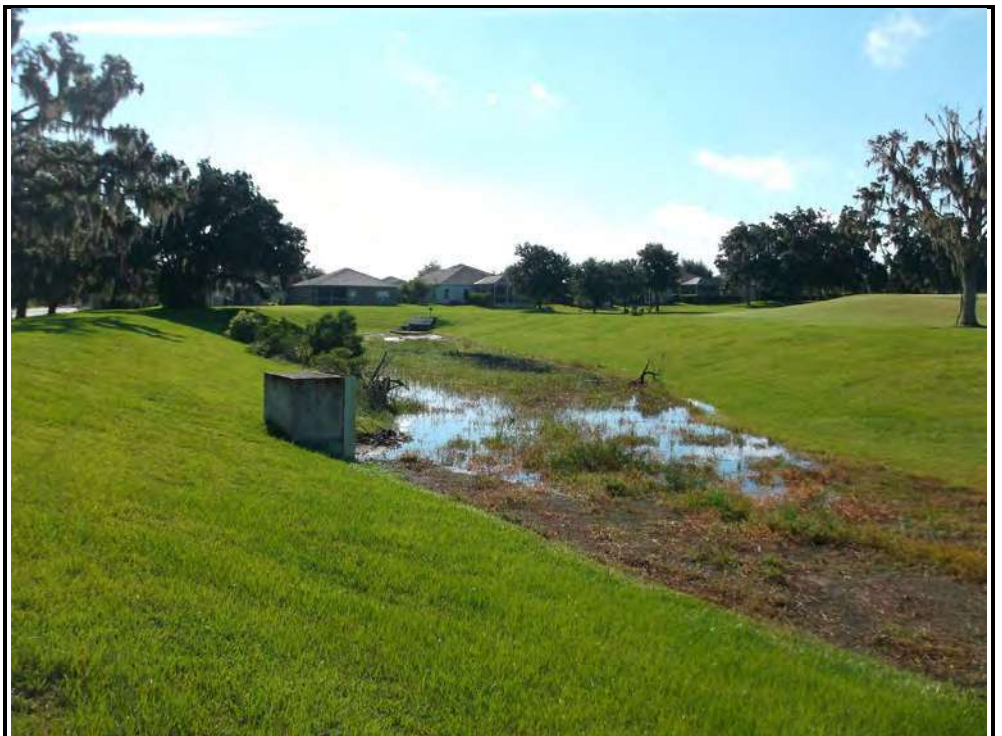
Comments: Easterly view of Pond 1350 (CDD # 13)

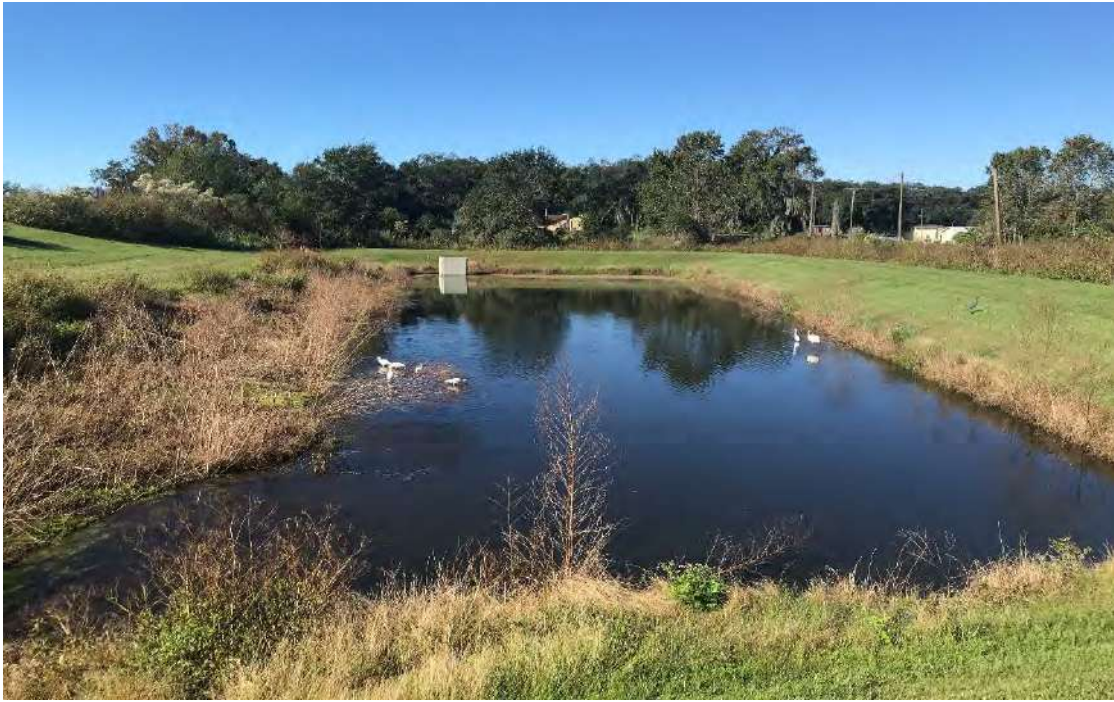
Photo 6
View of OCS 1200

<u>PROBLEM</u>	<u>RESOLUTION</u>	<u>RESPONSIBILITY</u>
1	POND 1200 OCS ORIFICE IS BLOCKED	REMOVE BLOCKAGE IN OCS 1200 ORIFICE REPAIRED 12/20	DIAMOND HILL CDD
2			
3			
4			
5			
6			
7

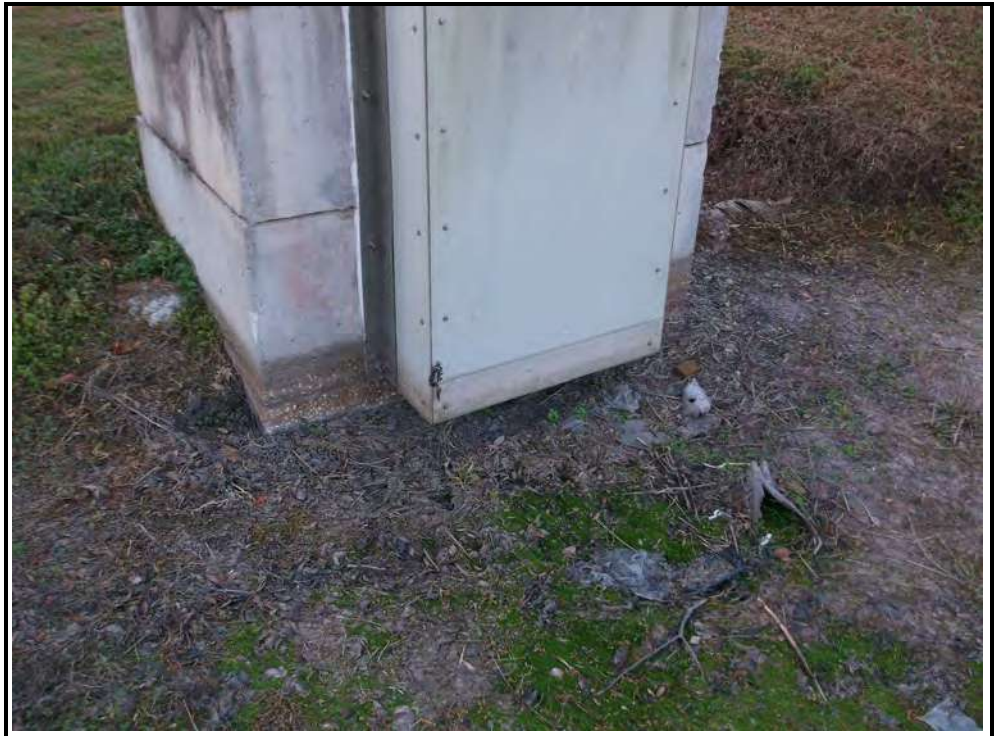
Comments: Looking at the sediment build up at CS 30

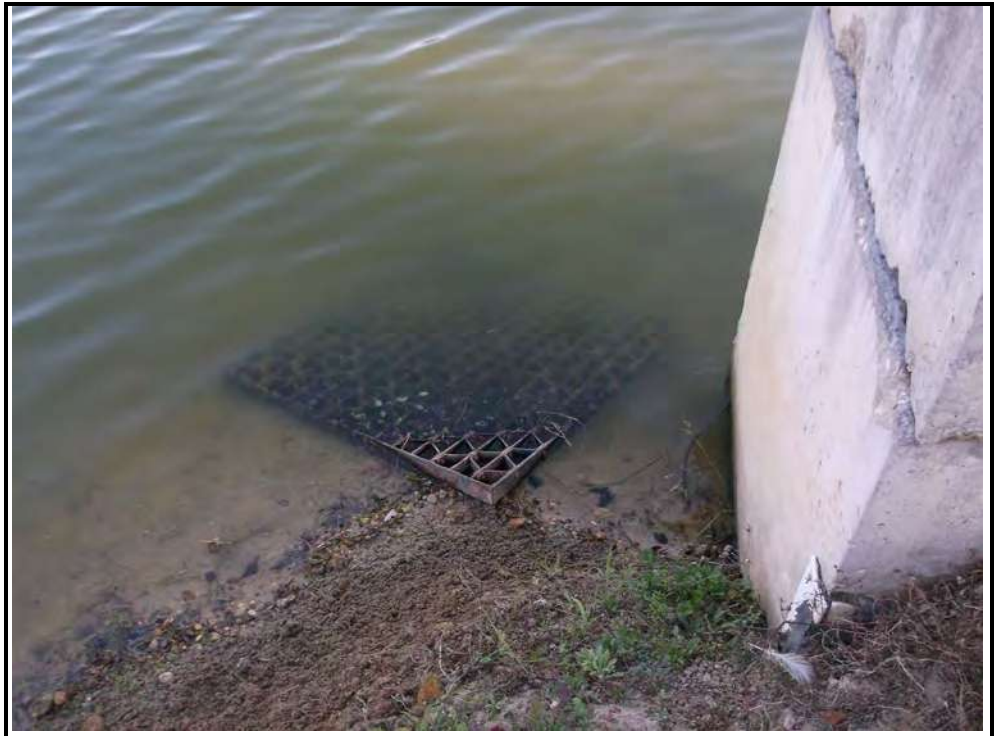
Comments: Dislodged grate from CS 40 within Pond 40

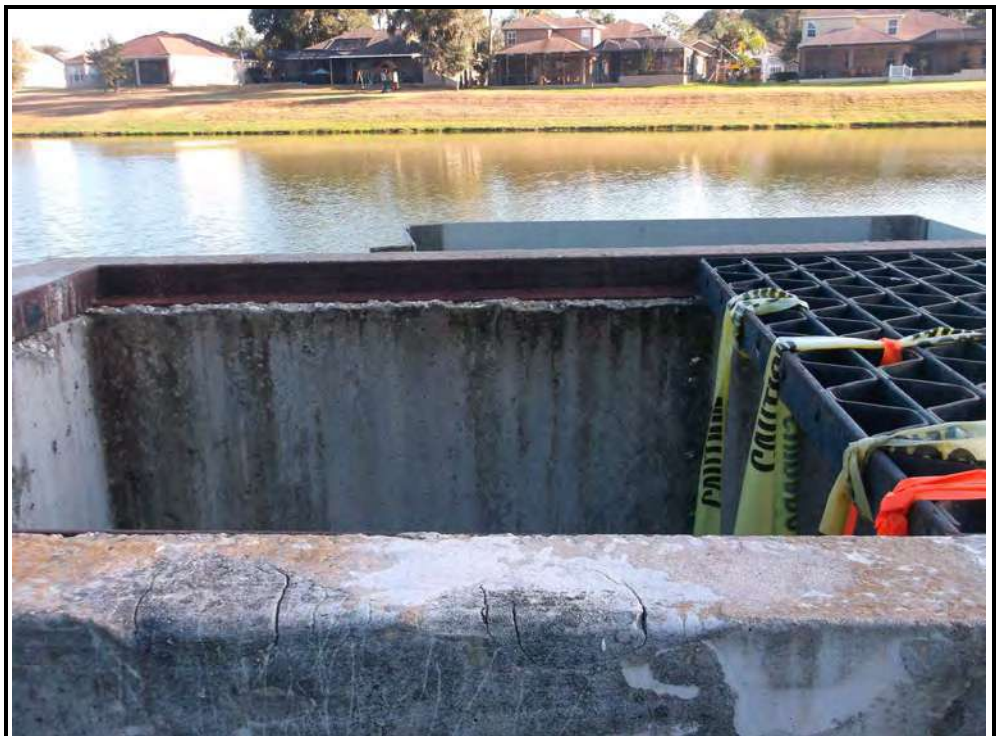
Comments: View of missing grate from CS 40

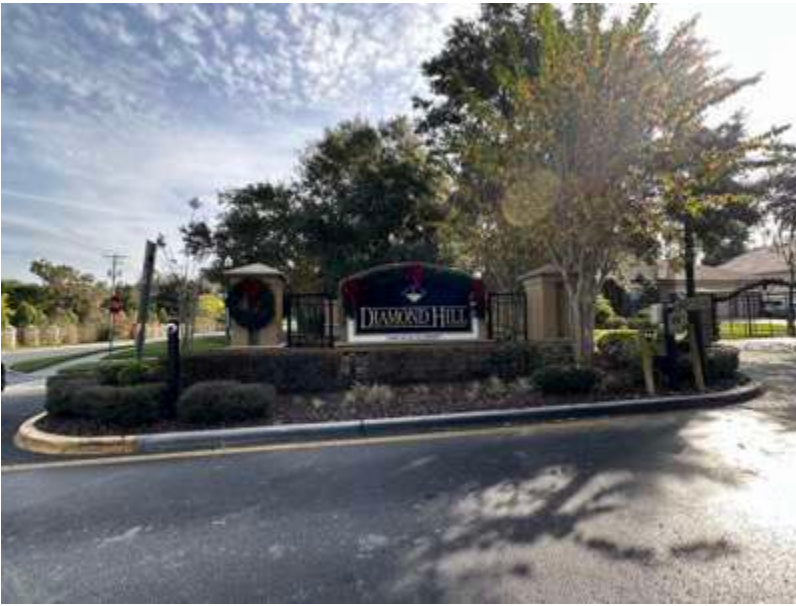
Replacement Of Aztec Grasses
May Be Needed
Cold damage to small Aztec grass.
Rejuvenation pruning will be
needed on plant material and
yellowstone will monitor recovery
into spring.

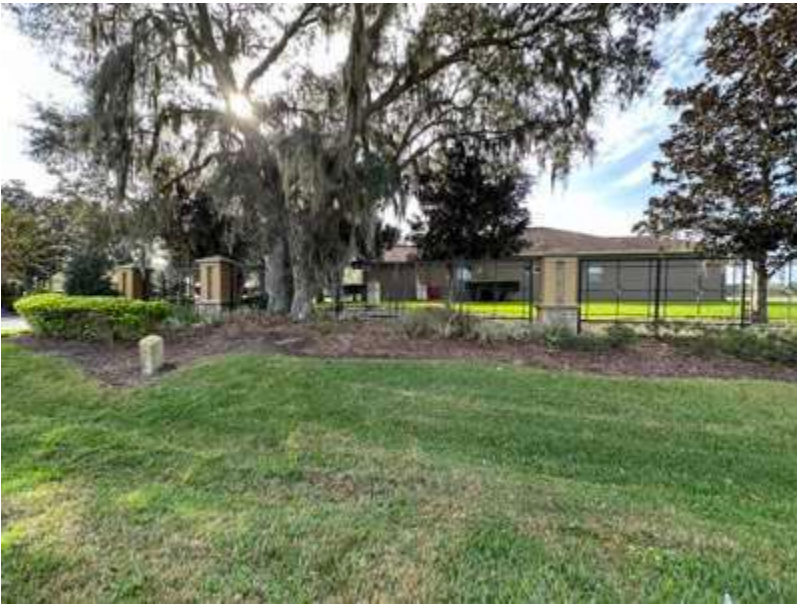
Trimming
Trimming is being completed.
Rejuvenation pruning will begin in
late February which will include
any crape Myrtle cutbacks.
Needed

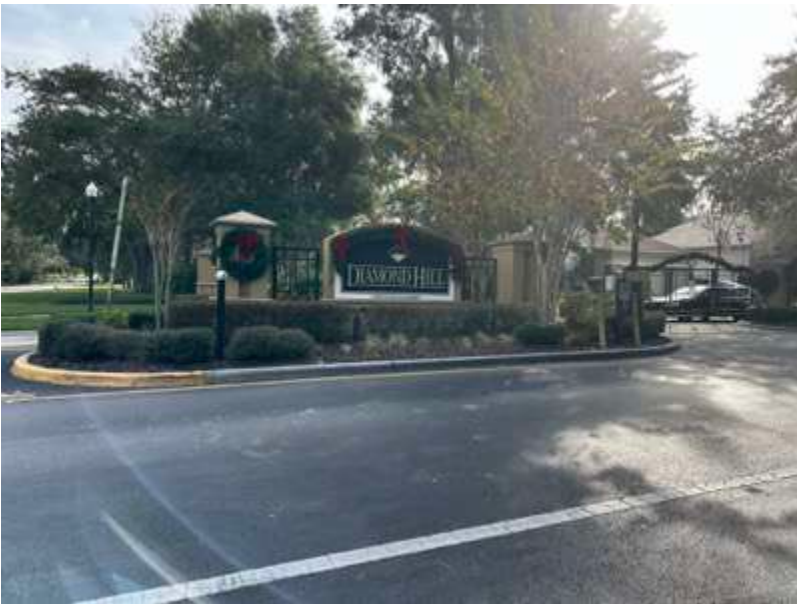
Moss Removal

Remove any low hanging moss from both entrances and all common areas throughout CDD
